March 2021  
SF617A

## **Subject: FCCC XC Orscheln Shift Actuator Software Update**

**Models Affected: Specific Model Year 2020-2021 Freightliner Custom Chassis XCR, XCM, and XCS model chassis, manufactured December 31, 2018, through August 24, 2020.**

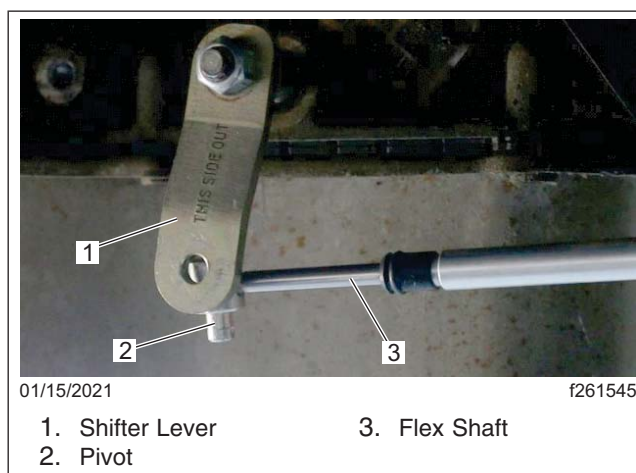
**Fig. 1, Shifter Lever and Pivot Disconnected**

5. Loosen the shifter lever jam nut.
6. Remove the cotter pin, and disconnect the shaft pivot from the shifter lever. Rotate the shaft pivot 90 degrees, so that the pivot axis is vertical and the pivot pin does not accidentally engage to the transmission lever. See [Fig. 1](#).

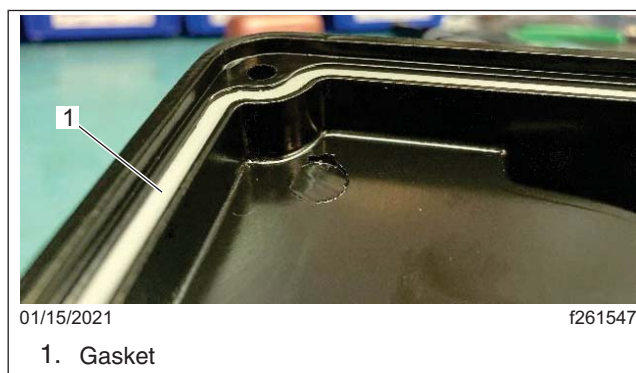
**Fig. 2, Gasket Location**

**IMPORTANT:** Take care not to damage the gasket while removing the actuator cover. Do not remove the gasket from the gasket groove. See [Fig. 2](#) for gasket location.

8. Remove the nine screws that attach the actuator cover to the actuator body. Retain the screws for reuse.

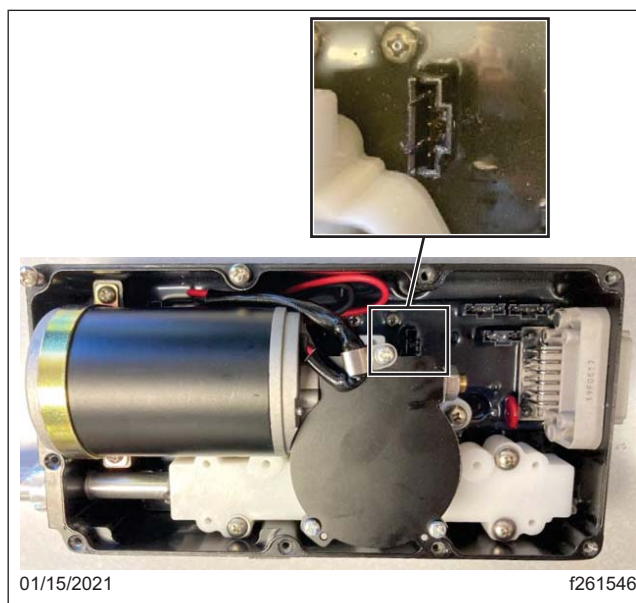
**Fig. 3, IDC Connector Port Location**

9. Connect the Orscheln® ORSEA02017-01 programmer cable into the 5-pin insulation-displacement connector (IDC) on the actuator printed circuit board (PCB). See [Fig. 3](#).

**IMPORTANT:** Do not remove the NyoGel® lubricant applied on the programming IDC port on the actuator PCB.

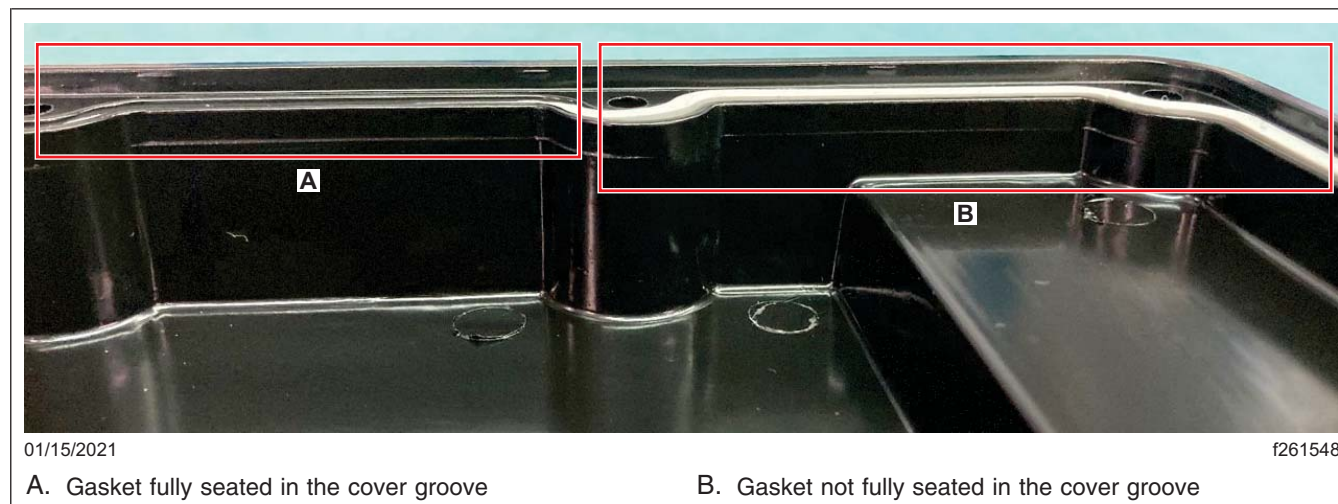
**Fig. 4, Example of Correct and Incorrect Seating of Gasket**

13. Confirm the gasket is properly seated into the groove on the cover. If the gasket is damaged, replace it. See [Fig. 4](#).

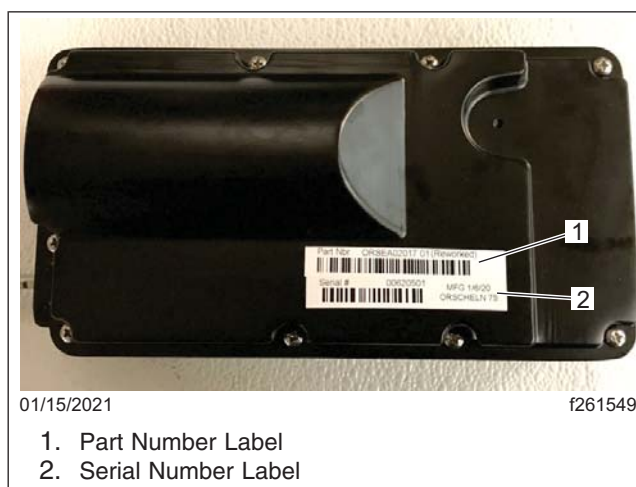
**Fig. 5, Part Number and Serial Number Label Location**

14. Place the cover onto the actuator, and install the nine screws that attach the actuator cover to the actuator body. Tighten the screws 26 lbf·in (294 N·cm).
15. Clean the part number label surface with a mixture of alcohol and water. See [Fig. 5](#). Attach the new part number label displaying P/N ORSEA02017-01 over the old part number label that displayed P/N ORSEA02001-01. Ensure not to damage/tamper the serial number. See [Fig. 6](#).
