TECHNICAL SERVICE BULLETIN

Technical Service Bulletin: 15-1308
Expiration Date: April 30, 2022

TECHNICAL SERVICE BULLETIN 15-1308 REMEDY INSTRUCTIONS

CORDLESS PLEATED SHADES CORRECTIVE ACTION FOR BALANCING SHADE

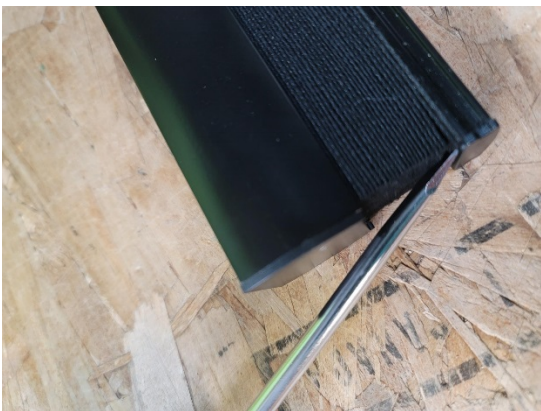
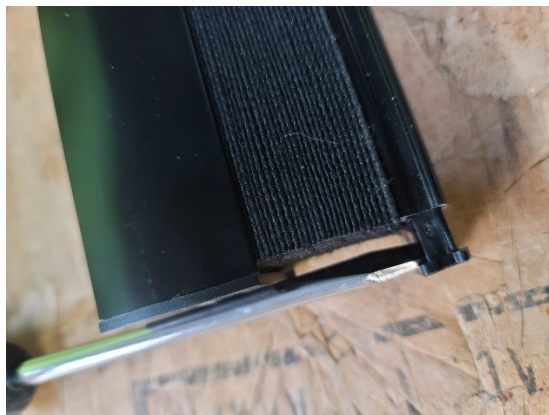
Step 1- Use the flathead screw driver to carefully remove the end cap. The end cap should slide out easily.

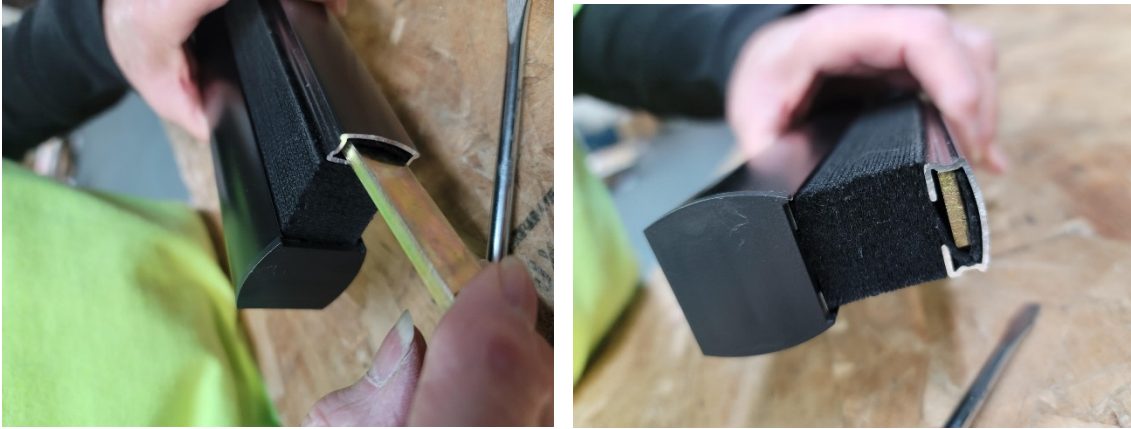
Step 2- Add the weight into the hem bar. Please refer to the chart for additional weight requirements by shade size.

Shade Size:	Width	Drop	Additional weights required
	15	24	2
	15	37	3
	16	38	3
	19	38	4
	26	24	3
	30	44	2
	39	24	3
	51	24	2
	51	37	2
	67	36	6

To determine shade size measure the width and height (drop) of the window and find the size that matches closes on the chart.

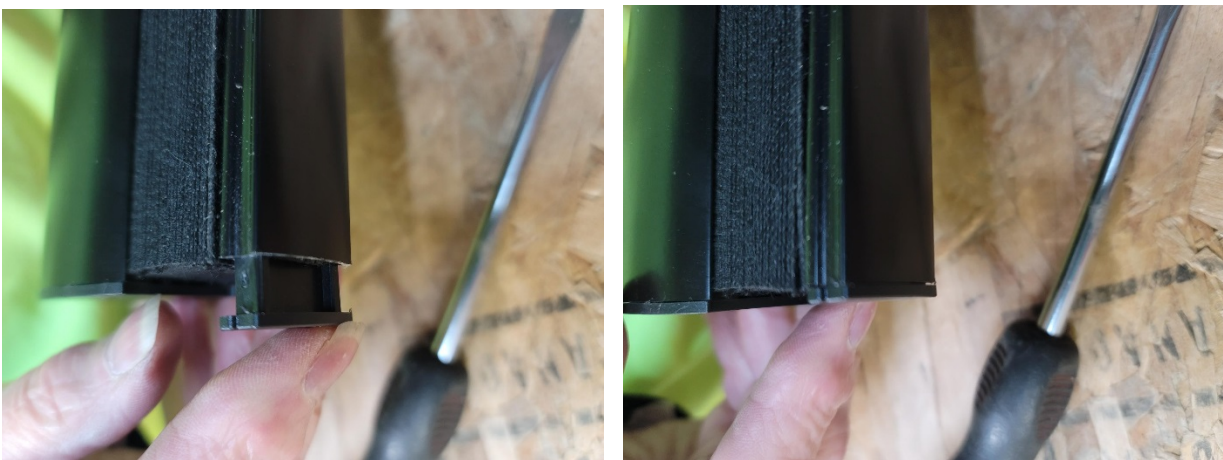
Step 3- Line the end cap up with the headrail and insert it into the rail, pushing it closed. Please note- the curved side of the cap needs to match with the curved side of the rail.

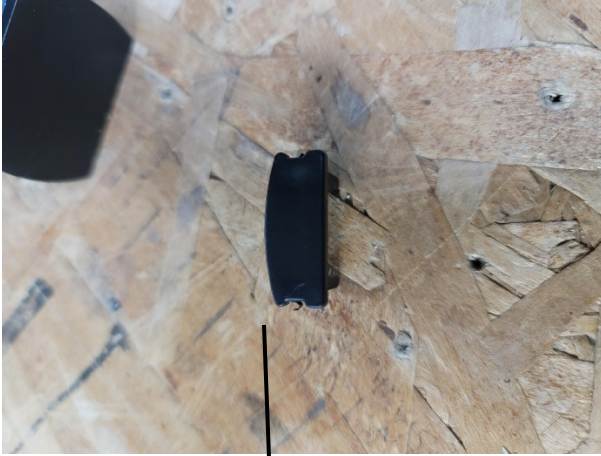
Curved side of end cap

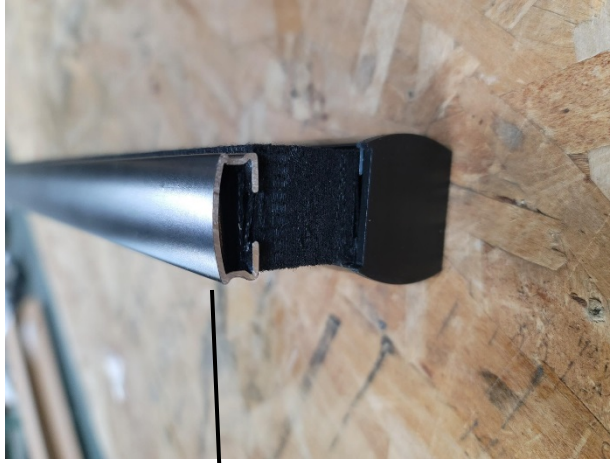
Curved side of hem bar
