Technical Service Bulletin

66 Exterior rear view mirror glass is cracked

66 21 71 2062715/1 March 29, 2021.

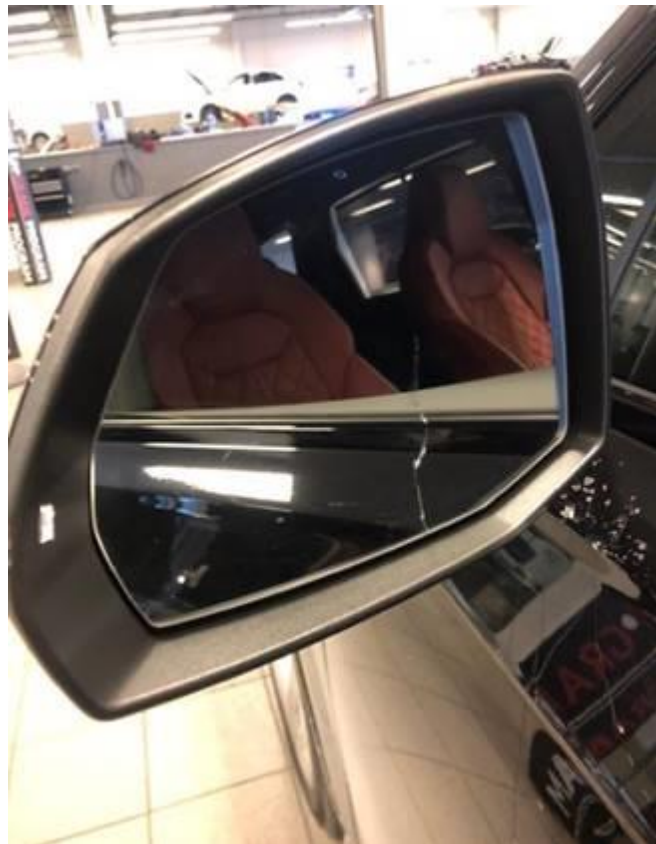
- The exterior rear view mirror glass is cracked (Figure 1).

- There is no evidence of outside influence or impact.

Figure 1. Exterior rear view mirror glass cracked.

The customer may likely describe the event as a crack forming in the exterior rear view mirror glass when the mirror glass heating was activated.

Should you receive a case where this condition is present, please order and replace not only the mirror glass but the rear view mirror mounting with electric adjuster as well. Replacement of the decorative cap and any lighting is not necessary. These components can be reused. The mirror mounting and damaged glass are both needed to analyze the root cause of this issue more accurately.

Retain the original rear view mirror mounting with electric adjuster and the mirror glass and pack both components securely such that no additional damage is sustained in shipment. Both components can be packed in a single box. These components **will** be requested for submission.
