Technical Service Bulletin

60 Sunroof glass panel or sunroof rollershade does not operate

60 21 52 2054505/3 March 26, 2021. Supersedes Technical Service Bulletin Group 60 number 20-48 dated December 9, 2020 for reasons listed below.

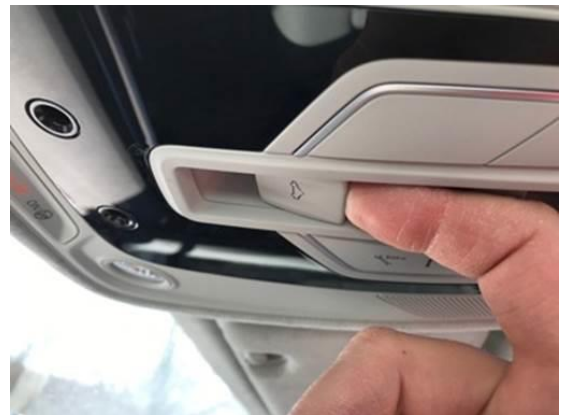
Figure 1. Set the sunroof panel basic settings by pulling the sunroof switch fully downward.

1. To set the basic settings on the sunroof glass panel drive the sunroof panel must be fully closed first. One-touch function is likely to be inactive so the panel may need to be closed holding the switch.

With the sunroof panel fully closed pull down the sunroof switch fully (past both detents) and hold it in this position (Figure 1). After 6 – 7 seconds the sunroof panel will begin to move rearward to its stop then move fully forward until fully closed. Do not release the switch from this position until the entire sequence is complete. Releasing this switch during the sequence will cause the basic settings to fail. It must then be repeated starting with a fully closed sunroof glass panel.

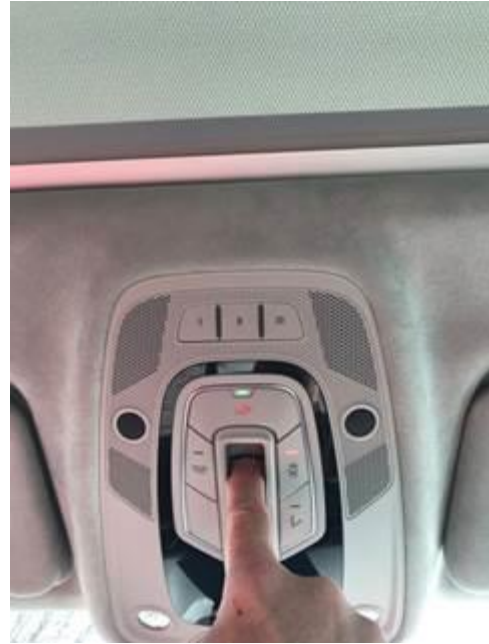
Figure 2. Set the sunroof shade basic settings by pushing the sunroof shade switch fully forward.

2. As in the procedure for setting the basic settings for the sunroof panel, the sunroof shade must be fully closed first as well. One-touch function is likely to be inactive so the shade may need to be closed holding the switch.

With the sunroof shade fully closed push the sunroof shade switch fully forward (past both detents) and hold it in this position (Figure 2). After 6 – 7 seconds the sunroof shade will begin to move rearward to its stop then move fully forward until fully closed. As in the case for the sunroof glass panel drive, do not release the switch from this position until the entire sequence is complete. Releasing this switch during the sequence will cause the basic settings to fail. It must then be repeated starting with a fully closed sunroof shade.

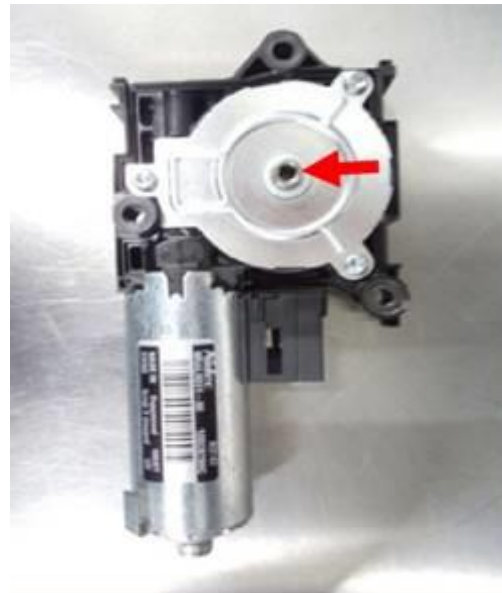
Figure 3. Sunroof motor V1 or sunroof sunshade motor V260.

3. If this adaptation procedure is not successful, gain access to either the sunroof motor V1 or to the sunroof sunshade motor V260. Using an Allen wrench de-couple the motor and depending on the sunroof panel or sunshade position manually turn the motor approximately $\frac{1}{4}$ turn in a free direction (e.g. open if component is closed, closed if component is open) then $\frac{1}{4}$ back. Neither the sunroof motor nor the sunroof sunshade motor (Figure 3) need to be removed for this step. In many cases this will reestablish the hall sensor orientation and the adaptation will then run. Try to run the adaptation procedure again.
