SERVICE BULLETIN

APPLICABILITY: 2020MY Legacy & Outback **NUMBER:** 12-315-21
SUBJECT: Steering Column Cover Rubbing -Type Sound **DATE:** 03/10/21

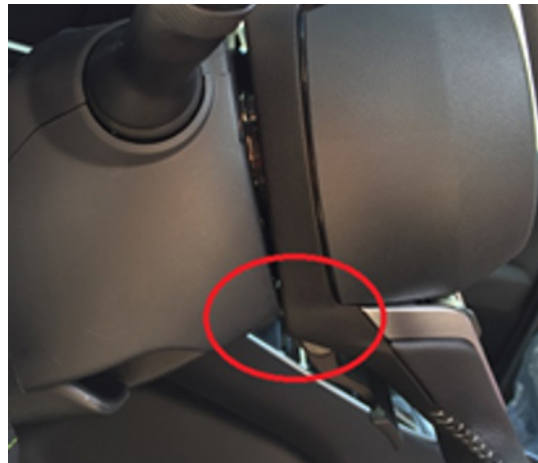
This bulletin announces a design change made to the steering column cover in response to customer concerns of a rubbing -type sound heard when turning the steering wheel. When the steering column is tilted upward and into the proper position, the back of the steering wheel may contact the lower portion of the column cover trim. A cushion has been added inside the cover to prevent the contact and eliminate the sound.

NOTE: The new cover assembly includes both the upper and lower sections.

Description	Part Number	Application
COVER ASSEMBLY- COLUMN	34341AN10B	Key Start Models
	34341AN11B	Push-Button Start Models
