Title: CV Air Spring Failure in Roll-Back / Wrecker-Hook Applications

Applies To: Vehicle Applications: Roll-Back & Wrecker-Hook (Recovery) built before 11/9/20 with feature codes 14TBL or 14TBM or 14TDG IROS Suspension and with 0014899 Suspension air control valve pressure release in cab SUSPENSION, REAR, AIR, SINGLE

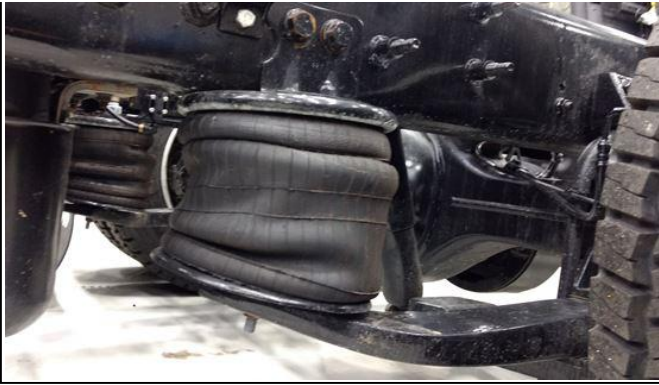
Figure 1: Normal view of air spring when suspension is dumped

In normal application conditions when switching feature code 0014899 to dump, the height control valve receives command to exhaust air and not refill the air springs until receiving fill command. When the rear air springs do not have air the frame rail will rest on the axle stops. The air springs are not pinched between the top and bottom plates (Figure 1).

Picture taken after suspension has fully dumped

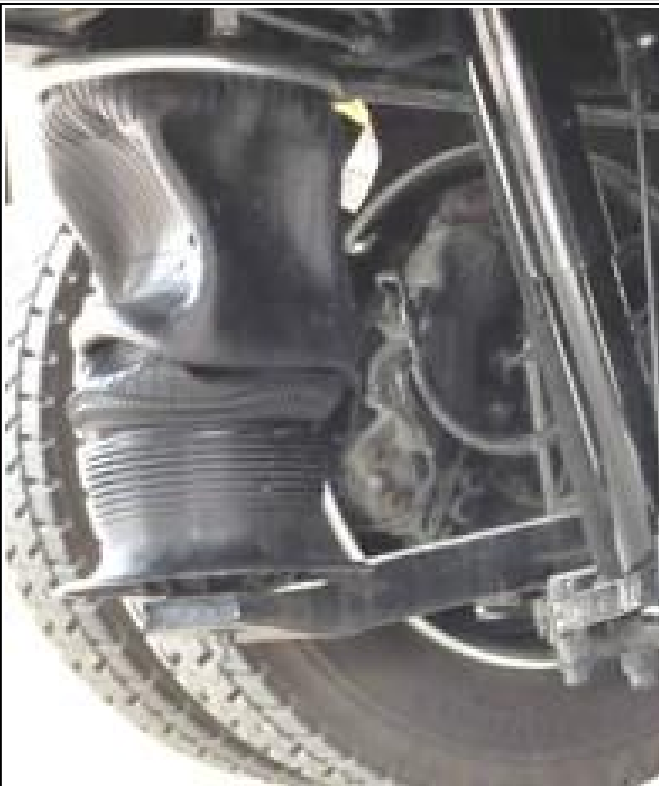
Figure 2: Collapsed Suspension Air Spring

In Roll-Back & Wrecker-Hook (Recovery) applications built before 11/9/20 with IROS suspension feature codes and suspension dump feature code 0014899, air spring failure may occur under certain circumstances when the air spring is pinched between the top and bottom plate. Body builder designs may not restrict the range of motion for hydraulic body controls which cause the frame rail to rise from the axle stops and the air springs to be stretched open & collapse without air pressure (Figure 2). The operator retracts the hydraulics toward the stowed position, the frame rail lowers back onto the axle stop and pinches the collapsed air spring (Figure 3). A pinched air spring may leak air (Figure 4). In some cases, the rubber may also be dislodged from the bottom spring plate (Figure 5).

Picture taken when body builder hydraulic controls are operated while suspension is dumped

1. Park vehicle on dry, level ground, install wheel chocks, set parking brake, and place transmission in Park
2. Replace both rear air springs and both rear shocks with the part numbers provided in this document using [CV Technician Manual \(Service & Diagnostic\) 0001111853](#)
3. Remove wheel chocks, repair complete

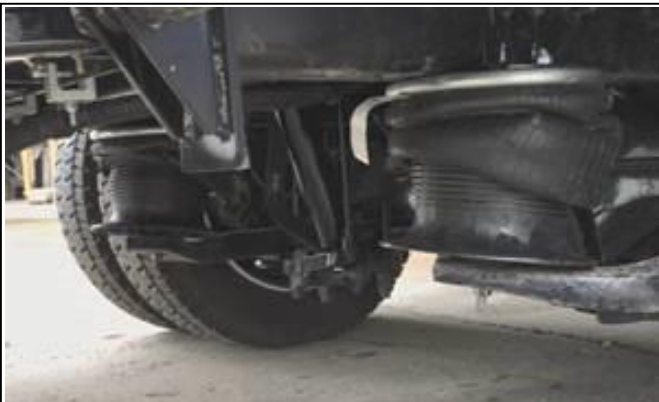
Figure 3: Pinched Suspension Air Spring (CONDITION IS NOT NORMAL)

Picture taken when body builder hydraulic controls are operated back towards the stowed / transport position while suspension is dumped

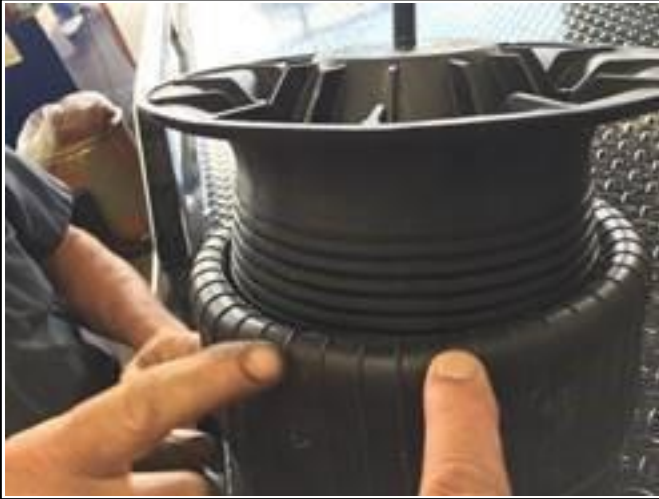
Figure 4: Torn Air Spring

Picture taken after air spring has been removed from vehicle to inspect for leaking air

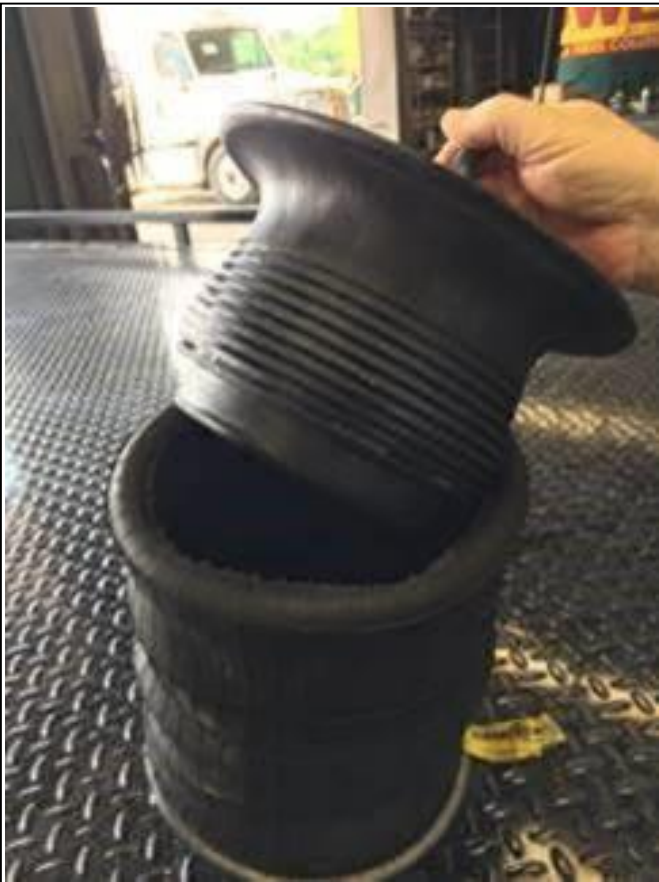
Figure 5: Damaged Air Spring

Picture taken after air spring has been removed from vehicle to inspect for leaking air
