Document ID: IK0500038

Title: **Steering Shake, Shimmy, Shudder, wobble, Steering Vibration**

Applies To: **LT/RH & Prostar/Lonestar with 14k front weight rated axles and below**

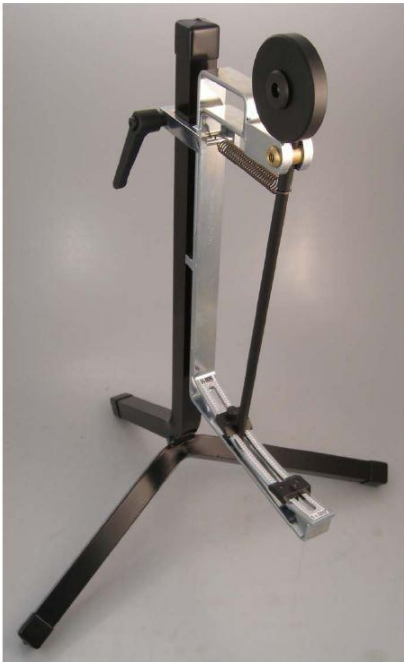
| Step | Action | Decision |
|---|---|---|
| 2 | <b>DIAGNOSTIC: Tire Pressure, Runout and Balance</b><br><br>Tire balance and runout are the primary factors in determining the likelihood of entering a shimmy event<br><br>Under-inflated tires can cause poor handling, fast and/or irregular wear, decreased fuel economy and permanent structural damage to the tire.<br><br>Overinflating can reduce traction, braking ability and handling, as well as result in uneven wear and an uncomfortable ride.<br><br><u>Check front tire's cold inflation pressures daily, for specification refer to owner's manual.</u><br><br>Measure lateral and radial run out on all tires using the tire runout gage RN 4532000. <a href="#">Tire Runout Gage Instructions Navistar PN 4532000</a><br><br><br><br>Specification:<br><br>LoneStar LT/RH refer to the Truck Service Manual 0000885380.<br><br>All other vehicles: lateral and radial run out must be below .065".<br><br><b>Is lateral and radial run out within specification?</b><br><br><b>Uneven Wear:</b> Check tread depth and note if tread is evenly worn. Minimum tread depth is 3 mm (4/32) on front tires and 2 mm (3/32) on other tires. Look for cuts or other damage to the tread sidewalls.<br><br><b>Wheel Balance:</b> Ensure tires are properly static and dynamically balanced.<br><br>For LoneStar LT/RH refer to the Truck Service Manual 0000885380. | Yes: Please proceed to step 3.<br><br>No: Correct tire pressure, wear, runout and balance then proceed to step 3. |

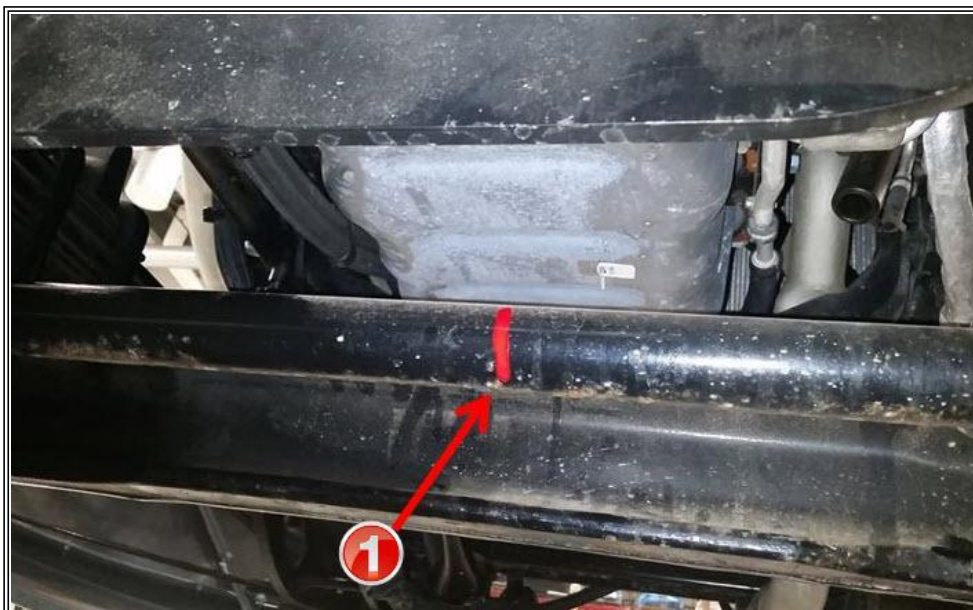
Figure 1: Tie rod assembly

Item 1: Tie rod assembly centerline

1. Ensure the vehicle has been driven and re-evaluated with the high friction composite bearing and rear engine mounts installed, prior to installing a steering stabilizer.
  - Steering stabilizer should not be installed unless re-evaluation is complete
  - Steering stabilizer should not be installed proactively
2. Shift transmission to Park or Neutral, set parking brake, and install wheel chocks.
3. Remove the front U-bolt from the passenger side steer spring and discard.
4. On the tie rod assembly, measure the distance between the right and left grease zerks.
5. Divide your measurement from step 4 by two. (This will help locate the centerline of the tie rod assembly)
6. Mark the centerline of the tie rod assembly per figure 1 & 2.

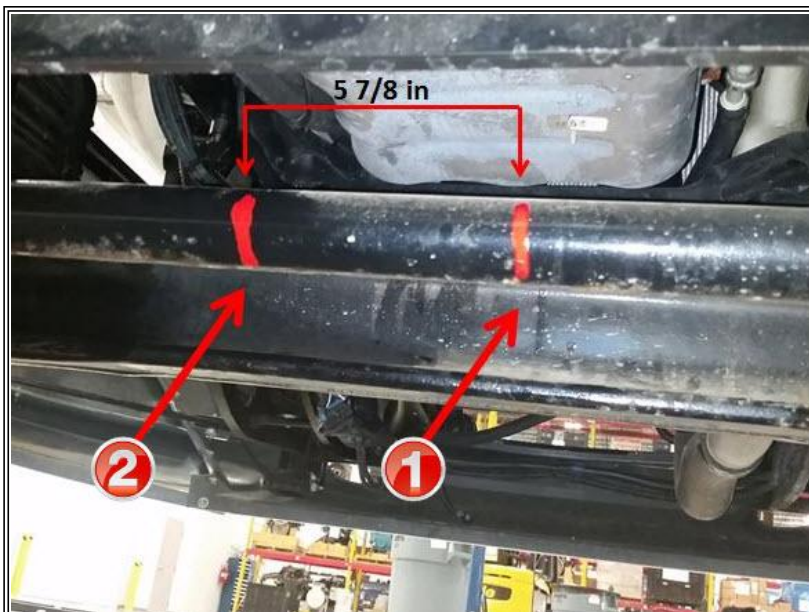
Figure 3: Tie rod assembly

Item 1: Tie rod assembly centerline (first mark)  
Item 2: 5 7/8 from tie rod assembly centerline (second mark)

7. From the tie rod assembly centerline, make a second mark 5 7/8 in towards the driver's side per figure 3. This will be the mounting location of the tie rod mounting plate.
