# TECHNICAL SERVICE BULLETIN

Technical Service Bulletin: 67-1311

Forest River is alerting you to an issue involving certain 2021 Shockwave and Sandstorm Toy Haulers. Please see the information below, which describes the issue and provides you with details on the steps you should take to have your vehicle repaired.

# TECHNICAL SERVICE BULLETIN 67-1311 REMEDY INSTRUCTIONS

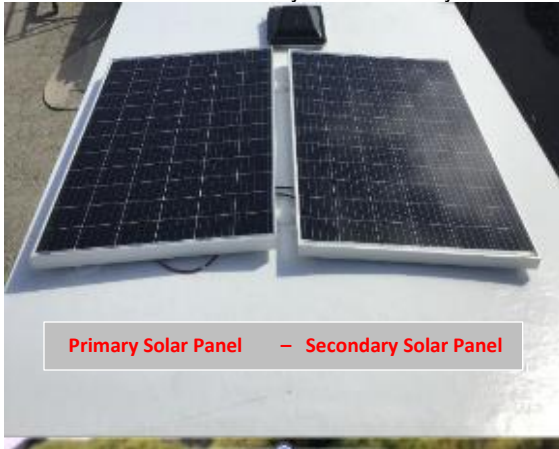
FIG - 1 Solar Panels – Primary and Secondary Panels

- Step 1. Locate dual solar panels on rear rooftop of RV. Prepare for access to roof area;
- Step 2. Solar panel on door side is considered Primary Solar Panel No# 1 Solar Panel. Solar panel on the roadside considered Secondary Solar Panel No# 2 (FIG 1);

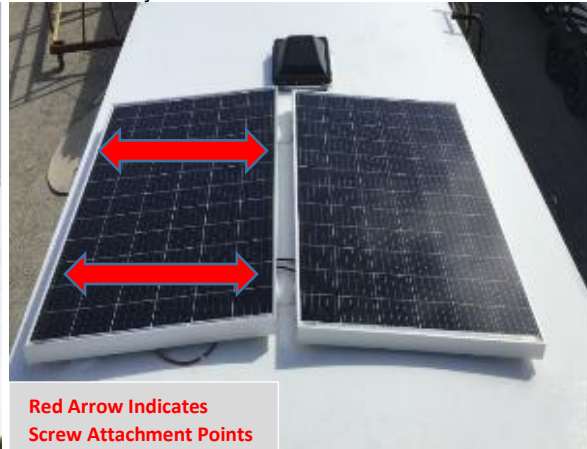
FIG - 2 Primary Solar Panel – Screw Removal Points

- Step 3. At the primary solar panel locate and remove (8) screws (2) at each support bracket located under sealant that attaches solar panel to roof (FIG 2) (setscrews aside for reinstall in later step);

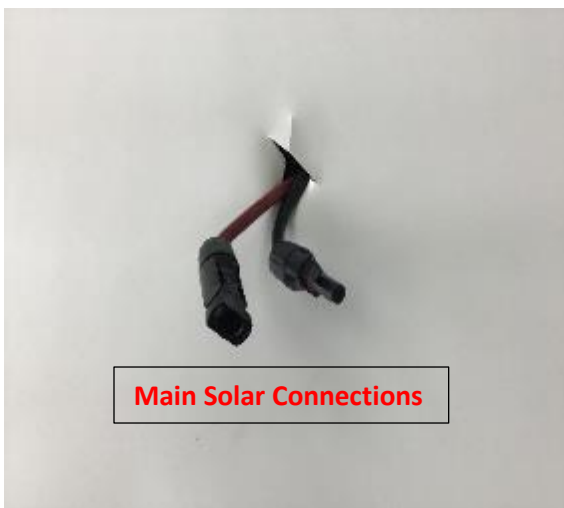
FIG - 3 Main Harness at Roof from Solar Controller

- Step 5. When all wiring and t-connectors are removed & disconnected wires present will be – male & female wire leads coming up through roof (FIG 3) these wires are the main power feed wires to interior solar controller. (2) male & (2) female wires leads from primary and secondary solar panels are now from solar panels. Disregard any prior installed t-connectors (do not reuse);

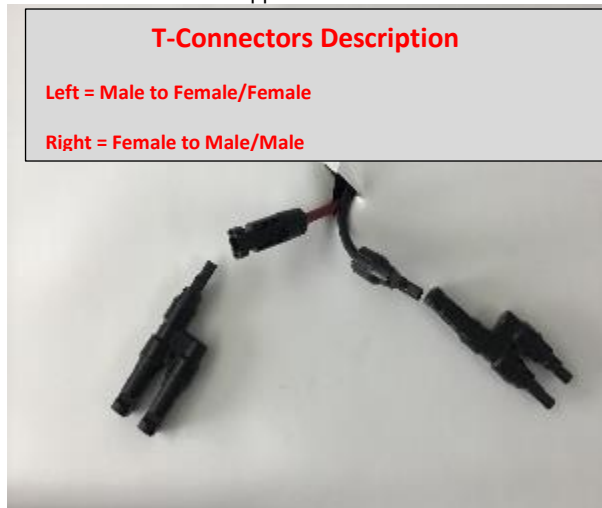
FIG - 4 T-Connectors Supplied

## T-Connectors Description

Left = Male to Female/Female

Right = Female to Male/Male

- Step 6. Install supplied t-connectors (1) male/female/female and (1) female/male/male t-connectors (FIG 4) to main power feed wires shown in (FIG 3). Ensure all new connections snap/lock in place. Perform a pull test at new connections. Newly installed t-connection should be installed as shown in (FIG 5);

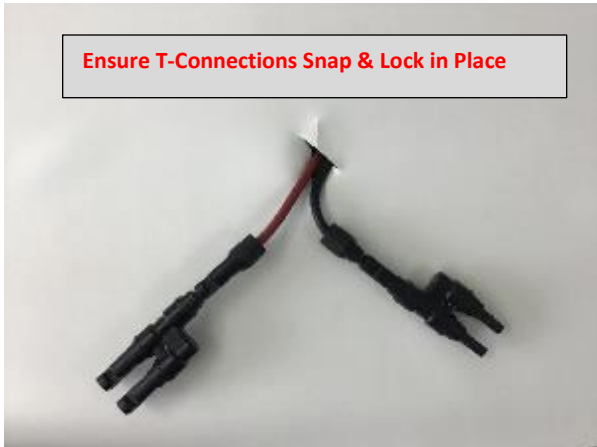
FIG – 5 Installed T-Connectors at Roof Power Feed

Ensure T-Connections Snap & Lock in Place

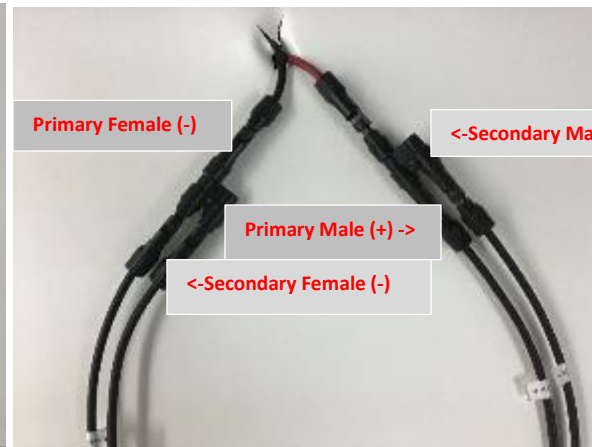
FIG - 6 Final Connections Solar Panels Roof Power Feed

Primary Female (-)

<-Secondary Male (+)

Primary Male (+) ->

<-Secondary Female (-)

- Step 7. Connect Primary Solar Panel no#1 wire leads male/female panel wiring to t-connections male and female connections (FIG 6);
- Step 8. Connect Secondary Solar Panel no#2 wire leads male/female panel wiring to t-connections male and female connections (FIG 6) Included in the TSB parts kit contains 2 ea. 3' lead extension male/female pigtailed. Extensions can be used if wiring is not the able to reach the connections from secondary solar panel #2 to primary solar panel #1 that contain the t- connectors. (fig 7);

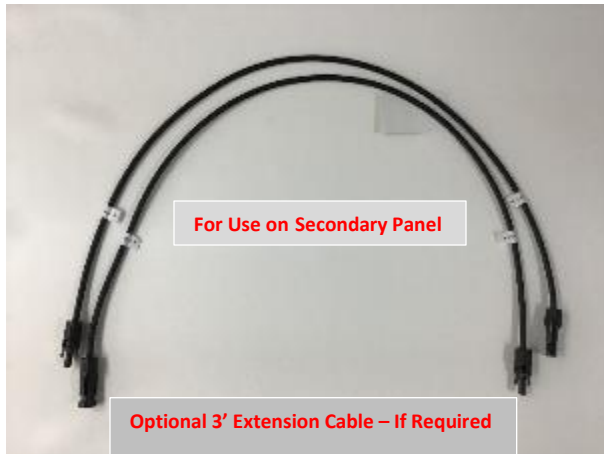
FIG - 7 Secondary Panel 3' Lead Extension Cable.

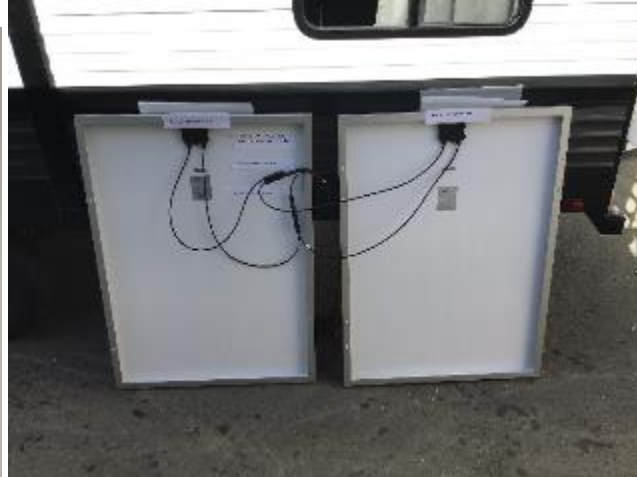
FIG - 8 Primary & Secondary Solar Panels Connected

- Step 9. Once primary and secondary solar panels are connected at t-connectors wiring will be shown as in as in (FIG 8) Note – this is a just a wiring reference photo;
