Subject: FUSES REMOVED AT THE FACTORY HAVE CHANGED	Service Alert No.: SA-024/21
	Last Issued : 03/25/2021

2021 CX-5 vehicles with 10.25" center display

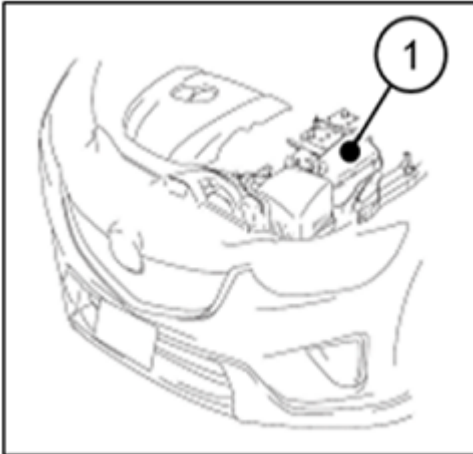
(1) Relay and Fuse block

The fuses removed from the relay and fuse block (1) are as follows:

- **Previous** Room (15A), Audio1 (15A)
- **New** Room (25A), BOSE (25A)

NOTE: The new BOSE fuse is in the same location as the previous Audio1 fuse.

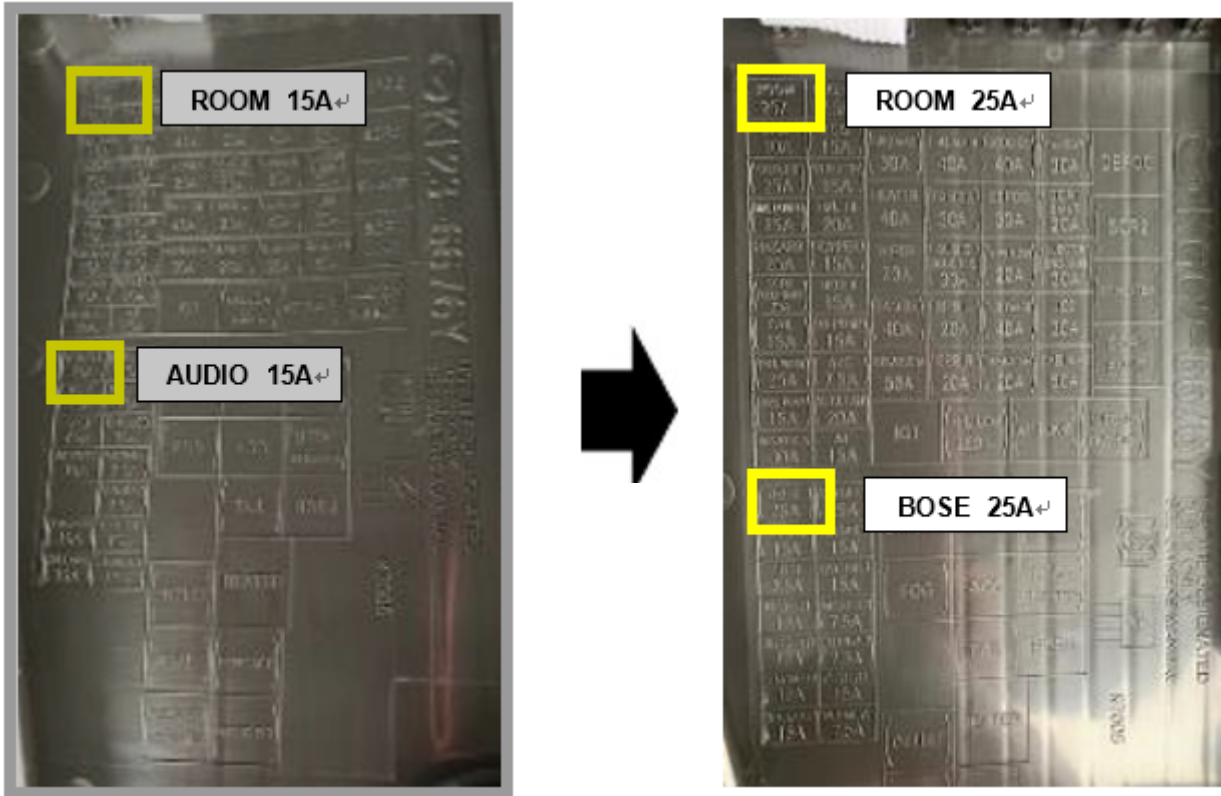
Previous CX-5

Insert 15A fuses in the ROOM / AUDIO locations.

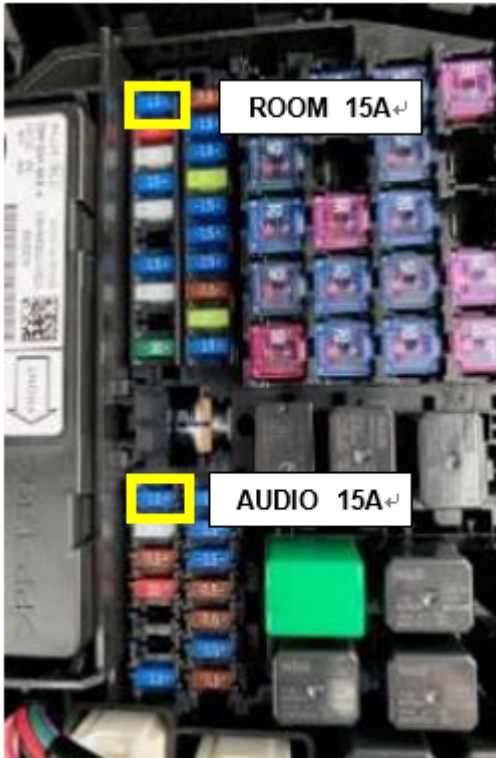
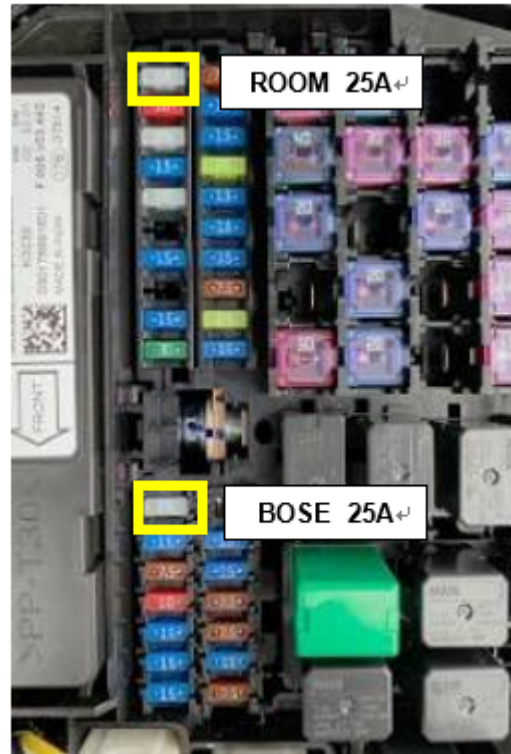
CX-5 Vehicles with 10.25" center display

Insert 25A fuses in the ROOM / BOSE locations.
NOTE: Without the BOSE fuse inserted, MAZDA CONNECT will not operate.
