# Technical Service Bulletin

GROUP <b>CAMPAIGN</b>	NUMBER <b>21-01-015H</b>
DATE <b>MARCH 2021</b>	MODEL(S) <b>Hyundai Genesis (DH)</b>

**SUBJECT:** HYUNDAI GENESIS (DH) BRAKE TUBE REPLACEMENT (SALT BELT STATES) (SERVICE CAMPAIGN T5W)

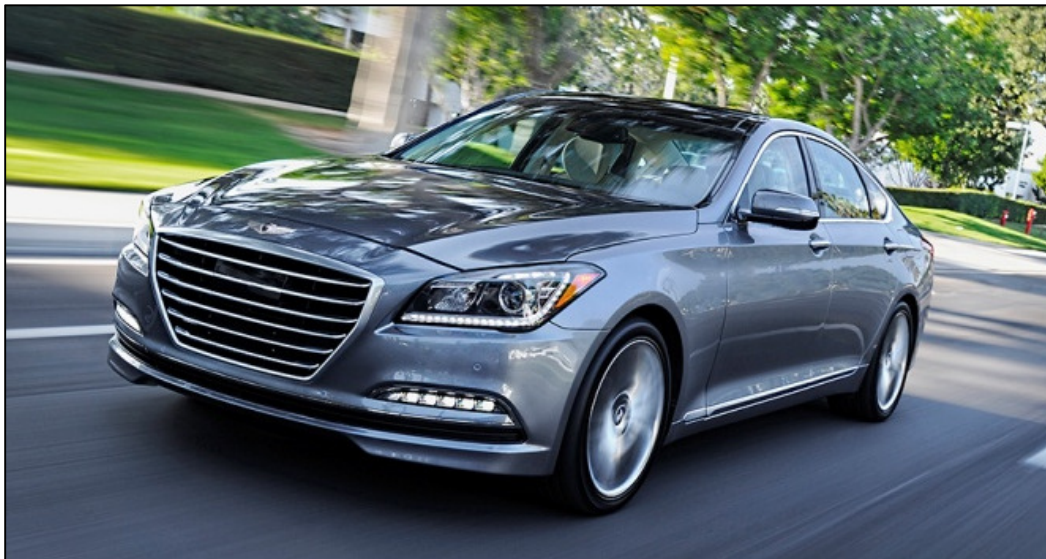
**Description:** This bulletin describes the procedure to replace the brake tube assemblies for certain 2015MY Hyundai Genesis (DH) vehicles located in the salt belt states. Salt belt states are listed below in **Applicable Vehicles**.

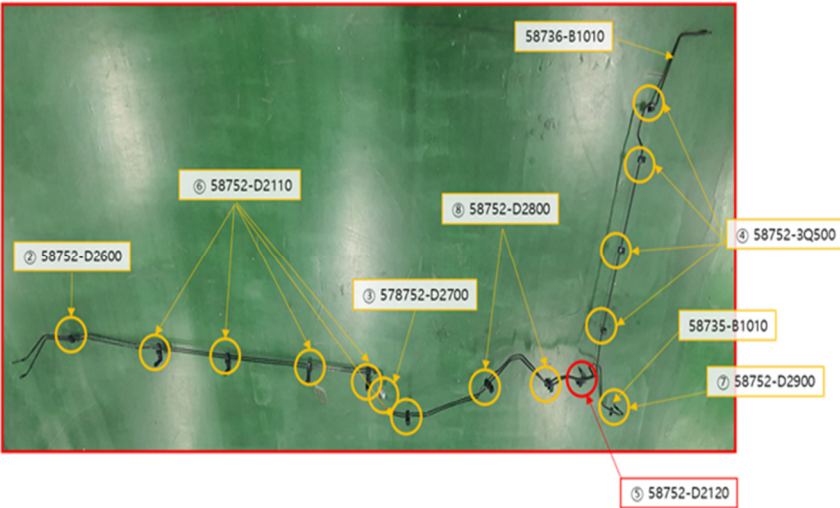
Part Information	Part Number	Remarks
<p align="center"><u>Brake Tube Assy</u></p>

<p align="center">58730-B1010-QQH</p>	<p align="center">QQH part number includes all required tube and holder assemblies.</p>
<p align="center"><u>DOT 4 Brake Fluid</u></p>

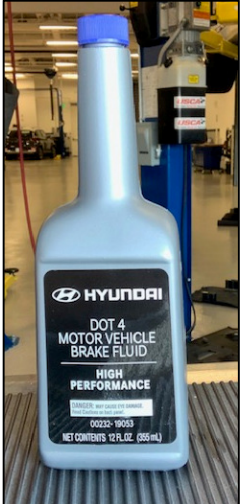
<p align="center">00232-19053</p>	<p align="center">Two 12-ounce bottles required per vehicle.</p>

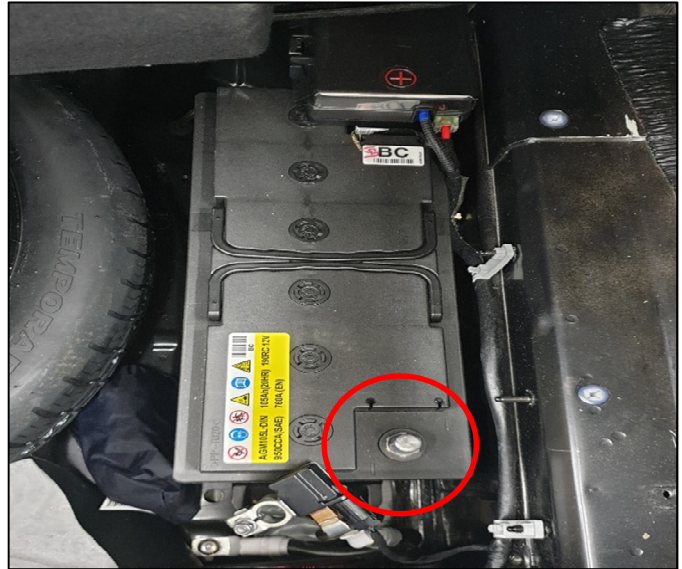
Disconnect the negative battery terminal.

<b>lb.ft</b>	•2.9 - 4.3
<b>kgf.m</b>	•0.4 - 0.6
<b>N.m</b>	•3.9 - 5.9

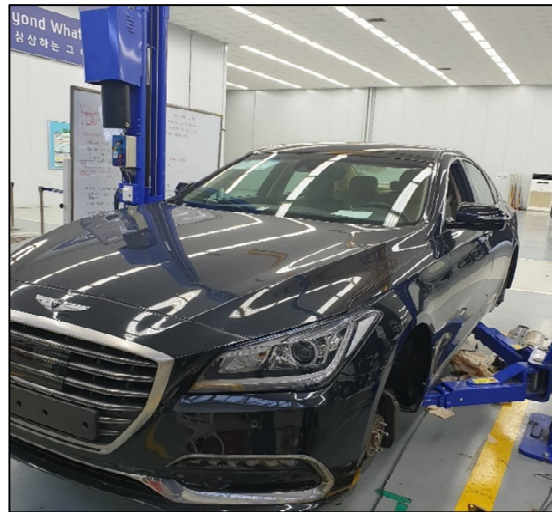
2. Lift the vehicle and remove the front left, rear left, and rear right wheels.

<b>lb.ft</b>	•79.6 - 94.0
<b>kgf.m</b>	•11.0 - 13.0
<b>N.m</b>	•107.9 - 127.5

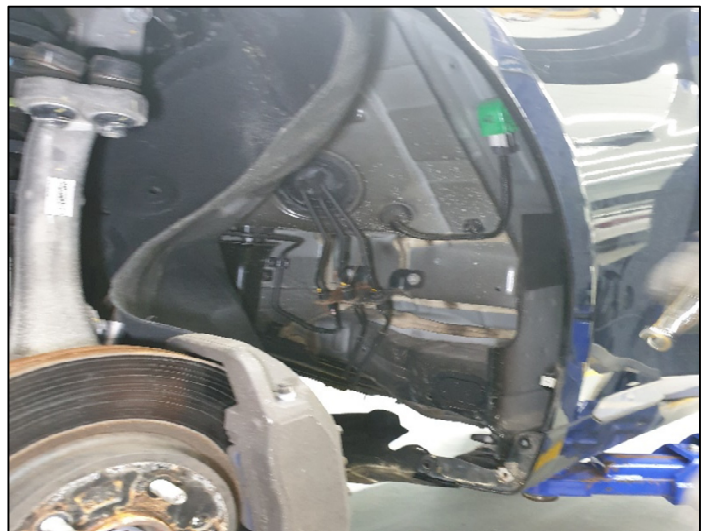
3. Access the brake lines through the wheel wells by loosening and moving the front left, rear left, and rear right wheel fender liners.

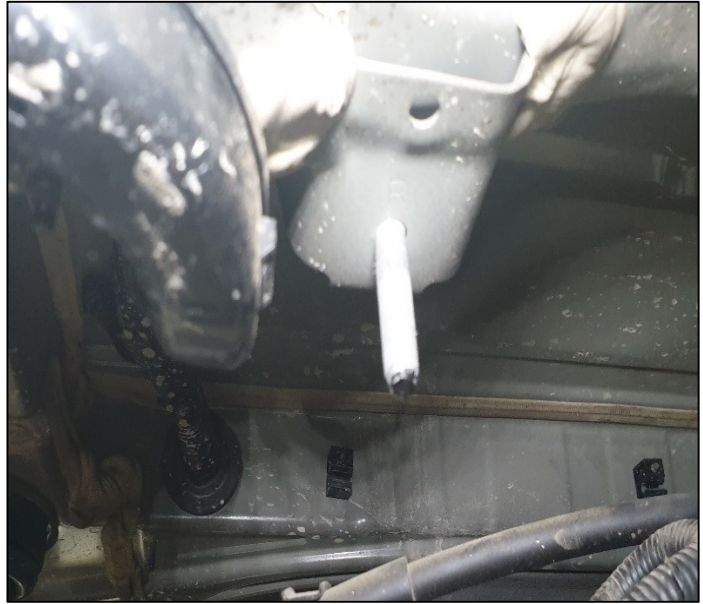
6. After removing the fuel tank and rear cross member assembly, remove the brake tubes and the holders from the body.

**Use a container to catch any remaining fluid from the disconnected brake lines as the lines are removed from the vehicle.**

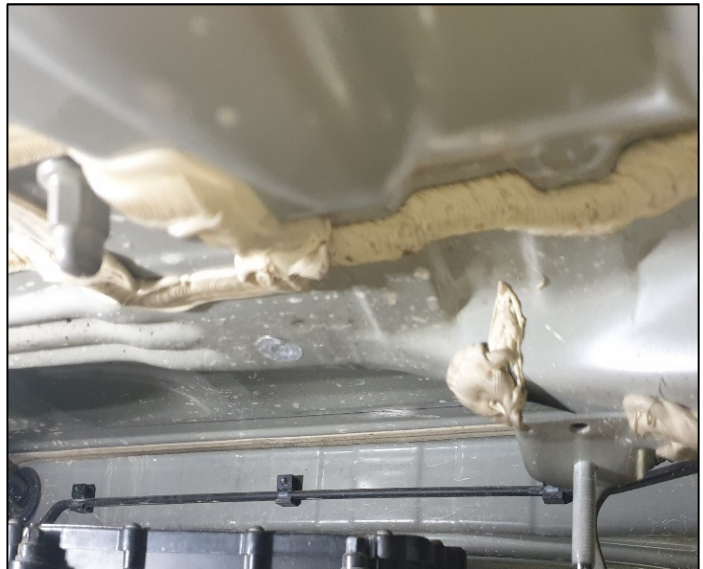
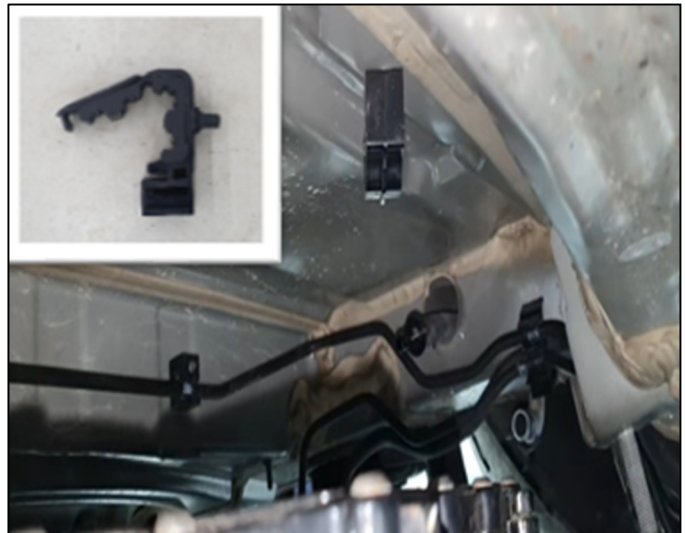
- 7a. Install the new brake tubes and holders onto the vehicle.

**Do not twist the brake lines during installation.**

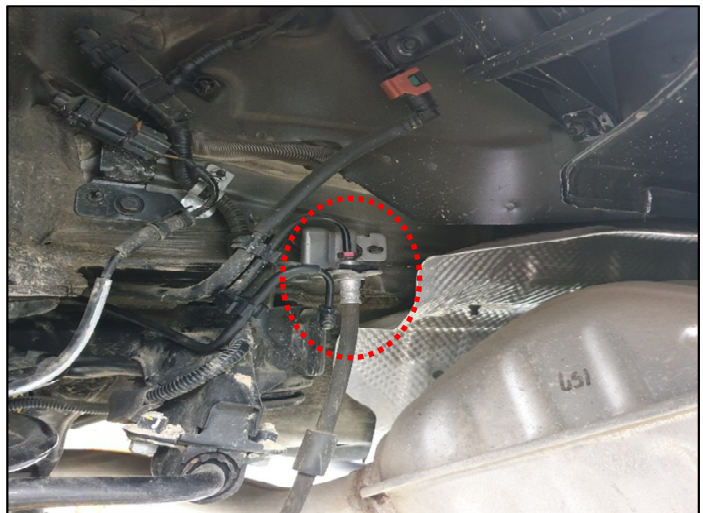
8. Connect the brake tubes to the brackets that lead to the rear brake caliper hoses.

<b>lb.ft</b>	•10.1 - 12.3
<b>kgf.m</b>	•1.4 - 1.7
<b>N.m</b>	•13.7 - 16.7
