HYUNDAI Technical Service Bulletin	GROUP CAMPAIGN	NUMBER 21-01-016H
	DATE MARCH 2021	MODEL(S) Hyundai Genesis (DH)
SUBJECT: HYUNDAI GENESIS (DH) BRAKE TUBE INSPECTION AND REPLACEMENT (NON-SALT BELT STATES) (SERVICE CAMPAIGN T5X)

Description: This bulletin describes the procedure to inspect and if necessary replace the brake tube assemblies for certain 2015MY Hyundai Genesis (DH) vehicles located in the non-salt belt states. Non-salt belt states are listed below in **Applicable Vehicles**.

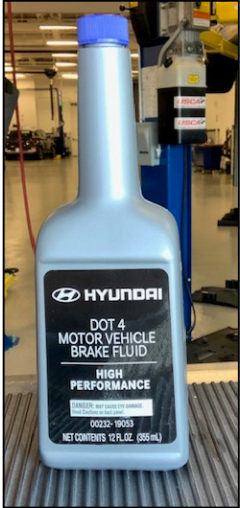
<p align="center">00232-19053</p>	<p align="center">Two 12-ounce bottles required per vehicle.</p>

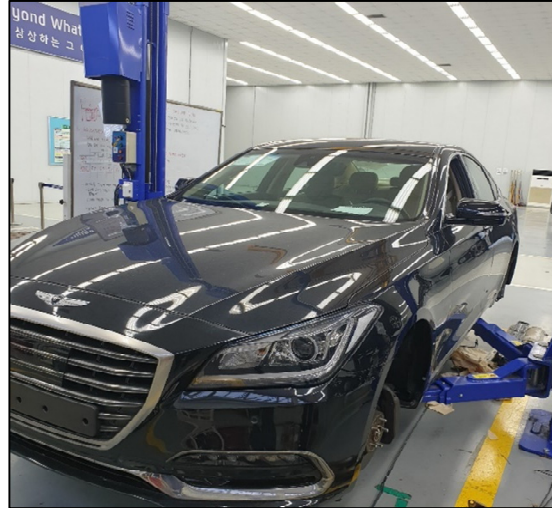
1. Raise the vehicle on a lift.

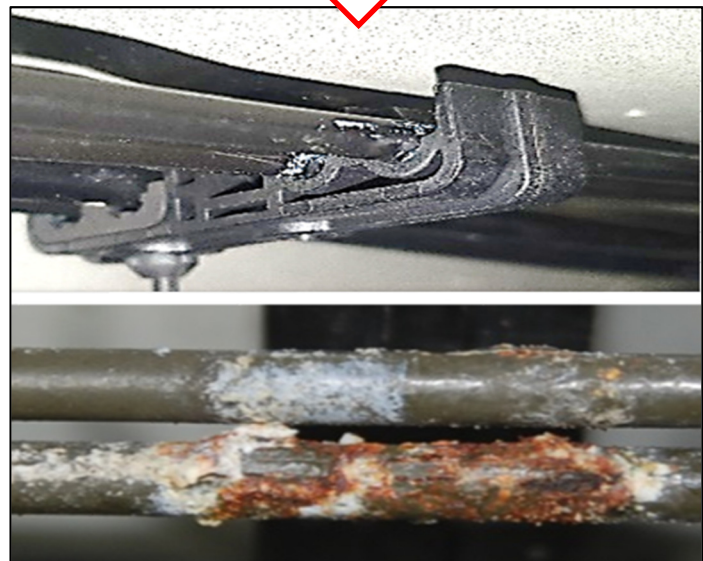
2. Remove the driver's side under covers to access the brake lines.

Inspect the brakes lines for corrosion, paying close attention to the brake line brackets locations.

- If no corrosion is detected, the service procedure is complete.
- If corrosion is detected, proceed to **Service Procedure: Brake Tube Replacement.**

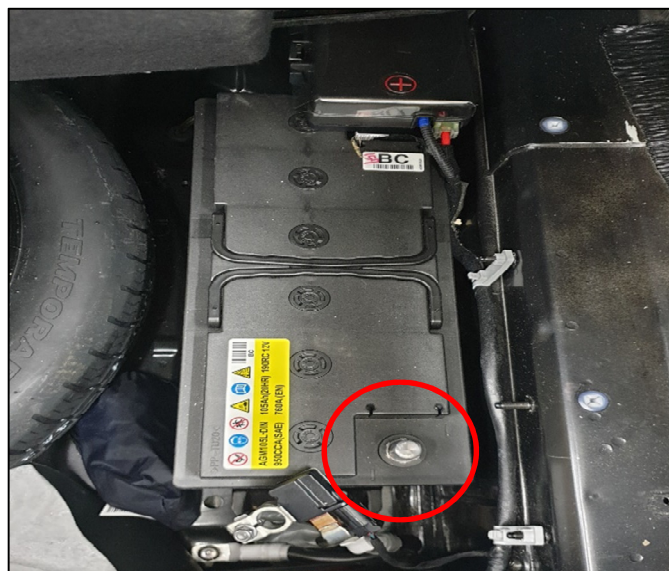
1. If applicable, record the customer's radio preset stations for AM/FM/XM.

Disconnect the negative battery terminal.

TIGHTENING TORQUE

lb.ft	•2.9 - 4.3
kgf.m	•0.4 - 0.6
N.m	•3.9 - 5.9

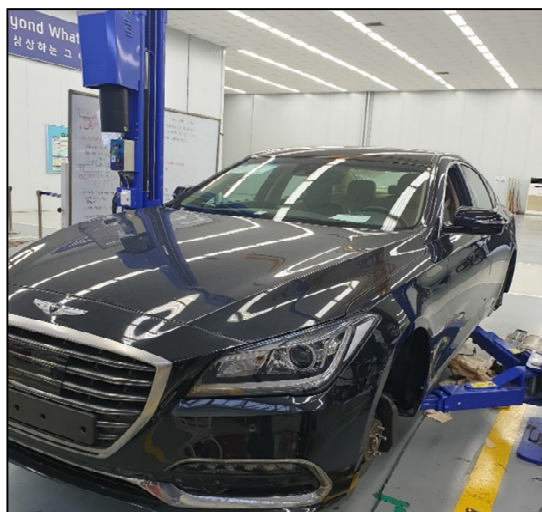
2. Lift the vehicle and remove the front left, rear left, and rear right wheels.

TIGHTENING TORQUE

lb.ft	•79.6 - 94.0
kgf.m	•11.0 - 13.0
N.m	•107.9 - 127.5

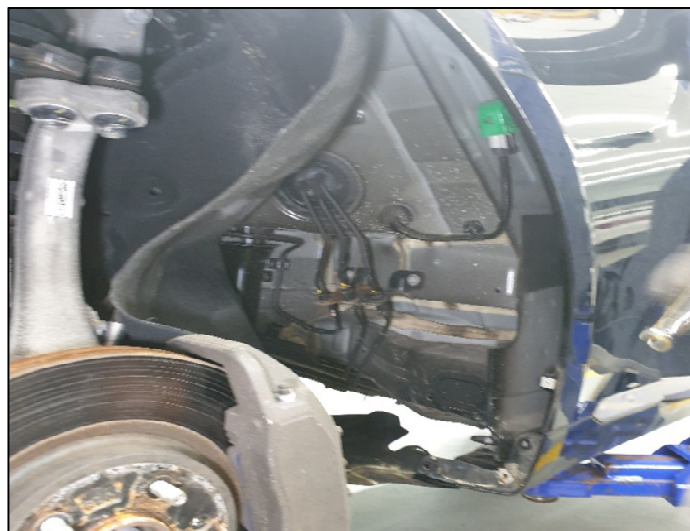
3. Access the brake lines through the wheel wells by loosening and moving the front left, rear left, and rear right wheel fender liners.

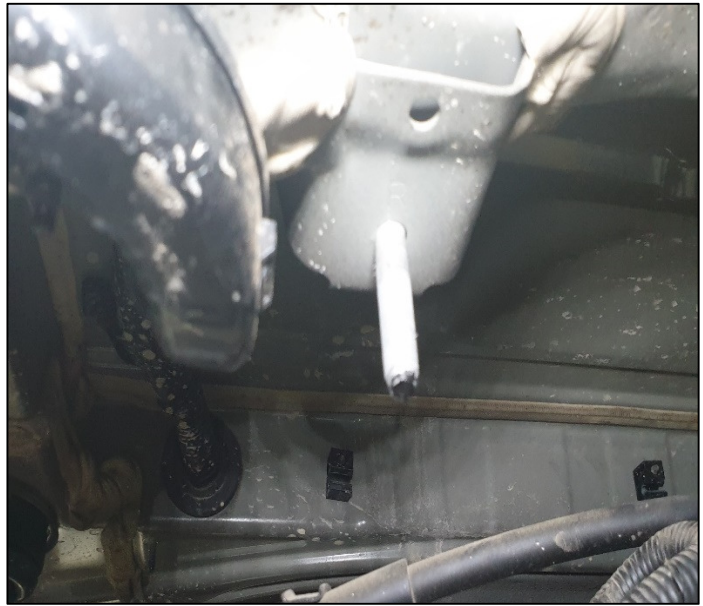
6. After removing the fuel tank and rear cross member assembly, remove the brake tubes and the holders from the body.

Use a container to catch any remaining fluid from the disconnected brake lines as the lines are removed from the vehicle.

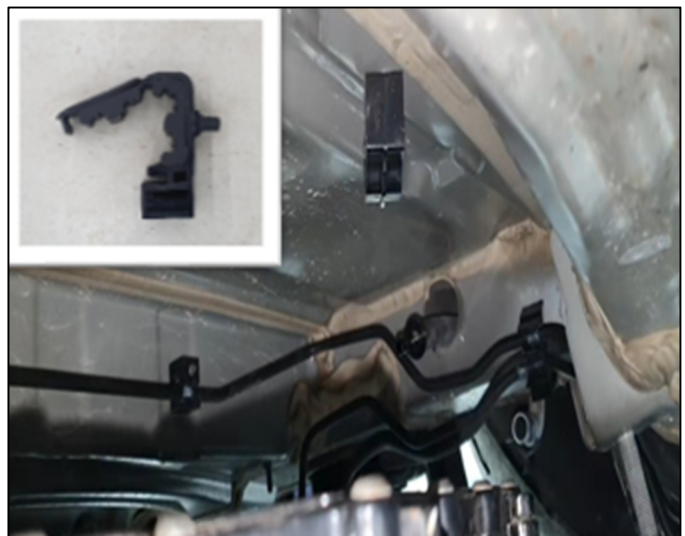
7a. Install the new brake tubes and holders onto the vehicle.

Do not twist the brake lines during installation.

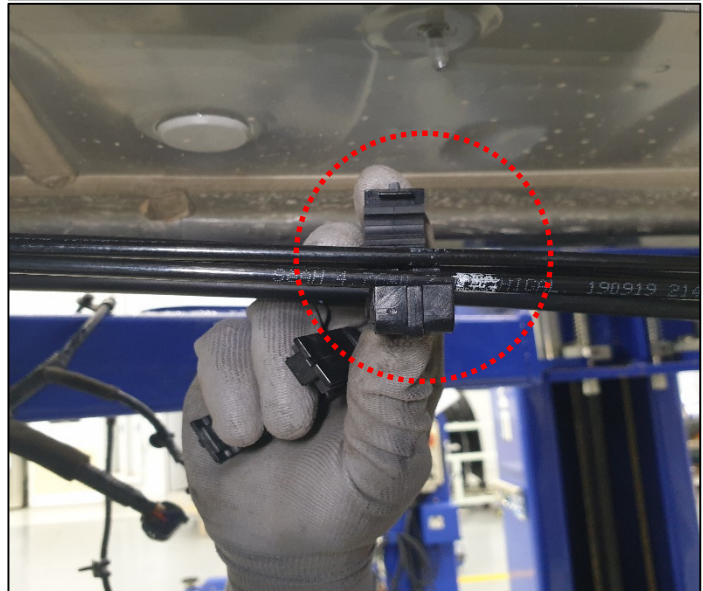
- 7b. Note the white alignment marks on the brake tubes coincide with the holders in some locations.

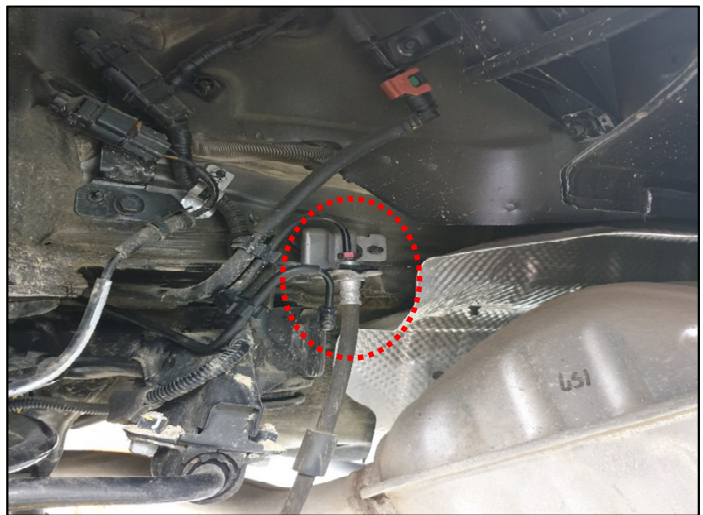
8. Connect the brake tubes to the brackets that lead to the rear brake caliper hoses.

TIGHTENING TORQUE

lb.ft	•10.1 - 12.3
kgf.m	•1.4 - 1.7
N.m	•13.7 - 16.7

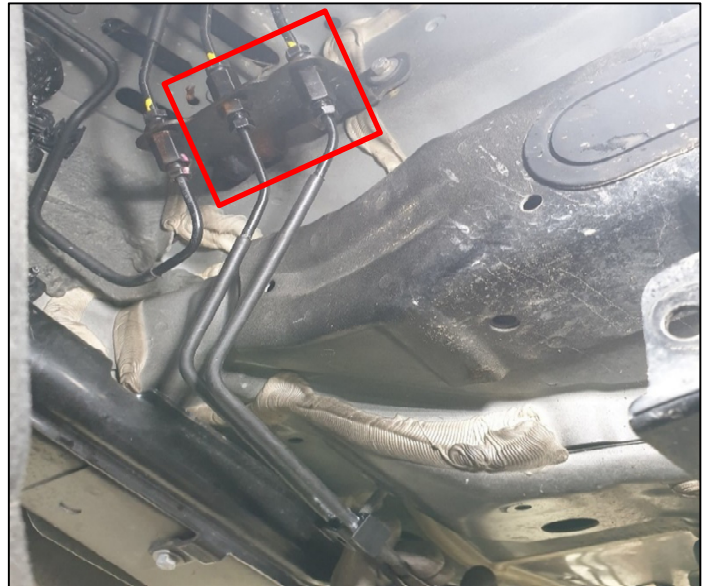
9. Connect and tighten the flare nuts located at the front of the vehicle.

TIGHTENING TORQUE

lb.ft	•10.1 - 12.3
kgf.m	•1.4 - 1.7
N.m	•13.7 - 16.7
