# Technical product information

<b>Topic</b>	Driver/Passenger door/s power latch creak on close
<b>Market area</b>	India (5IN),Kenia (5KE),Russische Föderation (5RU),Südafrika (5ZA),Australia E04 Bentley rest Asia and Australia (6E04),China 796 VW Import Comp. Ltd (Vico), Beijing (6796),Germany E02 Bentley rest Europe (6E02),Japan E03 Bentley Japan (6E03),Korea, (South) E08 Bentley South Korea (6E08),United Kingdom E01 Bentley UK (6E01),United States E05 Bentley USA and rest America (6E05)
<b>Brand</b>	Bentley
<b>Transaction No.</b>	2061582/2
<b>Level</b>	EH
<b>Status</b>	Approval
<b>Release date</b>

Driver or Passenger door creak during the power latch "Close" function

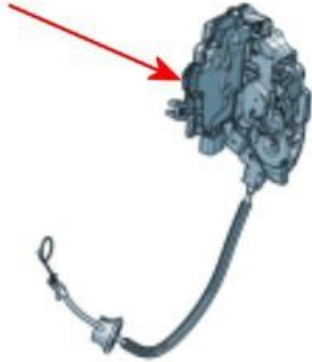
Figure 1

**IMPORTANT:** Refer to the vehicle repair history – In the event that all four door latches have been replaced previously, only the individual/faulty latch should now be replaced (See example of door latch in Figure 1)

2) Referring to the applicable Repair Group - Rep.Gr 57 (Front) or Rep.Gr 58 (Rear) - Replace one or all four door latches (as detailed in the Technical background section)
