Technical product information

DTC's stored for all cylinders on Bank 1 or all cylinders on Bank 2 - W12 TSI engine derivative

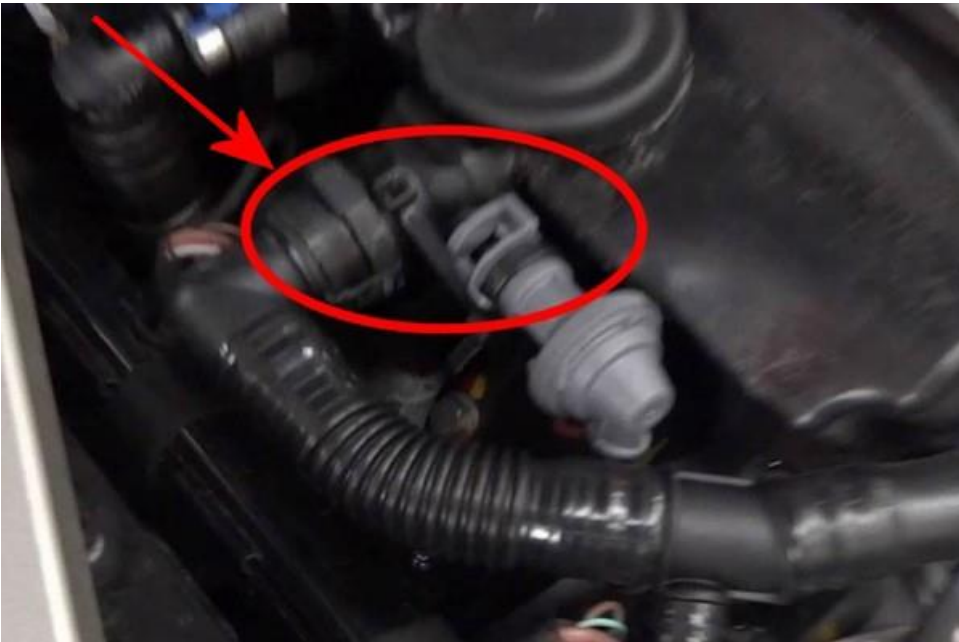
1) Referring to Figure 1 - Check the oil separator and adjoining pipework for any damage

NOTE: The cable tie attached to the grey joint is the damaged area, in this particular scenario a cable tie was fitted to aid diagnosis

2) In the event the oil separator and/or adjoining pipework is damaged and/or broken - Referring to the applicable Rep.Gr - Replace the oil separator and applicable pipework
