# Technical Bulletin

Technical Bulletin #:32D

**Subject:** Rear Tarp Crank Handle Retainer Fastener Inspection and Confirmation

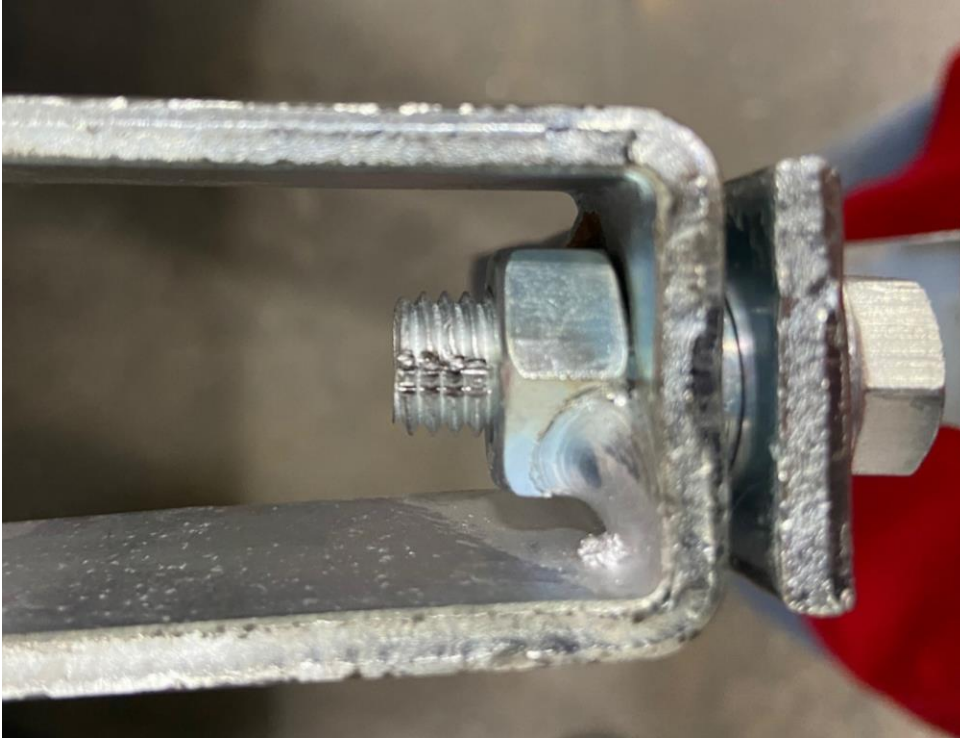
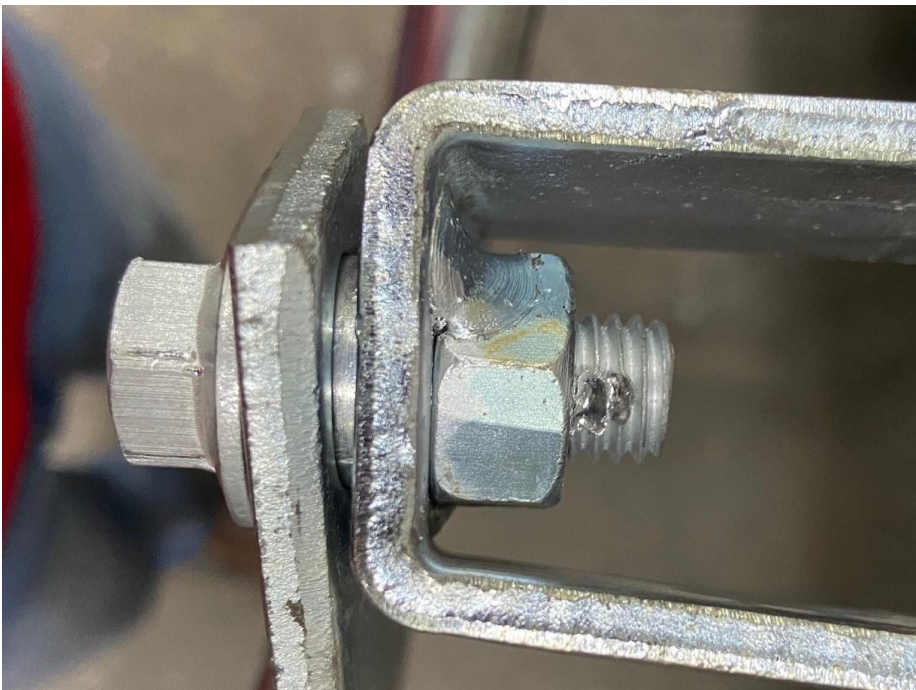
**Description:** There is the possibility that the tarp crank handle retainer on your trailer was not properly assembled with the appropriate locking hardware. We are asking that you inspect the trailers that you have received from TimpTE that are listed on the attached sheet to insure proper installation.

**Process Change:** In order to ensure that the bolt will not vibrate out of the nut on the retainer, we are asking that you “stake” the threads of the bolt – deform them – so that the bolt cannot be removed.

- Confirm Tarp Crank Handle Retainer fastener is installed correctly.
- Stake the Retainer fastener thread properly so dis-assembly cannot occur.
- Confirm the threaded connection cannot dis-assemble following the staking process.
- Please review the images on the attached page for reference for thread staking
