MODEL
2022MY
Carnival (KA4)

NUMBER
237

TECHNICAL SERVICE BULLETIN

**SERVICE ACTION: AC INVERTER
OUTLET REPLACEMENT (SA472)**

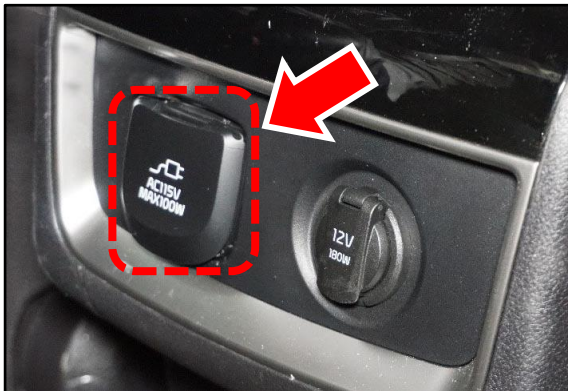
Front Console Outlet

AC Inverter Outlets

This bulletin provides the procedure to replace the two (2) AC Inverter Outlets (console and luggage areas) on some 2022MY Carnival (KA4) vehicles produced from January 4, 2021 through March 18, 2021, which may exhibit poor operation or failure of the AC Inverter Outlets. To correct this concern, follow the procedure outlined in this bulletin to replace both console and luggage outlets with new improved parts. Before conducting the procedure, verify that the vehicle is included in the list of affected VINs.

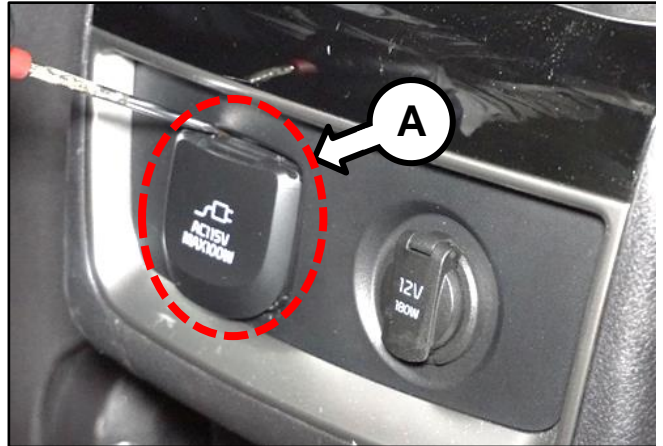
1. Disconnect the battery negative (-) terminal.
2. Remove the AC Inverter Outlet (A) on the front console using a flat-head screwdriver or similar tool, as shown.

Do Not use a sharp/metal tool as damage to the surface of the interior trim may occur. Instead, use a non-marring trim tool.

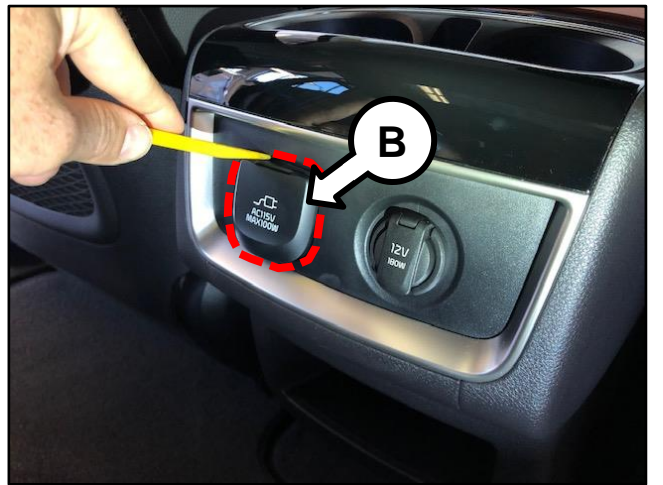
Install the correct part with **Green** sticker **'without'** the letter "V" marking.

3. Disconnect the AC inverter outlet connector (B) shown to remove the outlet.
- 4a. Install the new Console AC Inverter Outlet in the reverse order of removal.

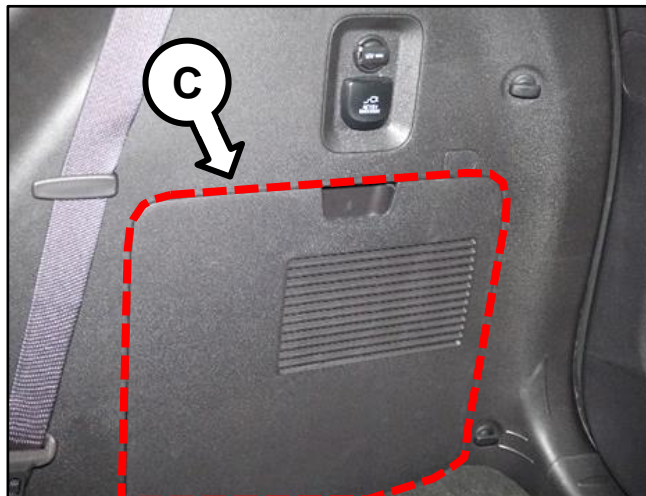
5. Remove the luggage side trim fire extinguisher cover (C).

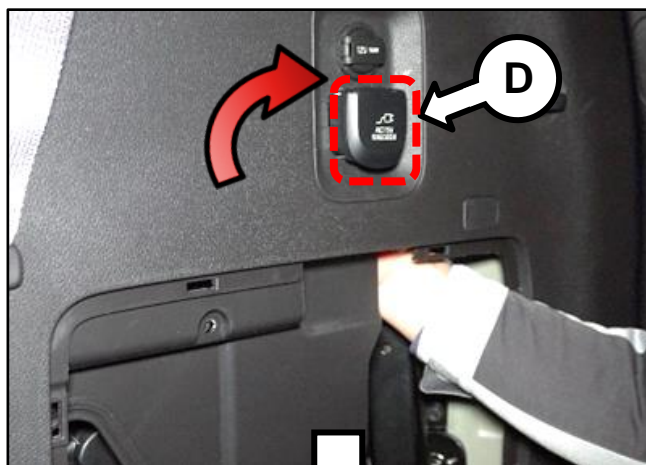
6. Reach inside with hand and feel the top of the luggage area AC Inverter Outlet (D).

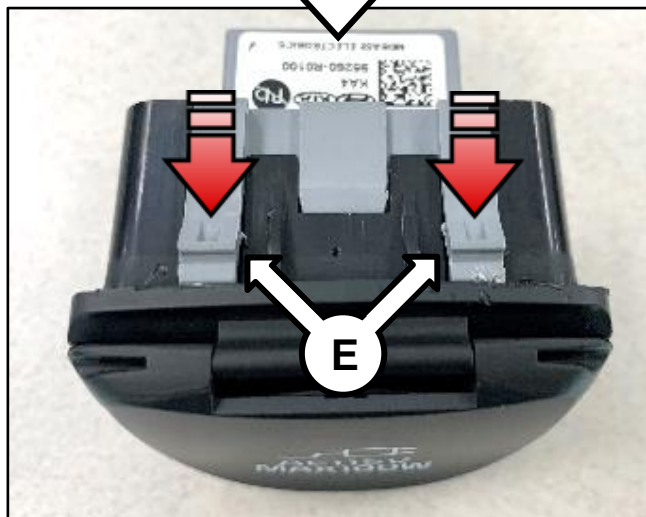
7. Push the top tabs (E) on the AC Inverter Outlet to release the outlet.

Carefully remove the luggage outlet. **Do Not** use a sharp/metal tool as damage to the surface of the interior trim may occur.

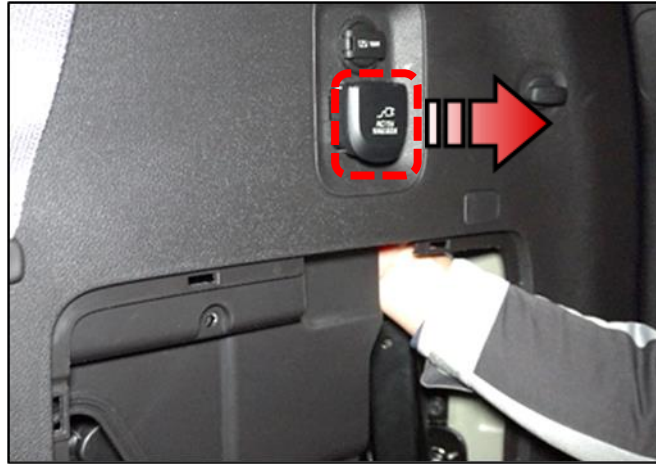
- 8. Once released, push out the AC Inverter Outlet by hand from the inside of the trim as shown and remove the outlet.

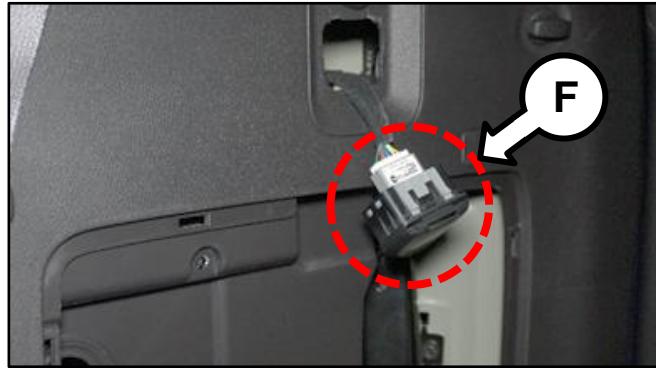
- 9. Disconnect the luggage area AC Inverter Outlet connector (F) and remove the outlet.

- 10. Install the new Luggage AC Inverter Outlet in reverse order of removal.

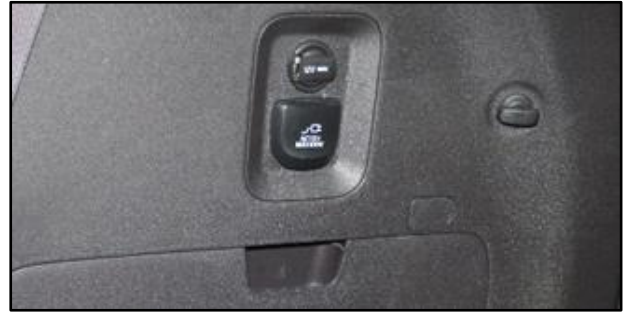
Install the correct part with **Green** sticker 'with' the letter "V" marking.

***Note:** When ordering the AC Inverter Outlet part number listed above, two (2) outlets will be supplied; one (1) for the front console, one (1) for the luggage area. **Be sure to use the part marked with a “V” with the green sticker for Luggage Outlet.**
