Bulletin No.: PIP5683A
Published date: 03/9/2021

PIP5683A Whistle Or Squeak or Squeal Noise From The Engine

Brand:	Model:	Model Years:	VIN:		Engine:	Transmissions:
			from	to		
Chevrolet	Blazer	2019 - 2020	All	All	3.6L LGX	All

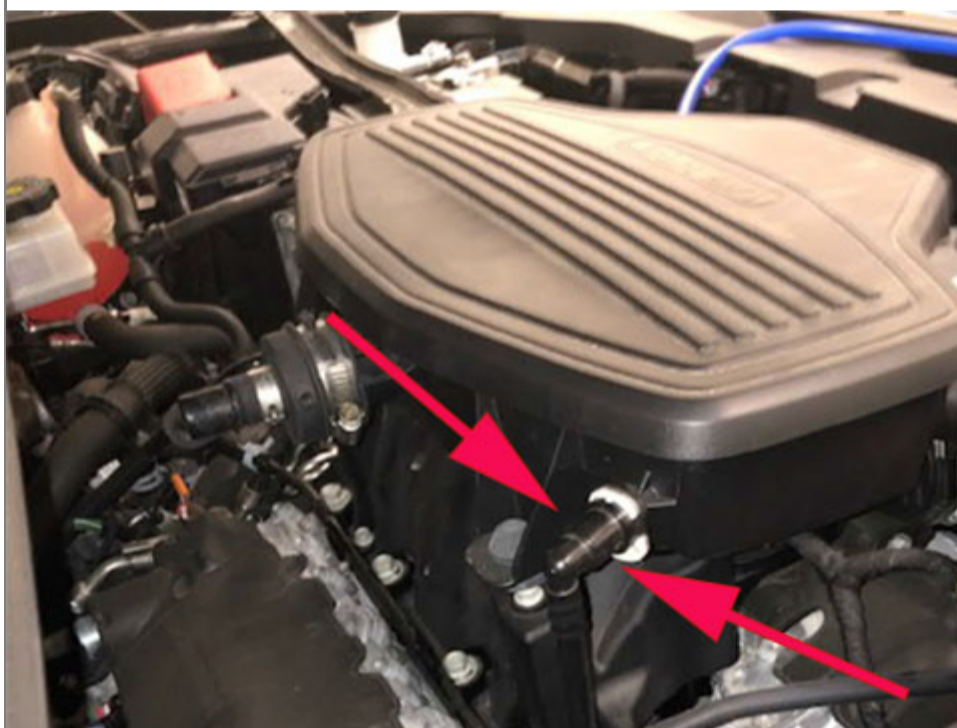
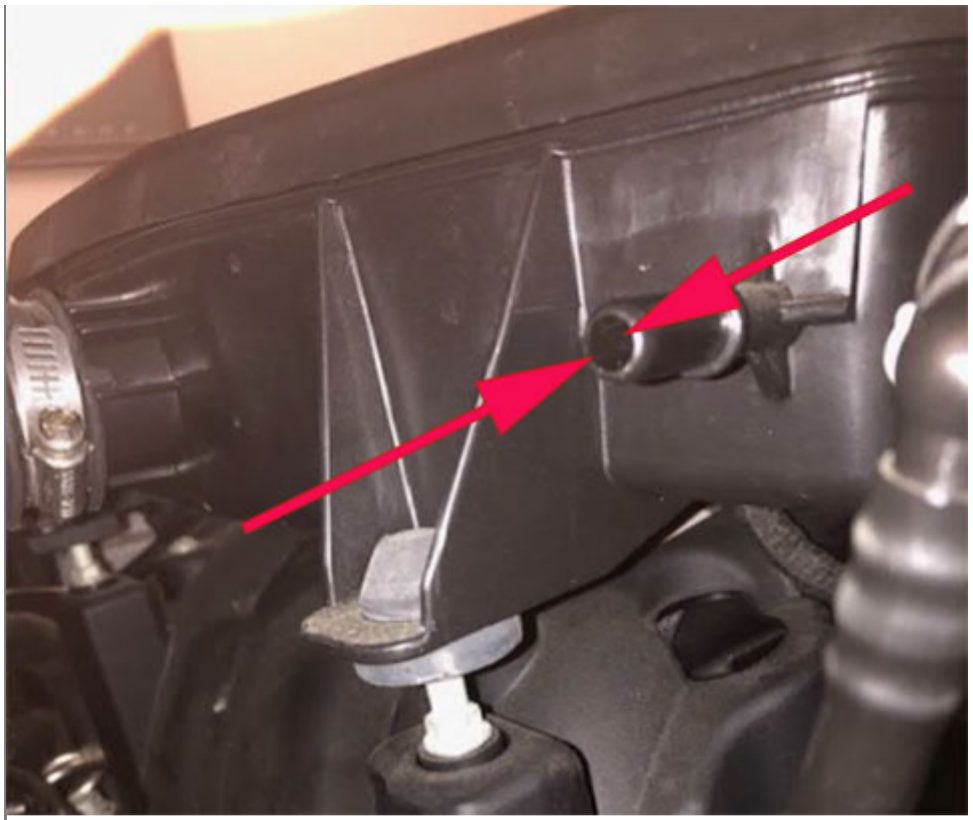
Cause The cause of this noise may be plastic flashing restricting the clean air port on the air cleaner duct on top of the engine as shown below.
The restriction or flashing will appear that the hole is not drilled out completely and can be seen about 2 inches inside the tube.

To correct this condition, replace the air cleaner duct and reevaluate for a noise concern.

Make sure you run the engine long enough to build up crankcase pressure during testing to ensure correction.
