## Campaign Update CA#9925

Subject: Sound Bar Installation  
Affects certain 2020 & 2021 Unity U24RL Motorhomes

SOP04787

## Post production U24RL Sound Bar Mounting Repair (QAAR 9925)

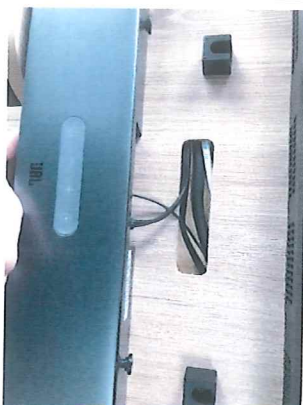
1

The sound bar may become loose and fall off the wall during travel movement or if pressure is applied from the top. A piece of plywood & 2 - #8 screws will be installed to secure the sound bar to the wall.

Unhook the rear lounge sound bar by sliding it up and then towards yourself.

Disconnect the power cord and optical wire
