## A-Frame Additional Support

<b>Bulletin Type:</b>	Technical Service Bulletin TSB	<b>Publication Date:</b>	April 23, 2021
<b>Bulletin #:</b>	20-025	<b>Make(s):</b>	Starcraft
<b>Job Code:</b>	9802517	<b>Model(s):</b>	GPS
<b>Flat Rate:</b>	1.5 Hours	<b>Model Year(s):</b>	2018

<b>Incident:</b>	Missing floor supports in the trailer frame could allow frame flexing that may cause cracks in the corner radius of the fiberglass.
<b>Affected Units:</b>	<b>2018 GPS Travel Trailer</b> J24A5050-5098 J24B5050-5116 J24L5050-5122 J24S5050 J24T5050-5113
<b>Parts:</b>	<b>Kit #: 20-025SC</b> <b>Contents:</b> 2 - CROSSMEMBER,C-CHN 3.00X1.50X1.50X.09XL14.00 16 GA Floor Support Channels
<b>Misc. Tools &amp; Supplies:</b>	C-Clamps & Tape Measure Grinder or Sander Steel Welder Wire Brush & Spray Paint (Black Rustoleum or Equivalent)

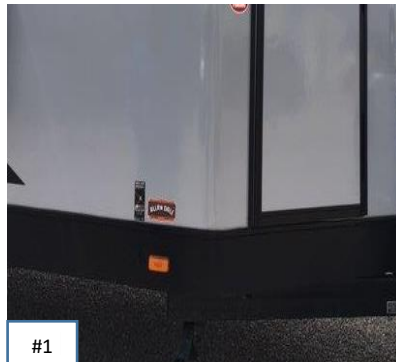
- Verify the VIN is in the TSB scope. All affected units require this remedy. #1
- Inspect unit for missing floor supports in frame and any signs of stress cracks at corner radius of fiberglass. #2

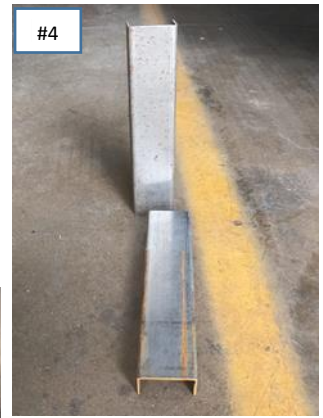
Step 2: Obtain parts kit containing instructions and two floor support channels shown in picture #4.

Step 3: Confirm two floor support channels - 3" tall x 1 1/2" flange x 1/16" thick x 14" Length

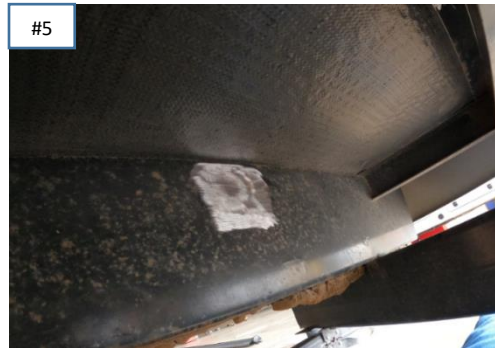
Step 4: Measure placement of c-channels and prep area for welding by grinding or sanding paint from frame member.  
Picture #5

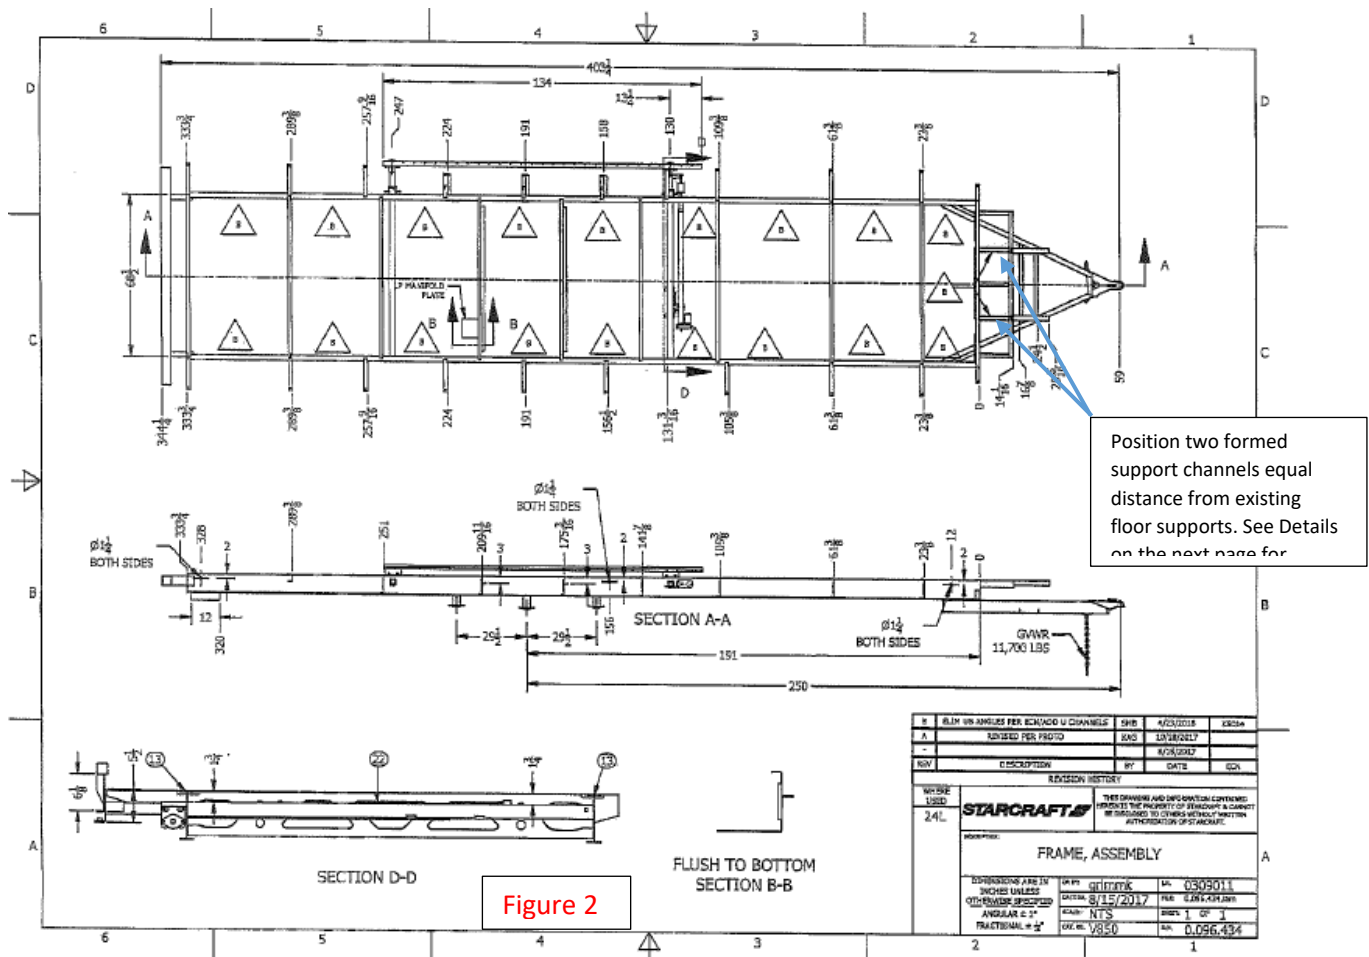
Step 5: Position c-channels equal distance between existing supports as shown in Figure 2. Raise the 3" c-channels upward and position flush to top of frames, bottom of floors as shown in section view Z-Z page 6. Clamp c-channels into position.

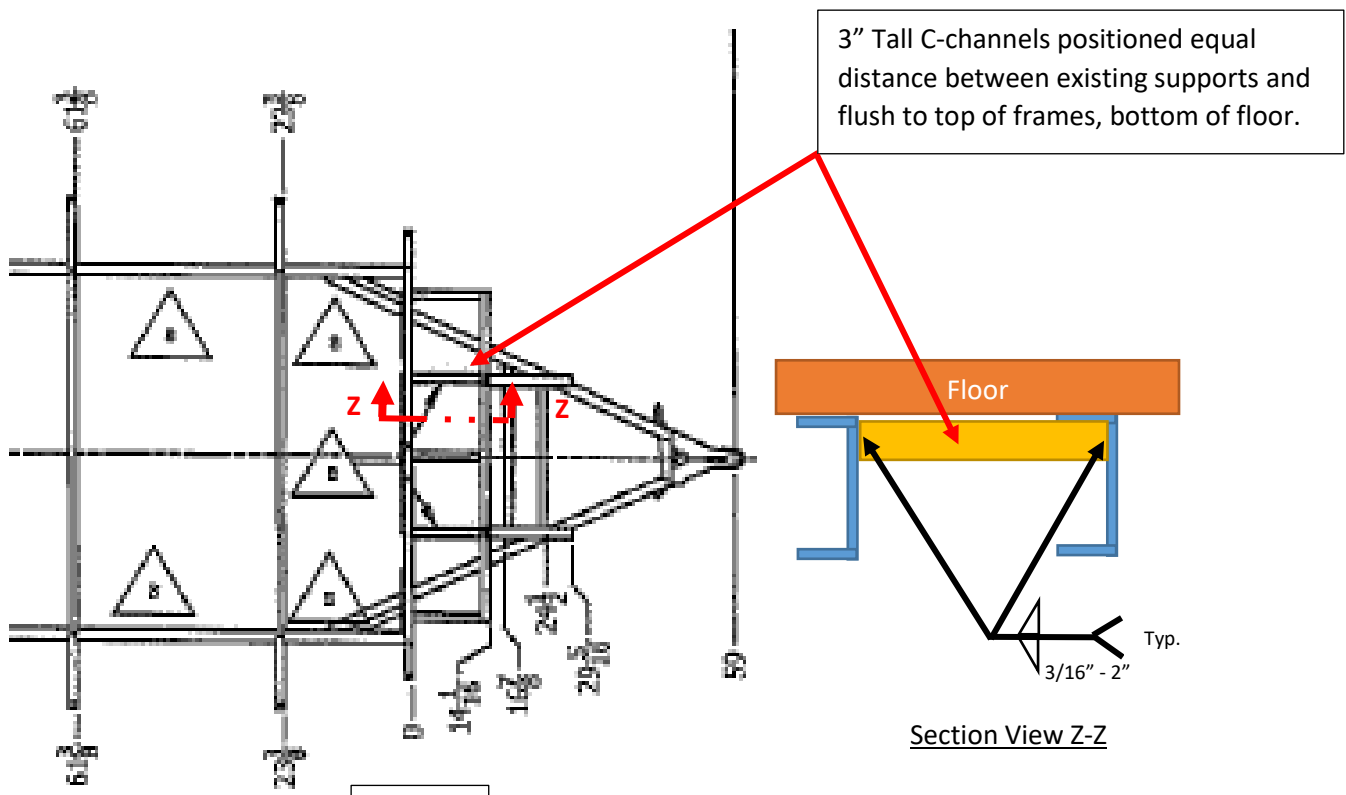
Figure 3

Step 6: Weld the two 3" c-channels into position as shown in figure 3 and section View Z-Z shown below.

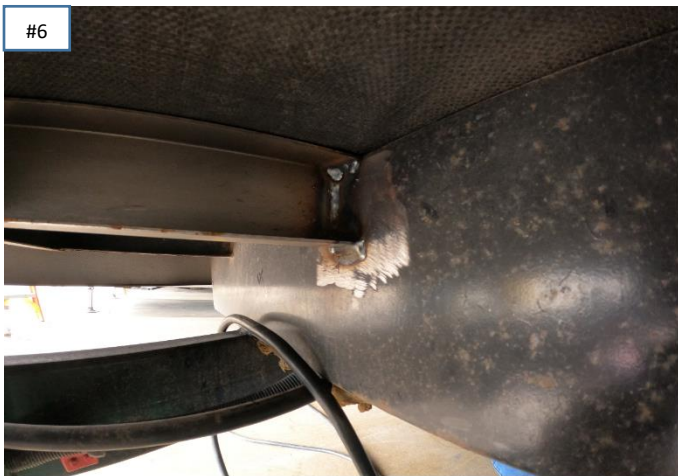
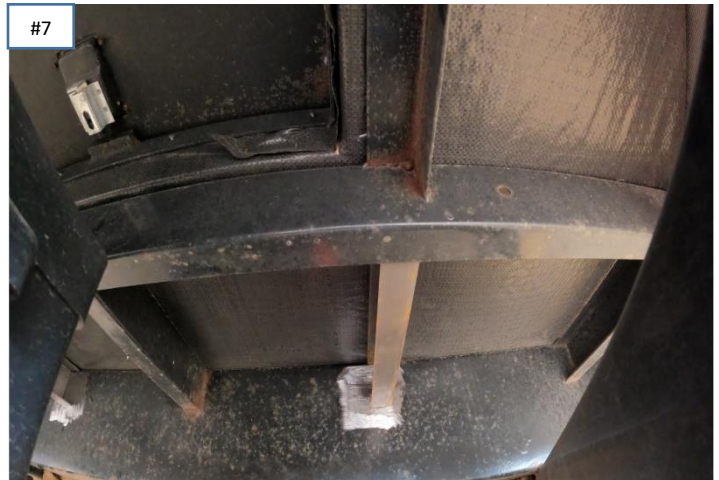
Step 7: After welding is complete, wire brush weld area (both channels) to remove all weld slag #6, #7.

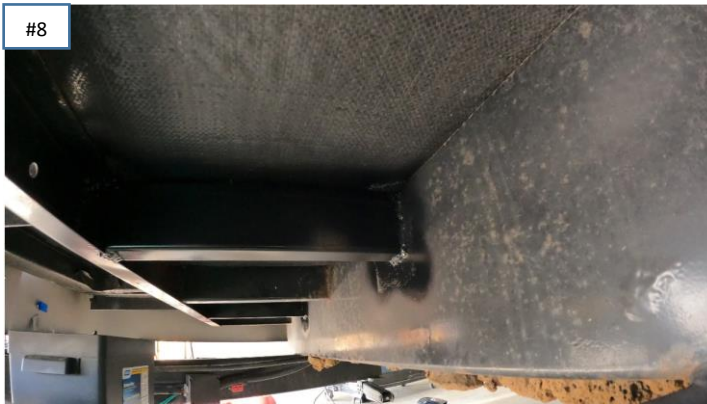
Step 8: Touch up bare metal with a Rustoleum spray paint or equivalent. Allow to dry and apply two coats.  
#8
