MODEL
2019-2021MY Forte
(BDm)

TECHNICAL SERVICE BULLETIN

SUBJECT: FUEL TANK INLET CHECK VALVE (ICV) MODIFICATION

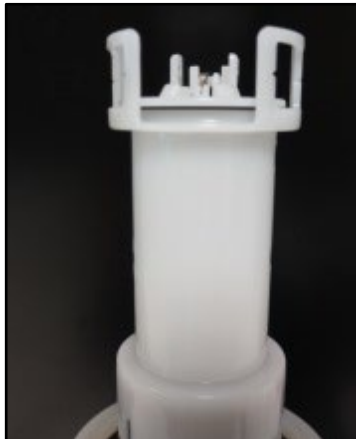
Fuel Inlet Check Valve

This bulletin provides information on the modification of the fuel tank Inlet Check Valve (ICV) on some 2019-2021MY Forte (BDm) vehicles produced from July 9, 2018 through December 2, 2020, which may exhibit fuel spit-back from the Fuel Filler Neck, after the tank has been filled up, and the nozzle clicks off. This condition may occur when the ICV in the fuel tank (at end of Fuel Filler Neck) becomes temporarily stuck in the open position due to the ICV ribs preventing the ICV from closing completely. Follow the procedure outlined in this publication to modify clearance between the ICV ribs and the flap to correct this condition.

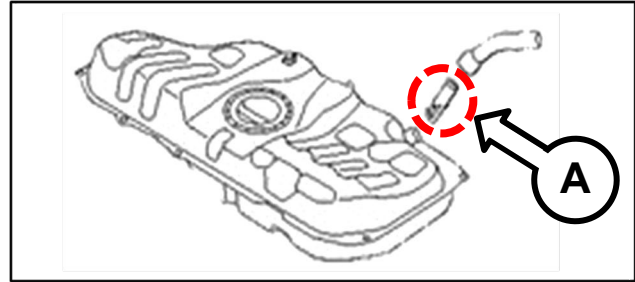
Because the Inlet Check Valve (ICV) (A) is located at the bottom of the fuel filler neck connection, inside the fuel tank, it cannot be accessed from outside. Follow the steps below to access the ICV through the fuel pump location.

1. Drain the fuel level down to less than 1/8 of a tank. We recommend recovering additional fuel directly from the fuel pump access point; to minimize contact during the procedure.

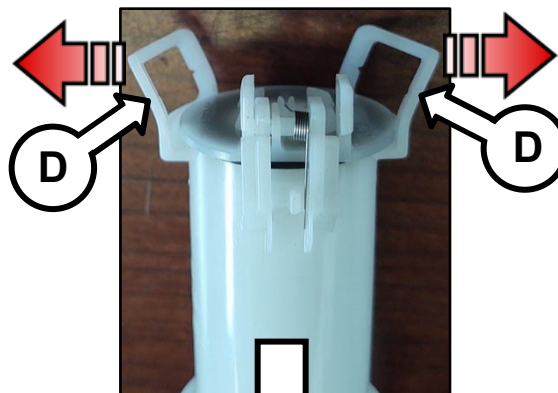
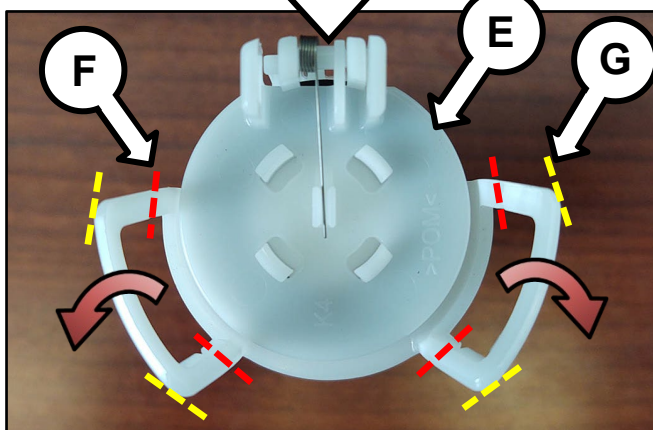
ICV is shown outside of vehicle for illustration purposes only.

- F: Original position (Red line)
- G: New modified position (Yellow line)

6. Using your hand (with ICV in the fuel tank), bend each rib (D) outward, away from the flap (E), to a 90° angle, or more, and allow to relax as shown.
