## STAR ONLINE PUBLICATION

**Case Number:** S2121000001

**Symptom/Vehicle Issue:** CV Boot Leak Inspection, Boot Inspection

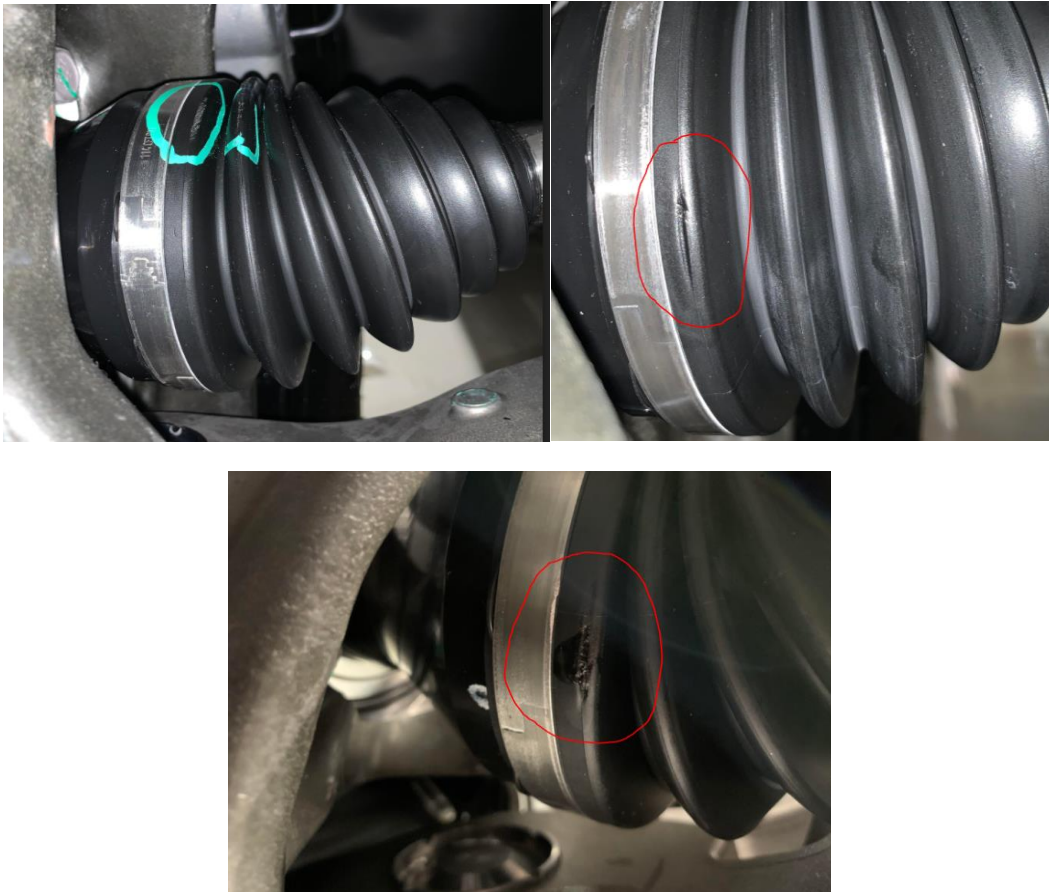
**Discussion:** As part of launch awareness and quality assurance, the outer CV boot areas should be inspected for signs of contact damage as highlighted. Use the attached photos as a reference guide while examining the outer CV boots. If there are contact marks like the highlighted, replace the "**front halfshaft**" as needed.
