## Technical Bulletin 215

### 03.2021

**Description:** Alarm Arm/Disarm Indicator Function - Instrument Software Update

**Item:** 215.2  
**Description:** Triumph Shift Assist Accessory Kit A9770426  
**Model Affected:** Trident (from VIN AC6898)

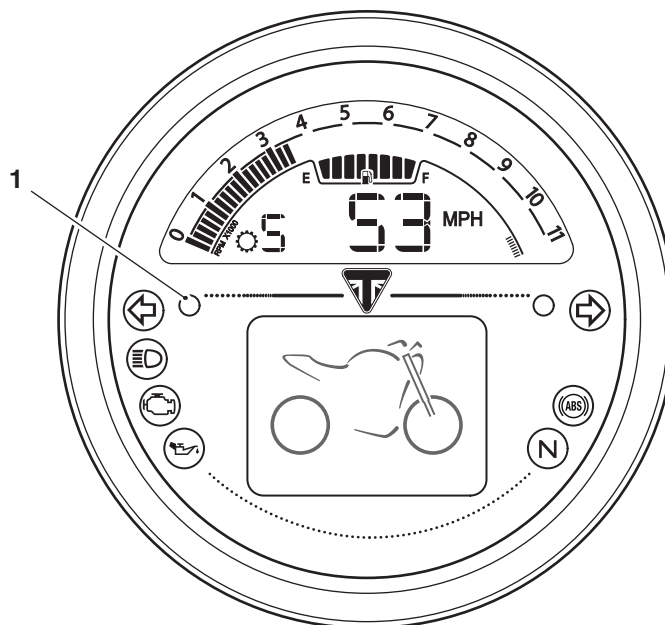
#### 1. Alarm light

It has come to our attention that the above models that are fitted with an accessory alarm may have intermittent illumination of the direction indicators when the alarm is armed or disarmed. In some cases the only indication of the alarm being set is the red LED light on the instruments which will illuminate for 2-3 seconds after arming. The alarm operation is not affected and no action is needed if no alarm is fitted.

An instrument calibration update will be available from 15th March 2021 in Triumph diagnostic tool version 2021-05 to resolve this issue. Dealers are requested to use **Manual Model Selection** to download instrument calibration **INST00162\_ROW\_CM** to affected models at the next service/visit to the dealership.

Check the instrument build data screen. The Triumph Boot Software part number and issue level should be reported as follows after updating via **Manual Model Selection**:

- Boot Software Part Number - 02570841
- Boot Software Issue Level - 020000

In the meantime, it is suggested that by activating 'Passive Arming' as outlined in the alarm user manual, this arms the alarm automatically when ignition is turned to OFF.

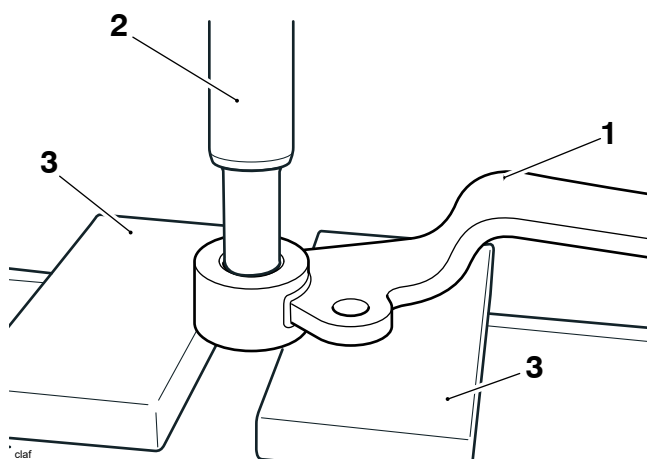
1. Gear change pedal
2. Press
3. Press bars

#### **Removal**

1. Support the original gear change pedal on the press bars.
2. Press on the bush outer edge to remove it from the original gear change pedal.

3. Check the gear change pedal for damage. If damaged a new bush must be fitted.

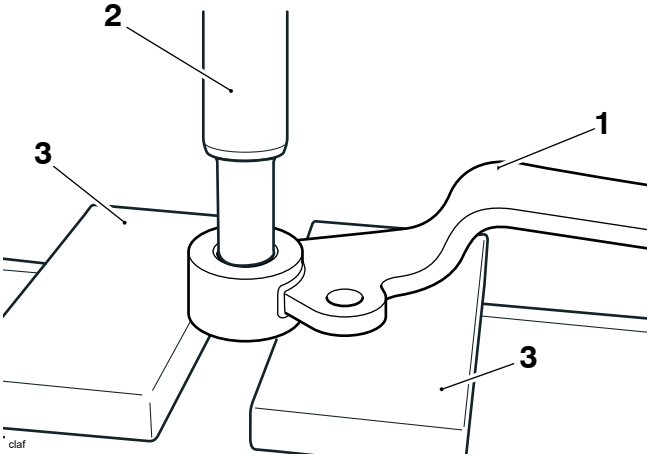
- 1. Gear change pedal
- 2. Press
- 3. Press bars

**Installation**

- 1. Support the new gear change pedal on the press bars.
- 2. Press on the bush outer edge to install the bush in to the new gear change pedal to the depth noted for removal.
