SIB 63 03 18 LED LIGHT CARPET IS DIM OR DISTORTED

2021-03-15

This Service Information Bulletin (Revision 2) replaces SI B63 03 18 dated **February 2019**.

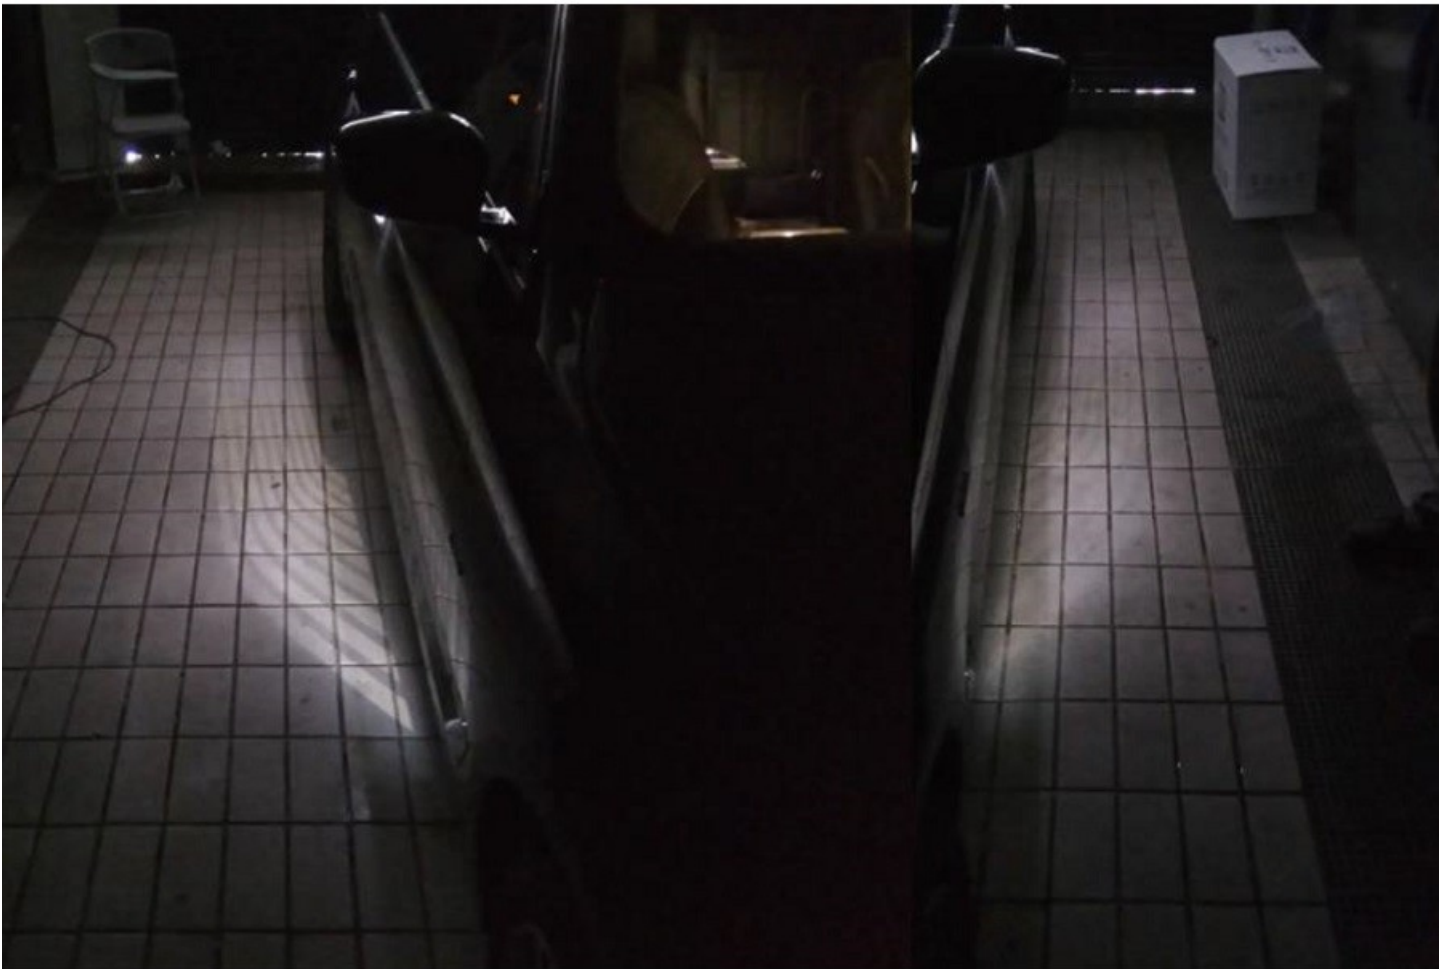
GRUSB6318-05

The light carpet may appear dim or distorted on one or both sides.

The light carpet LED lens may be blocked by debris.

Clean the lens of the light carpet module. Replace the light carpet module only if the lens cannot be sufficiently cleaned.

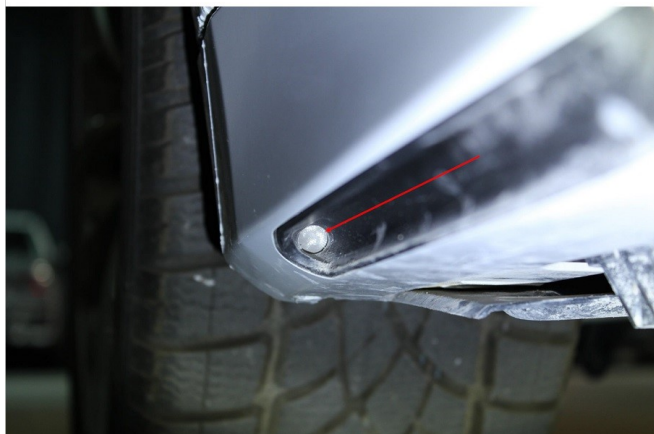
GRUSB6318-02

1. Using a flashlight, inspect the lens of the light carpet module from underneath the vehicle.

Is the lens covered by debris?
