GROUP Service Campaign	MODEL 2018MY Stinger (CK)
	NUMBER SC204	DATE April 2021
VOLUNTARY SERVICE CAMPAIGN		
SUBJECT: SUPPLEMENTAL VACUUM PUMP INSPECTION AND REPAIR (SC204)

This bulletin provides the procedure to inspect and replace the rotor and vane in the supplemental brake vacuum pump on some 2018MY Stinger (CK) vehicles produced from September 21, 2017 through April 24, 2018. When the engine has not reached the normal operating temperature, particularly right after being turned on after being parked overnight, repeatedly and quickly applying the brakes can damage the rotor in the supplemental brake vacuum pump. If the rotor is damaged, the Brake Warning Light may illuminate in the instrument panel, and/or the brake pedal may feel hard to press. (Note: This condition does not affect the proper functioning of the brakes while driving.) Before conducting the procedure, verify that the vehicle is included in the list of affected VINs.

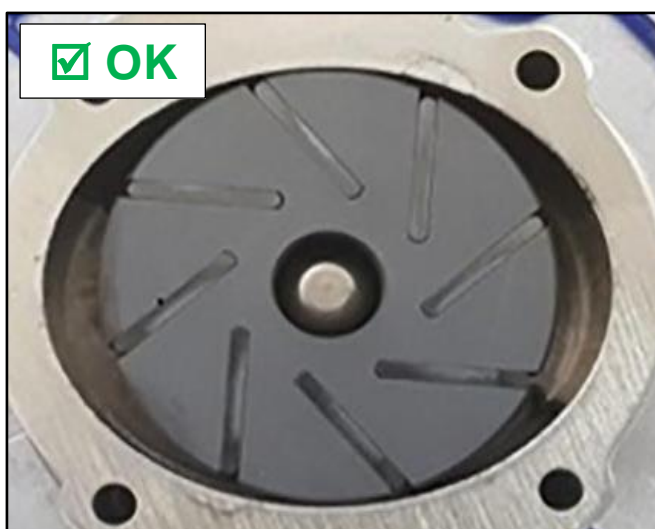
OK: Example of Good Rotor/Vane Parts

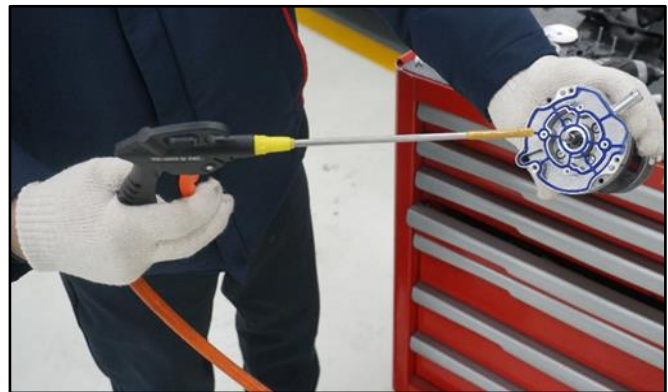
- Blow out the part from dust & foreign substances gently using compressed air gun/nozzle.

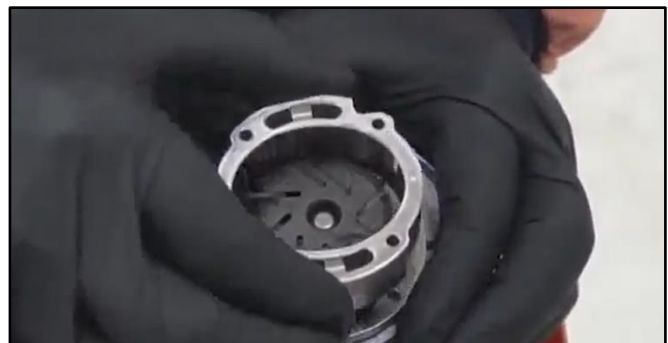
- Install the new rotor/vane parts.
