TO: Service Locations

FROM: Service Systems Engineering

SUBJECT: **Gen 5 DD15 Exhaust Valve Adjusting Screw Excessive Wear**

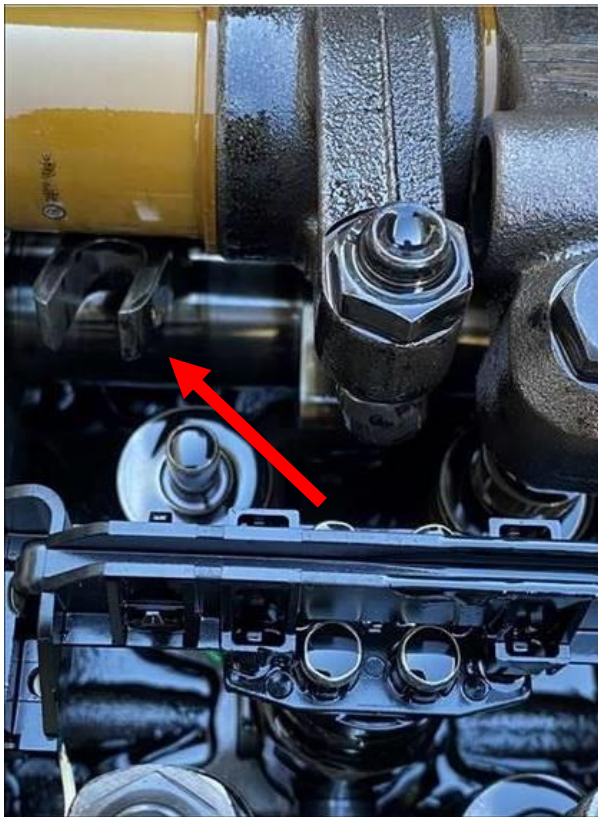
Some Detroit Heavy Duty Gen 5 DD15 engines are experiencing exhaust valve bridges that fall out of position while running. The engine may experience conditions such as rough running, misfire, or popping out of the intake. Misfire or exhaust pressure fault codes may also be present.

**Figure 1. Exhaust Valve Bridge Out of Position**

Excessive valve lash caused by a worn rocker arm adjusting screw foot results in the valve bridge falling off the exhaust valves.

Replace the affected valve bridge and inspect the related valve train components on that cylinder for wear or damage. Do not replace the exhaust camshaft unless there is damage to the camshaft lobes. Remove and measure the length of **all six** exhaust rocker arm adjusting screws to determine amount of wear. The adjusting screw length specification is between 42.45 and 43.85 mm (1.67 and 1.73 in).

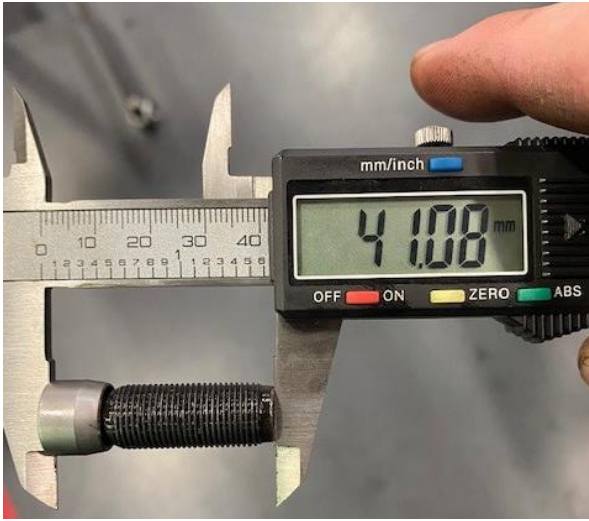
3. Disconnect the batteries.
4. Open the hood.
5. If necessary, remove bumper for access.
6. Remove air filter housing.
7. If equipped, remove air compressor resonator.
8. Remove the rocker cover.
9. Position the engine at Top Dead Center (TDC) on the appropriate cylinder.
10. Loosen and remove the exhaust rocker arm adjusting screw locknut.
11. Thread the adjusting screw down between the exhaust valves to remove the screw from the exhaust rocker arm.
12. Measure the length of the adjusting screw. Replace the adjusting screw if the length does not meet the specification between 42.45 and 43.85 mm (1.67 and 1.73 in). See below example.

**Figure 2. Measuring Rocker Arm Adjusting Screw**
