HOW TO INSPECT AND REPAIR A SCHWINTEK SLIDE OUT

Bulletin Type:	SRP	Publication Date:	April 2021
Bulletin #(s):	20-035	Make(s):	Jayco & Entegra
Job Code(s):	<i>If affected unit has warranty remaining, submit your claim following the normal process</i>	Model(s):	Redhawk & Odyssey
Flat Rate(s):		Model Year(s):	2019-2021

Incident:	The Schwintek slideout mechanism binds after extending 6"-8"		
Affected Units:	2019-2021 Jayco 24B Redhawk & 2019-2021 24B Entegra Odyssey		
Parts Kit:	2 - Adjustable rollers for the floor (0203564) 4 - z-brackets (0313775) 24 - #8 x 3/4" self-taping screws		
Misc. Tools & Supplies:	<ul style="list-style-type: none"> - Screw gun - Self-taper - Glue 	<ul style="list-style-type: none"> - Pry-bar - Hammer - Pin Nailer - Hammer 	
Parts Return Information:	N/A

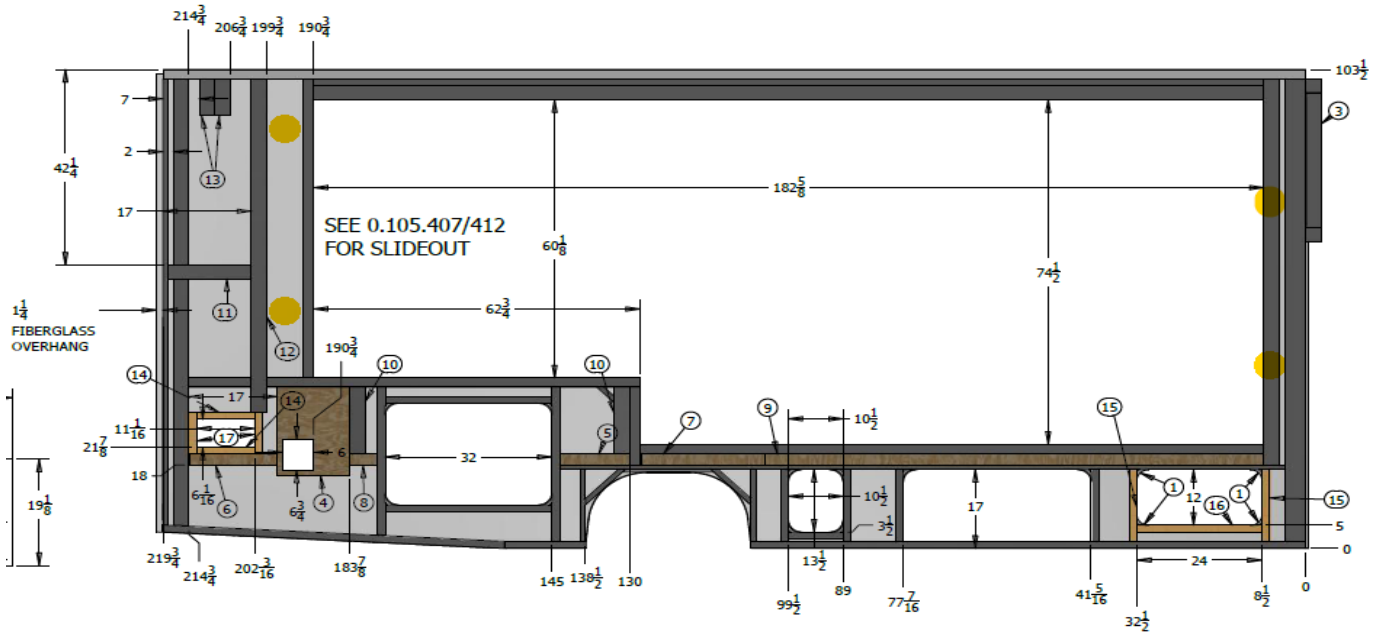
- Inspect slideout print shown below and locate the highlighted four yellow dots for the original placement of the z-brackets. Remove and save the 4 z-brackets and #8 x 3/4" self-taping screws for reinstallation after roller repair.

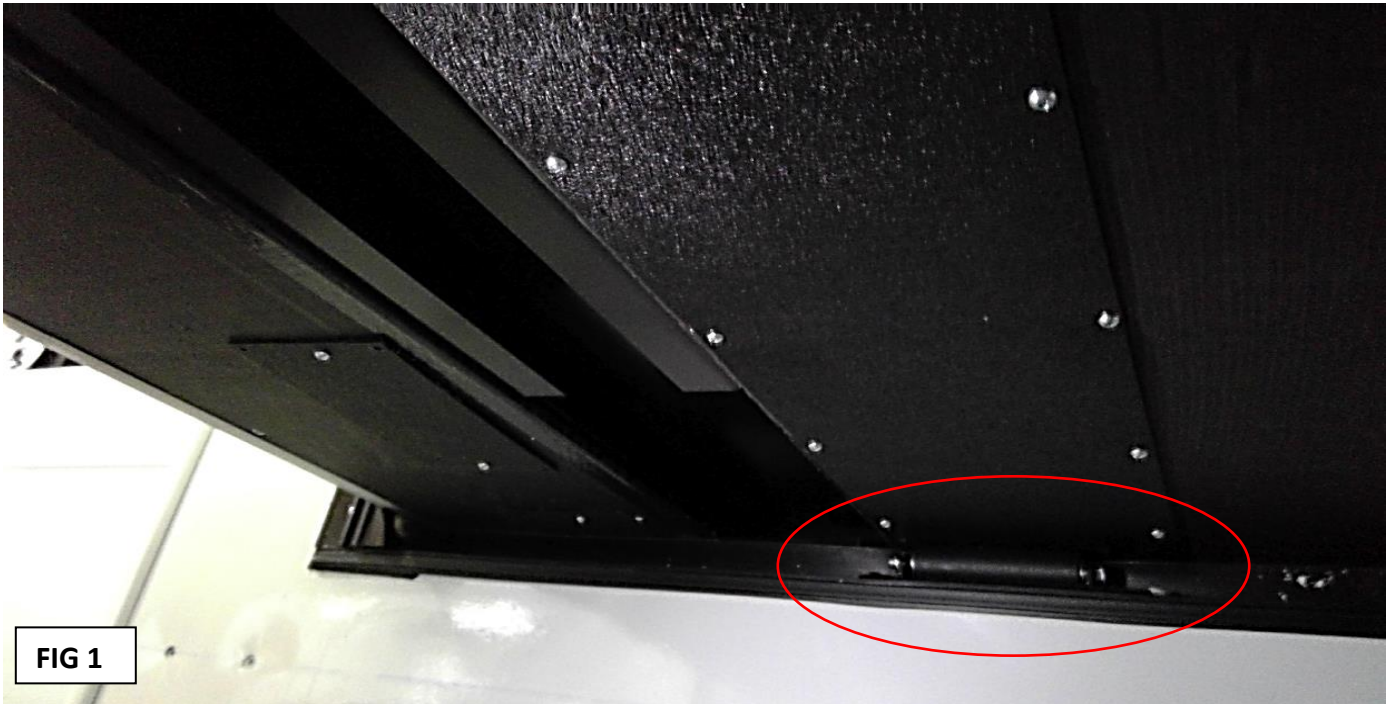
FIG 1

- Figure 1 shows the correct placement of the slideout roller. If the slide roller is not properly placed (as shown in picture), loosen roller and move it the proper location.

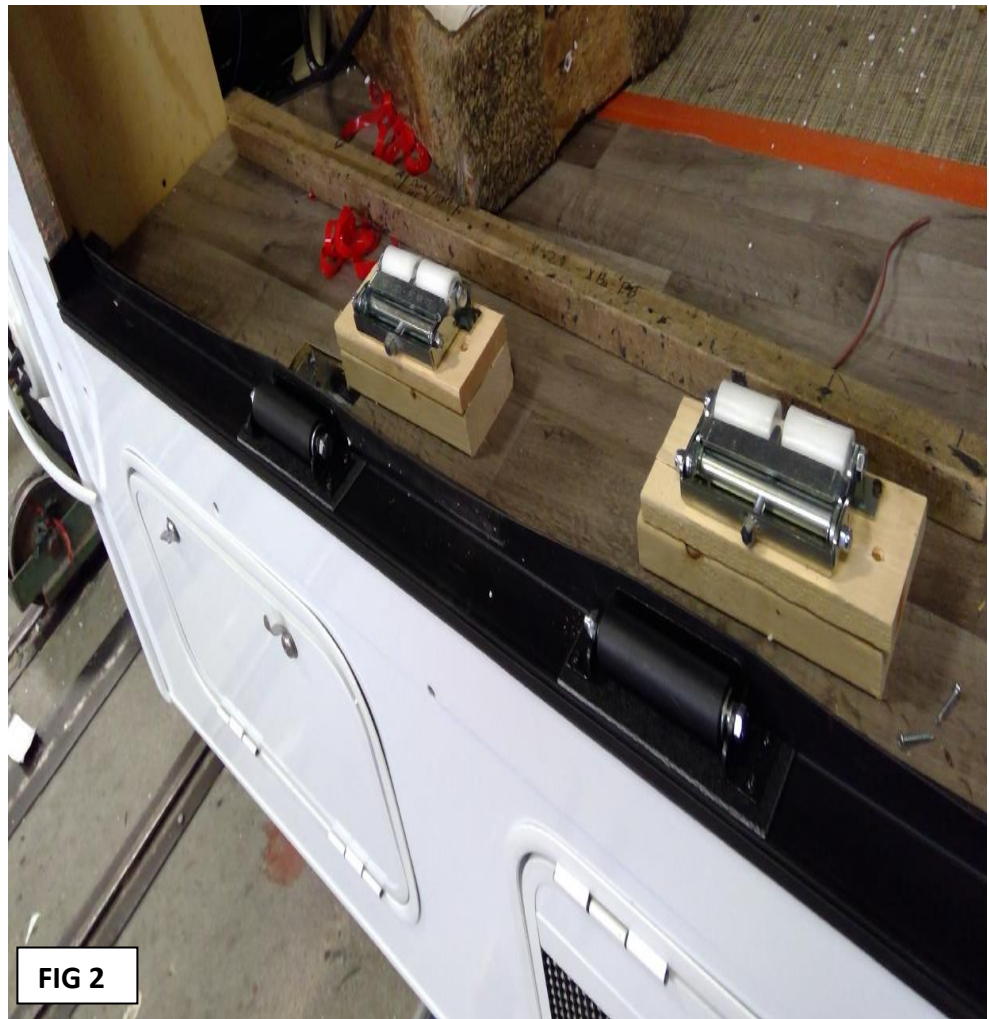
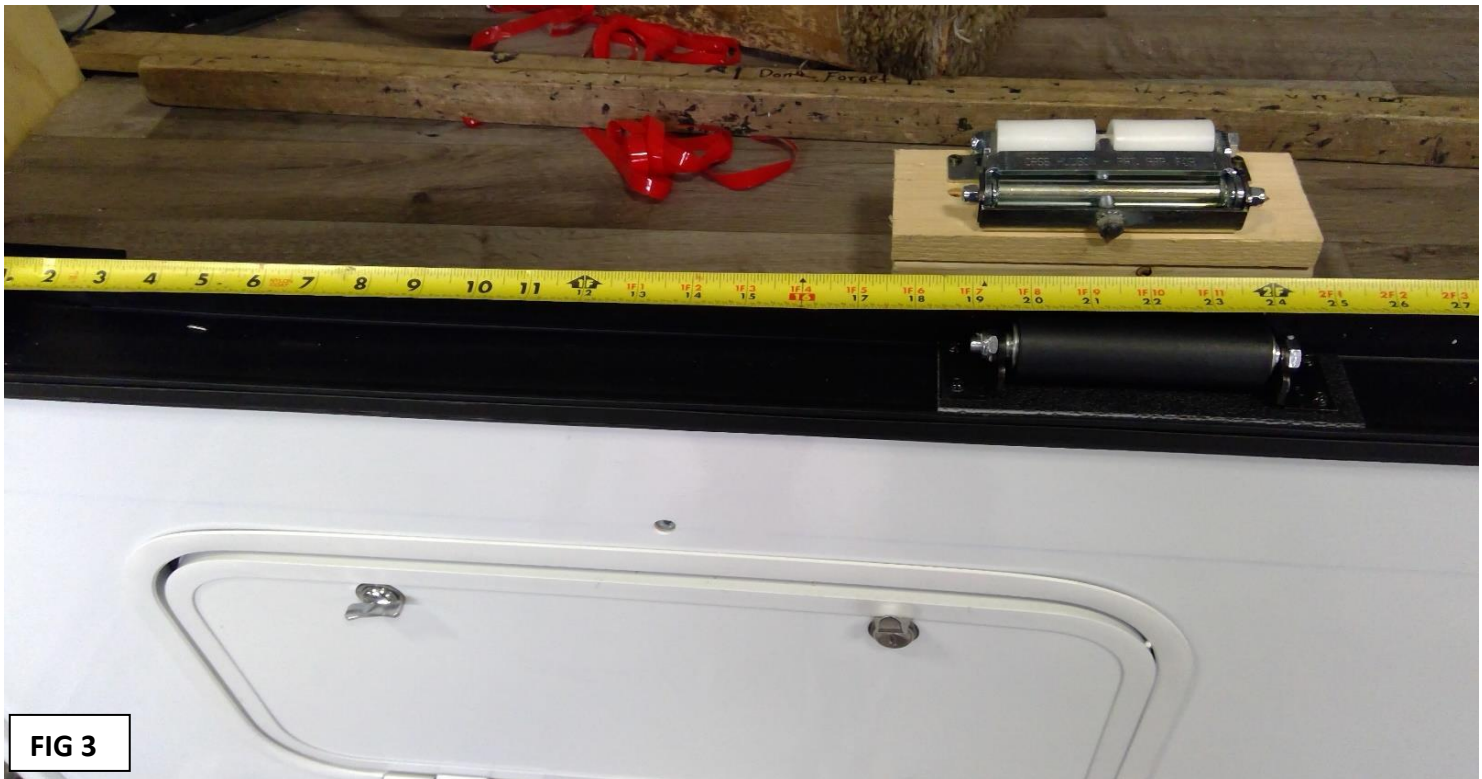
2. Figure 2 and 3 below shows the proper location of floor rollers. They should be aligned and parallel to the wall rollers. Measure 22 inches from each side of the bottom slide out opening. The center of each floor roller should be exactly 22 inches from the side of the bottom slideout opening.

Note: The white rollers are adjustable to take pressure off of the slideout to ease operation

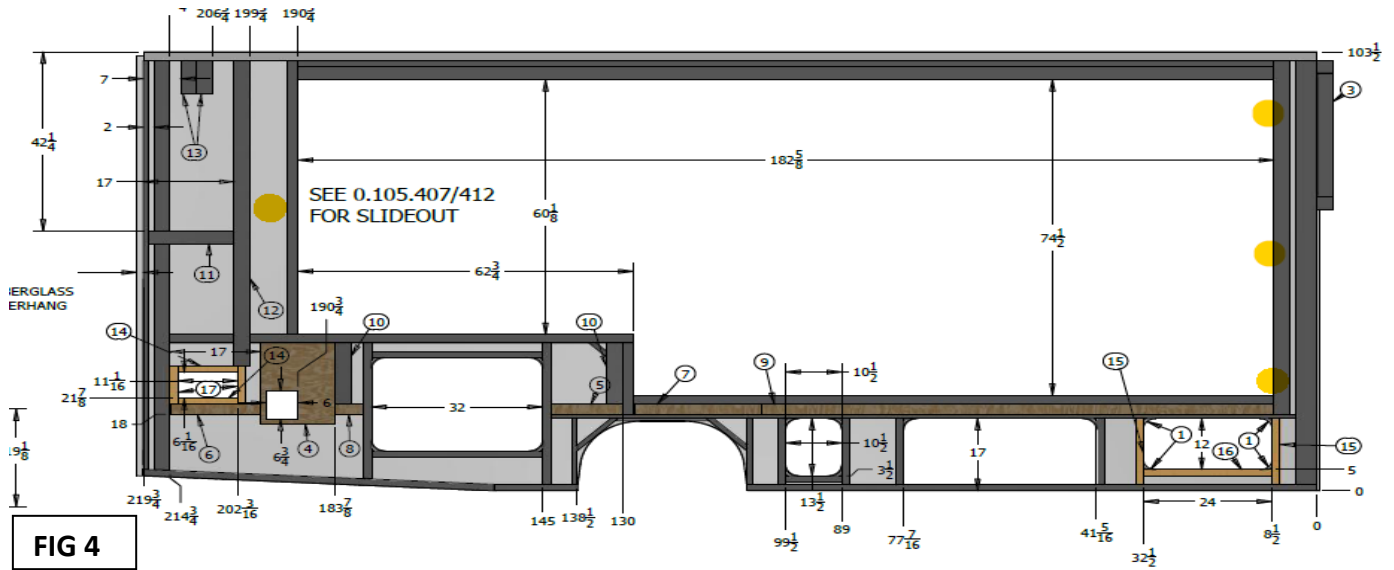
- Reinstall the four z-brackets removed from step #2. Figure 4 highlights in yellow 4 locations for additional z-brackets on the slide system frame and the frame of the wall to enhance alignment during operation. Use 6-#8 x 3/4" self-taping screws to install each z-bracket. The brackets should be located equal distance between existing z-brackets and top and bottom of slideout opening. You will need to do this to each side of the room if they are not present.

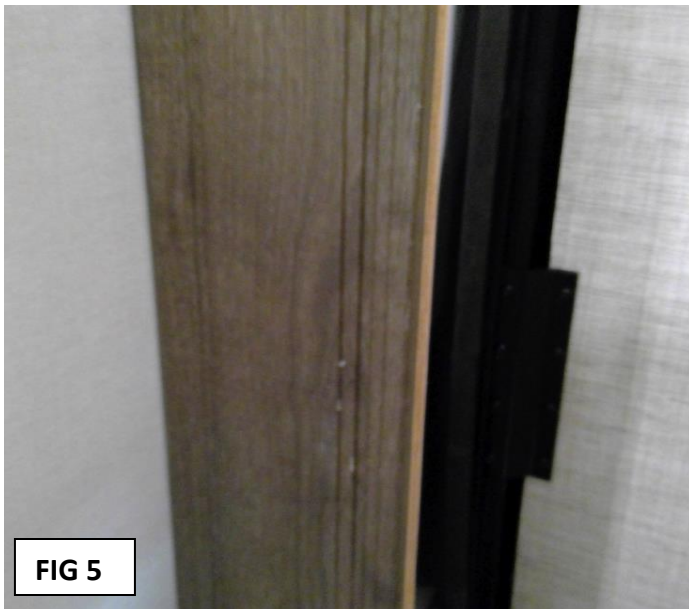
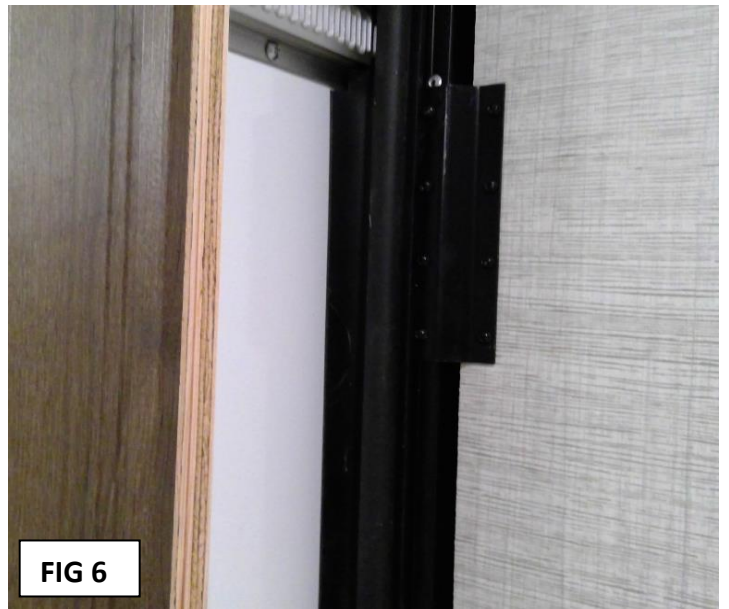
- Figures 5 and 6 below are examples of the addition of two extra z-brackets.
- This process will help the room run in/out normally without causing the gear track to get damaged.
