# TECHNICAL SERVICE BULLETIN

## Manual Sliding Door(s) - Various Manual Sliding Door Related Symptoms

**21-2102**  
13 April 2021

Ford 2015-2021 Transit
---------------------------

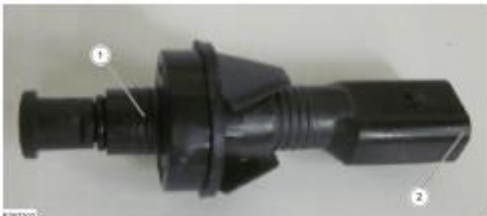
Figure 1

Item	Description
1	Measurement grooves
2	Switch connector

6. Remove the ajar switch mating connector. Tap the switch connector (Figure 1, Callout 2) lightly using a soft tool to move the switch housing outboard by about 3 to 4 grooves (Figure 1, Callout 1).
