# Service Bulletin

Bulletin No.: 20-NA-225

**Subject:** Low Battery Charge After Vehicle Sits for Short Period of Time

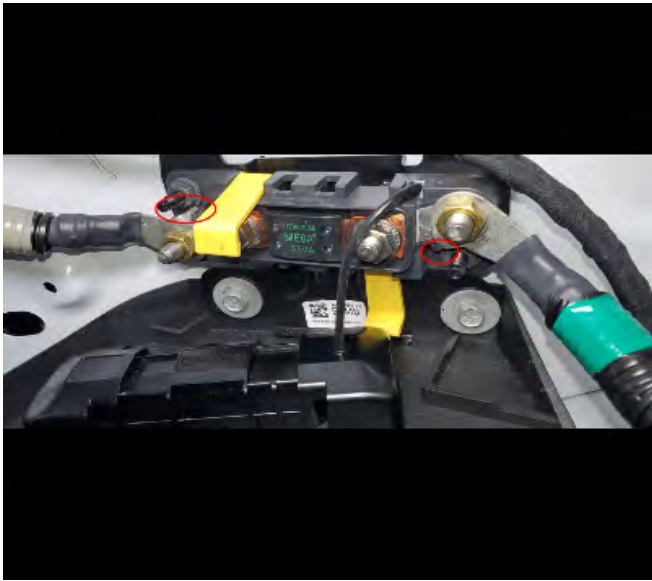
| <b>Cause</b> | <p>This condition may be caused by a voltage draw.</p> <p>5693951</p> <p>– The anti-rotation tabs on the positive side cables, located at the mega fuse, may contact the mega fuse mounting stud nuts.</p> |

| <b>Correction</b> | Trim the anti-rotation tabs on the positive battery cables located at Mega fuse. |

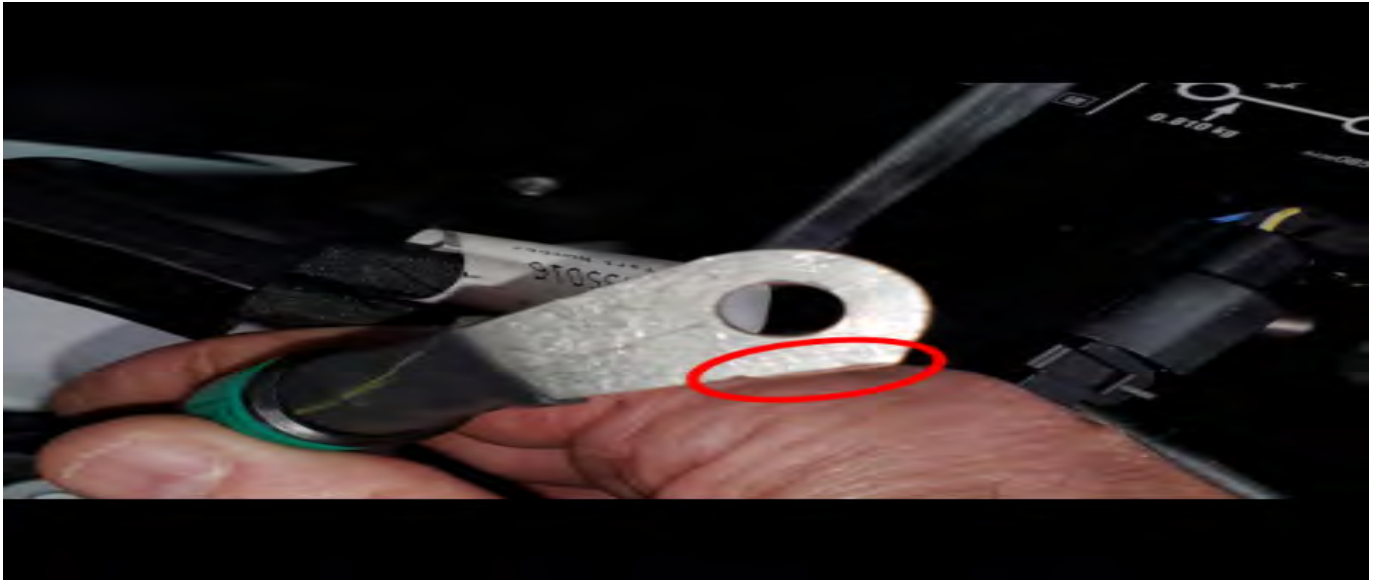
5693961

**Important: DO NOT** cut the all the anti rotation tab flush, as shown in the graphic above. Cutting the tab flush may cause the cables to rotate and contact the fasteners or the Mega fuse mounting studs.
