## Spartan RV Chassis

Technical Service Bulletin  
CSB21-360-001

- DATE:** April 22, 2021
- APPLIES TO:** This service bulletin applies to 2020, 2021, and 2022 model year, K1, K2, K3, and K4 model motor home chassis built between 2/4/2020 and 10/22/2020 equipped with a Tire Pressure Monitoring System (TPMS) supplied by SpartanLync.
- CONDITION:** The Spartanlync TPMS modules were supplied with a resistor in circuit board that is not desired for Spartan RV Chassis due to potential interference with the motor home channels on the house side.
- CORRECTION:** Replace the nonconforming modules with certified no resistor modules and reprogram baselines and unit's tire sensor serial numbers.
- LABOR ALLOCATION:** 1 HR

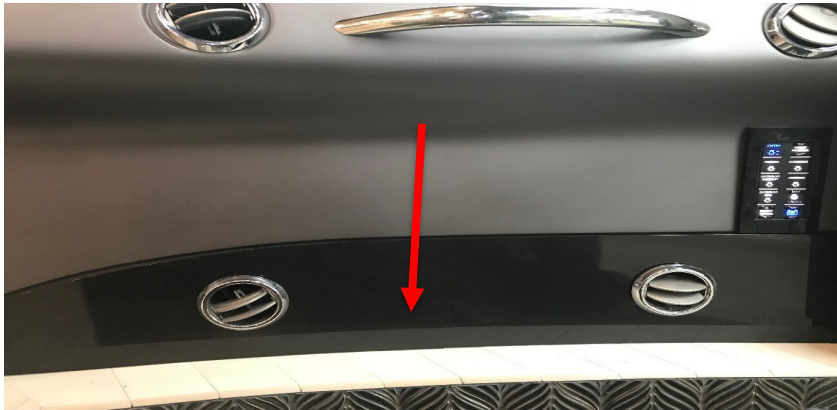
Figure 1.1 The Omnivue camera module is held against the sidewall by Velcro. Remove this module to gain access to the far-right screw holding the Trimark board in place.

Remove the metal dash cover above entry stairs held in place with Velcro. Remove A/C hoses from louvers.
