Vehicles affected: P11-12C Coupe & Spider, 625C Coupe, 650S Coupe & Spider

Location: Body & BIW – Active Aero

Topic: Airbrake warning displayed on the instrument cluster

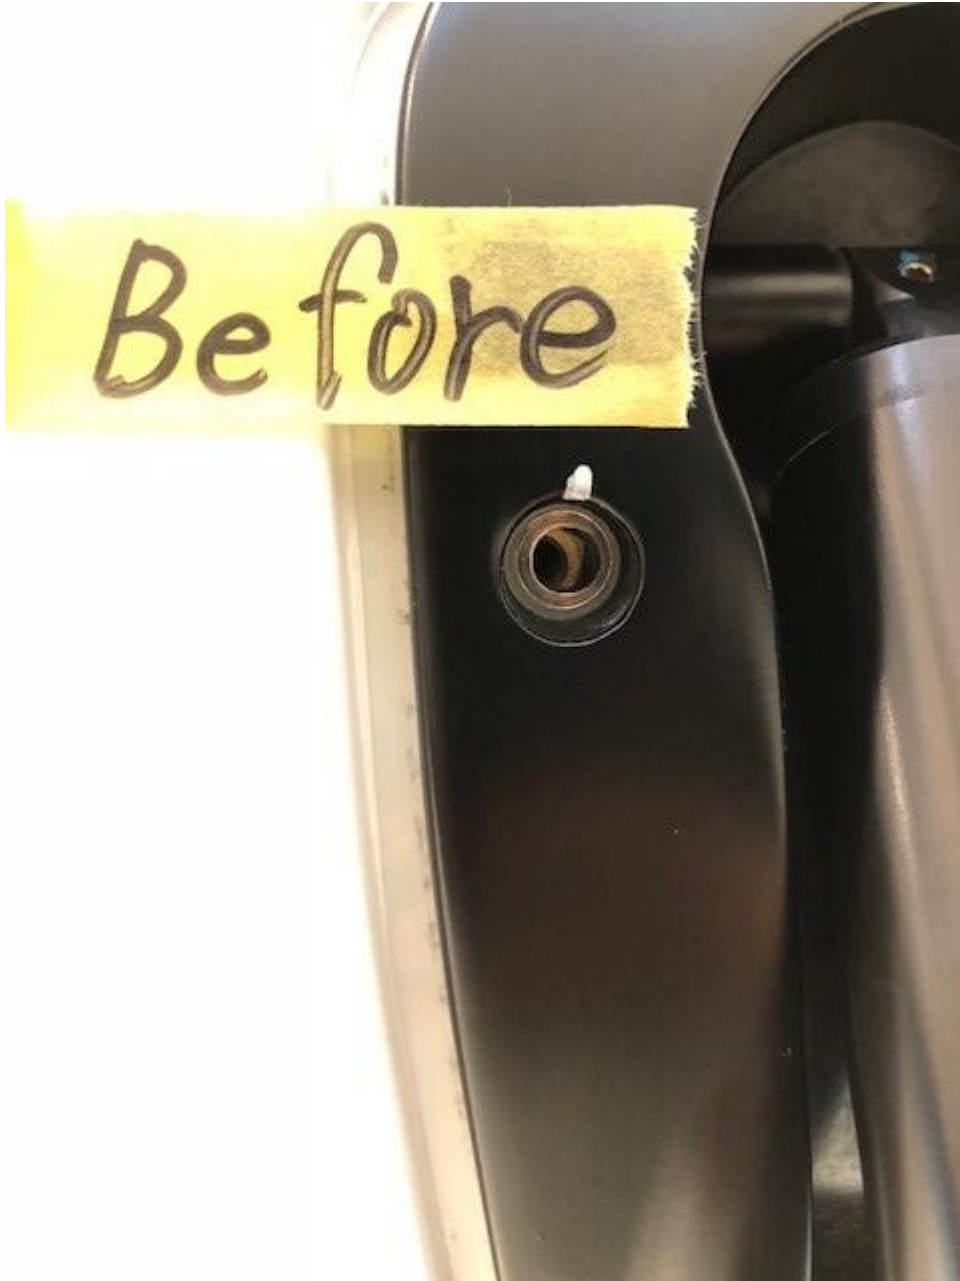
In the event of a customer complaint for Airbrake Warning Message on the instrument cluster and the Airbrake Twist DTC C111492 is present in the PCCU, it is possible that the airbrake actuators are not running parallel to each other. This will cause increased drag and a twist condition in the airbrake panel.

1. Remove the airbrake panel fixing bolts of the right hand side actuator only.
2. Check if the holes of the airbrake panel with the hole of the actuator line up. If ok, reinstall the bolts and remove the bolts of the opposite side (left hand side).
3. If the holes do not line up as shown in the image below, is possible that the airbrake actuators are not parallel and require shimming.

Figure 1: Airbrake panel holes not aligned.

4. To do this insert shims between the airbrake actuator mounting and the subframe. Different thickness shims are available via SPC (screenshot below).

Refer to SPC Body Systems / Airbrake section to identify correct shim thickness

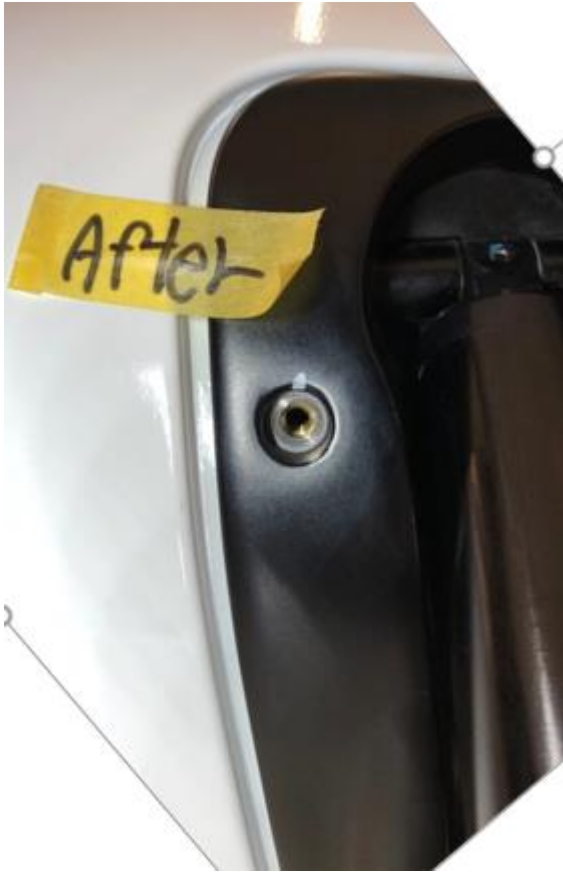
5. Once the actuators are shimmed correctly check the airbrake panel holes alignment. The image below shows a good alignment.

Figure 3: Airbrake panel holes aligned

6. If ok, reinstall the airbrake panel fixing bolts.
7. Run the Airbrake Calibration Sequence within the PCCU module.
8. Delete all DTCs.
9. Road test the vehicle and operate the airbrake panel as many times as you can.
10. If no warning message is present, the above procedure has been completed successfully.
11. If the DTC returns, please submit a Technical Request for further assistance.
