Model 579 Chassis Fairing Loose

Technical Information Bulletin

02-161

Model 579 Chassis Fairing Reinforcement

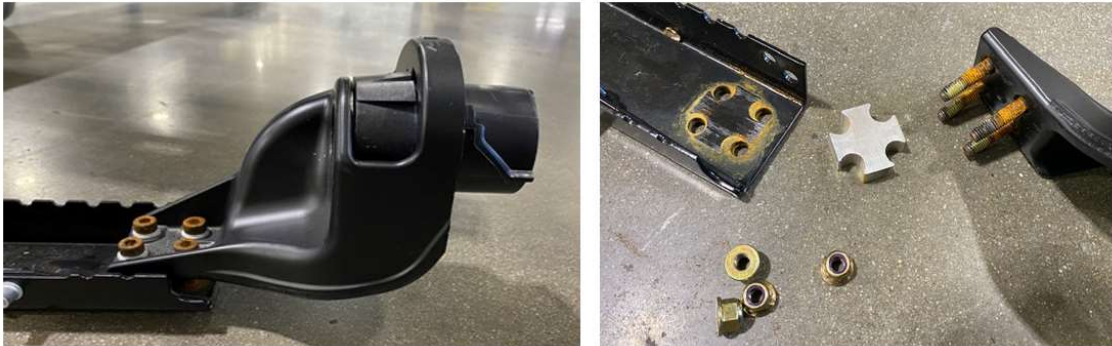
Figure 1

1. Remove the steps and chassis fairings from both sides of the truck.
2. Remove the fairing bracket from the top step on both sides of the truck. See Figure 1.

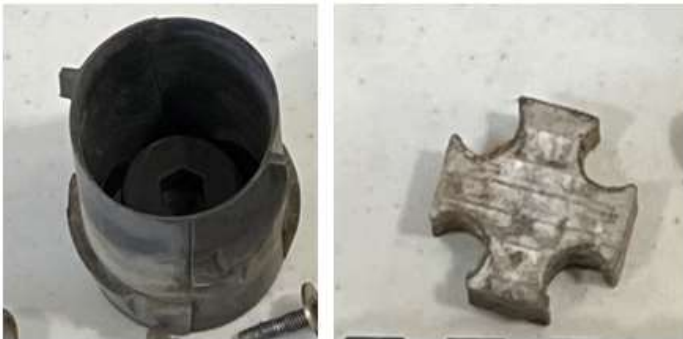
Figure 2

3. Remove and discard the plastic collar and aluminum spacer shown in Figure 2.

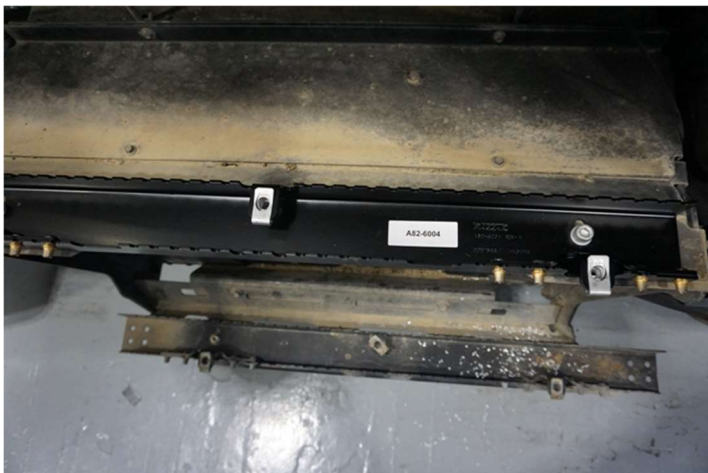
Figure 3

4. Install the new top step on both sides. See Figure 3.

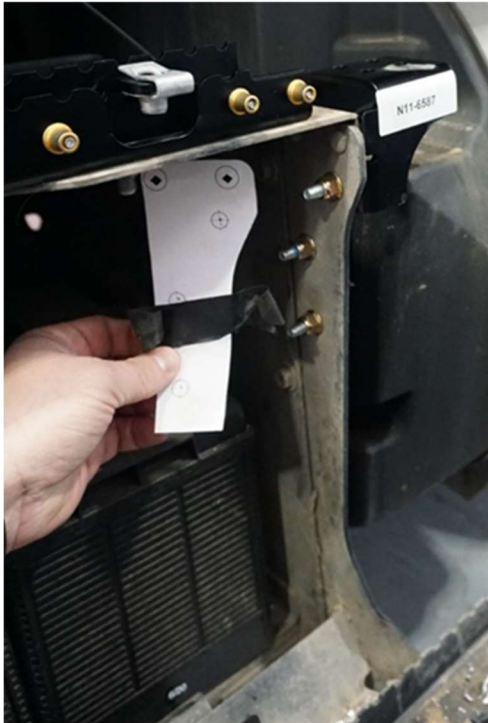
5. A paper drilling template for the LH Chassis Fairing Bracket is included in the kit. Align the paper template as shown in Figure 4 and, using a backing plate to protect surrounding components, drill the holes. Install the LH Chassis Fairing Bracket as shown in Figure 5 (three M8 bolts and nuts).

Use a backing plate when drilling to prevent damage to surrounding components.

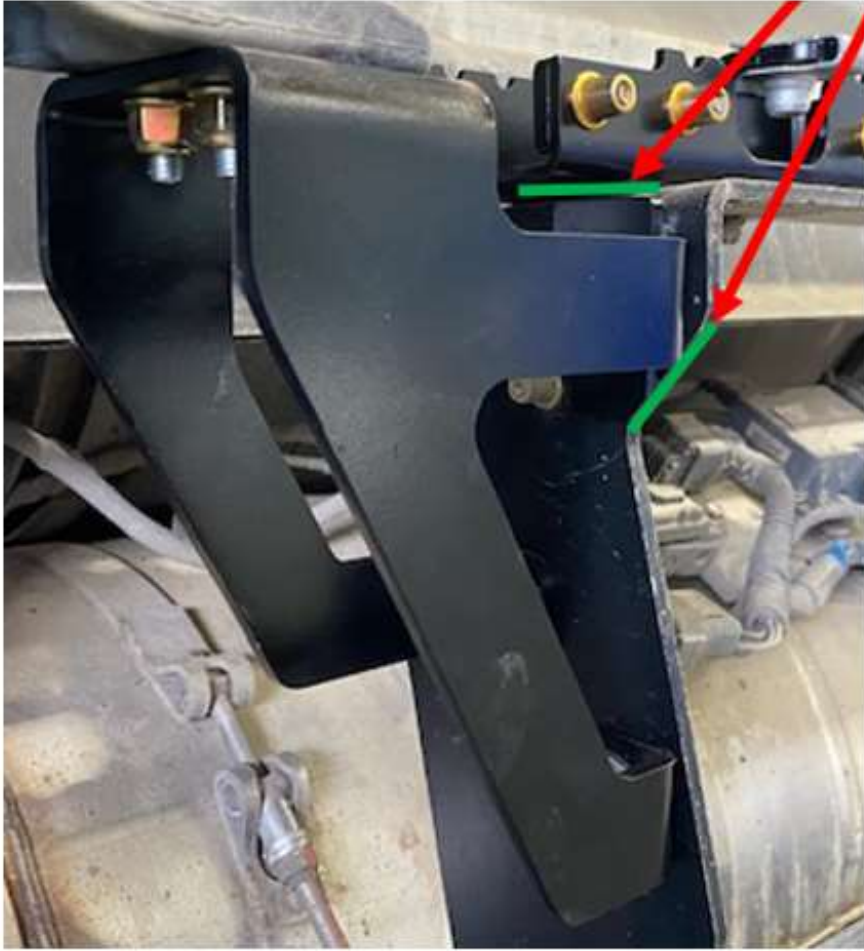
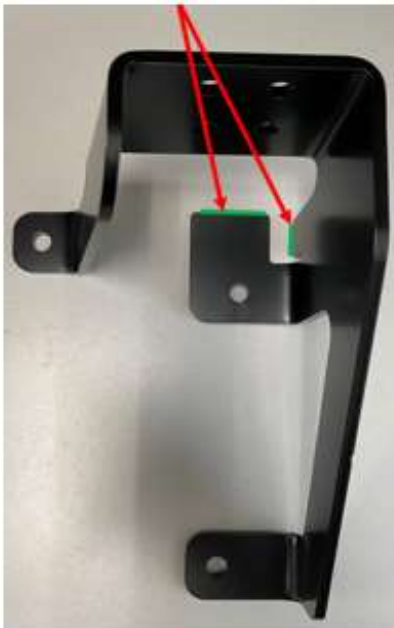
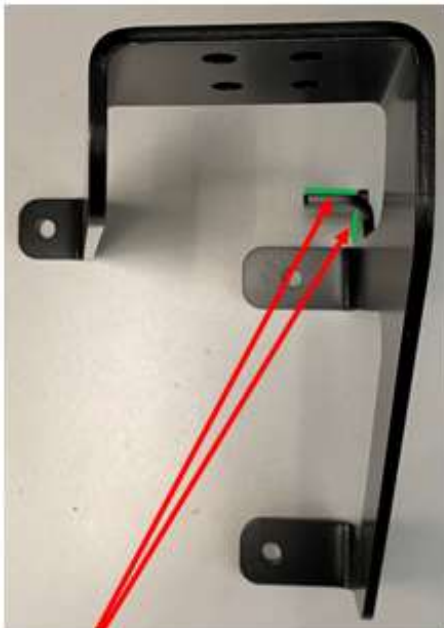
Figure 6

6. Using the Parts Usage Matrix attached to the bulletin, select the appropriate RH Chassis Fairing Bracket.
7. Use the alignment features on the bracket, as shown in Figure 6, to determine the drilling locations. Using a backing plate to protect surrounding components, drill the holes. Install the RH Chassis Fairing Bracket (three M8 bolts and nuts).

Use a backing plate when drilling to prevent damage to surrounding components.

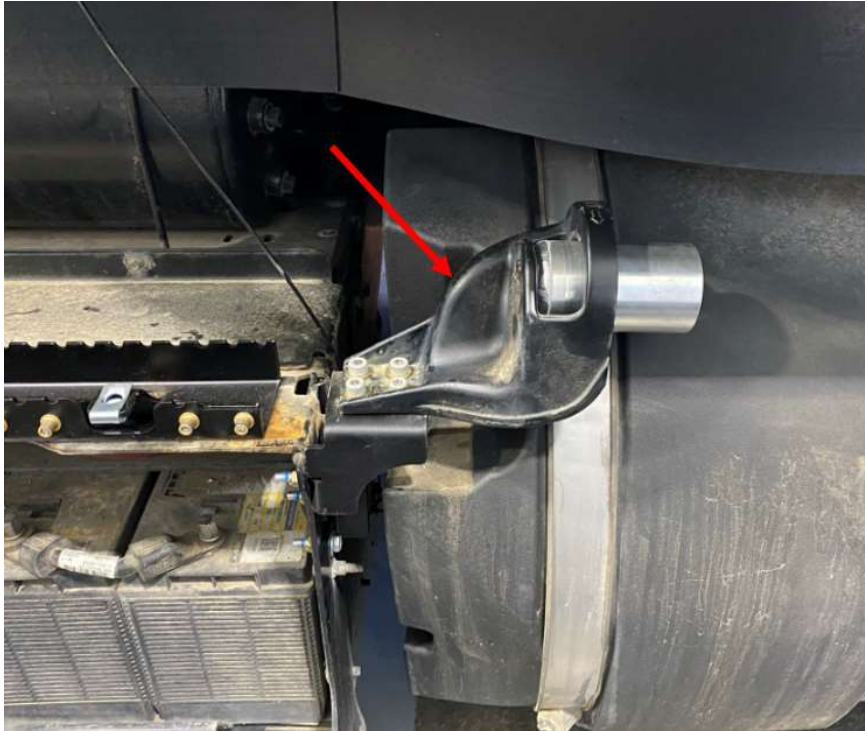
Figure 7

- Using new hardware, reinstall the LH and RH collar support brackets (four M8 socket head screws, M8 flange nuts and M8 flat washers per side). See Figure 7.

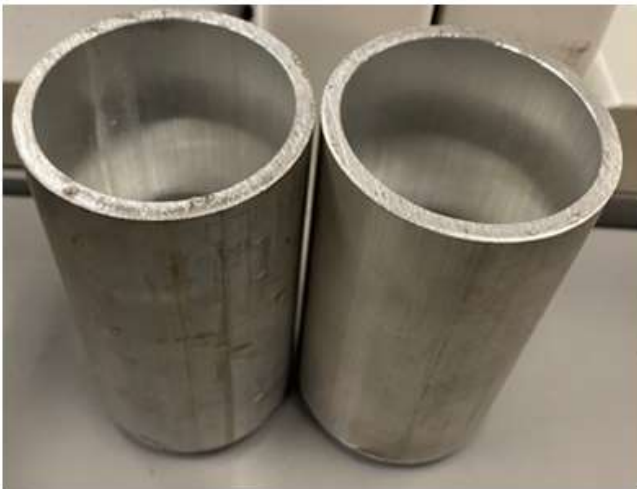
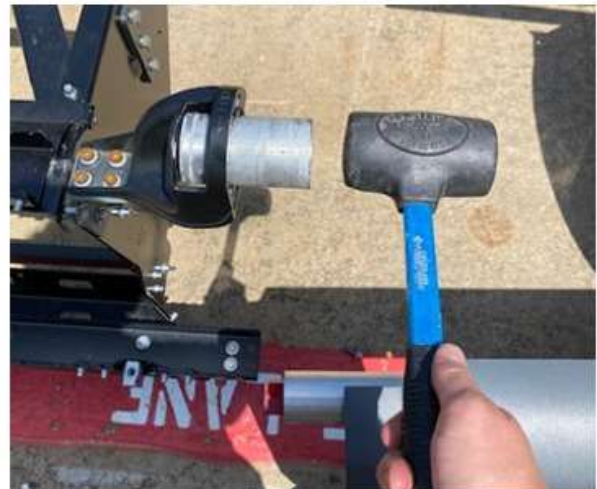
Figure 8

- Install the front collars into the collar support brackets on both sides. A rubber mallet may be required to seat the aluminum collars. See Figure 8.

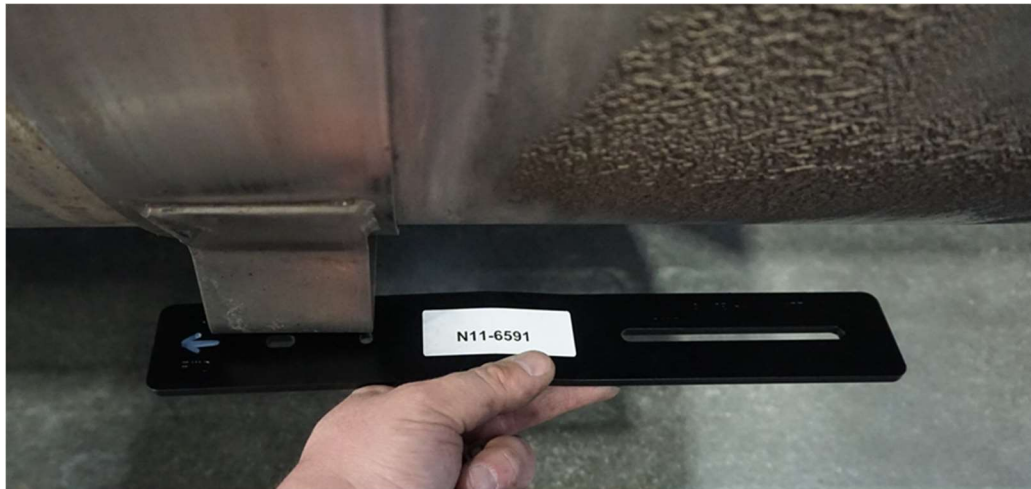
Figure 9

- Using the Parts Usage Matrix attached to the bulletin, select the appropriate Lower Rear Skirt Brackets. Replace the bracket mounted to the fuel tank strap with a new bracket as shown in Figure 9. N11-6591 is shown in Figure 9, but the part can vary depending on vehicle configuration.

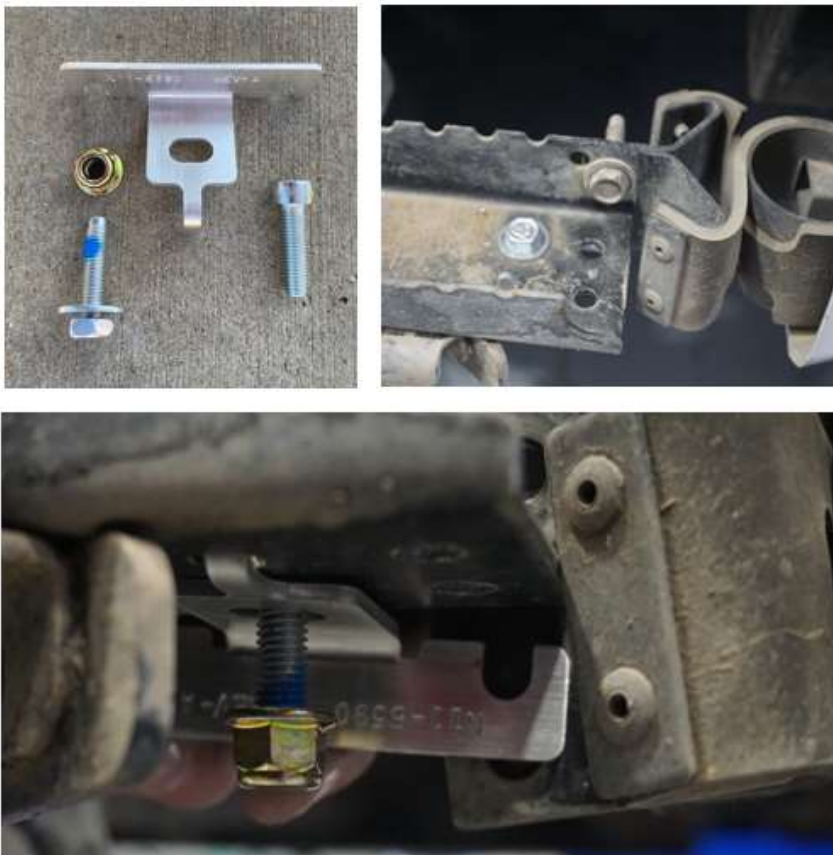
Figure 10

- Install the LH and RH Chassis Fairing Isolator Brackets to the Lower Service Steps. Loosely install the bolt as shown in Figure 10.

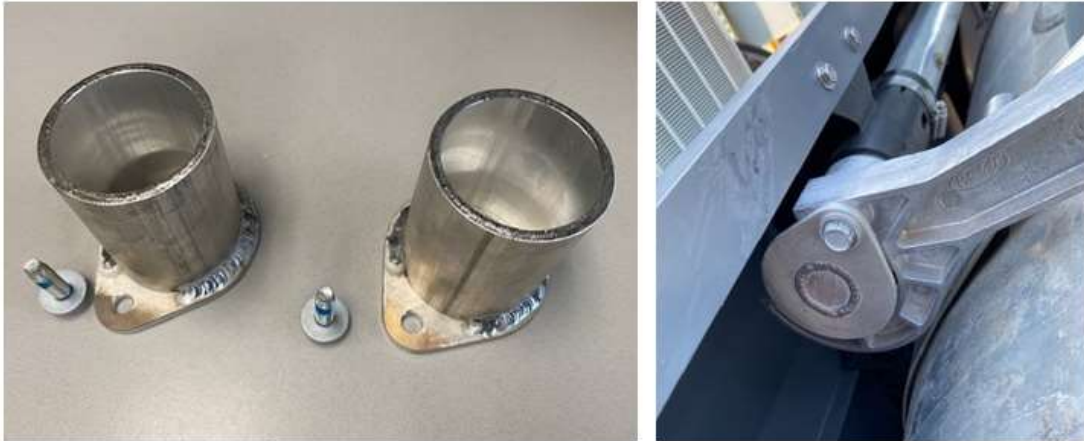
Figure 11

12. Install the LH and RH fairings using the new aluminum rear collars as shown in Figure 11.

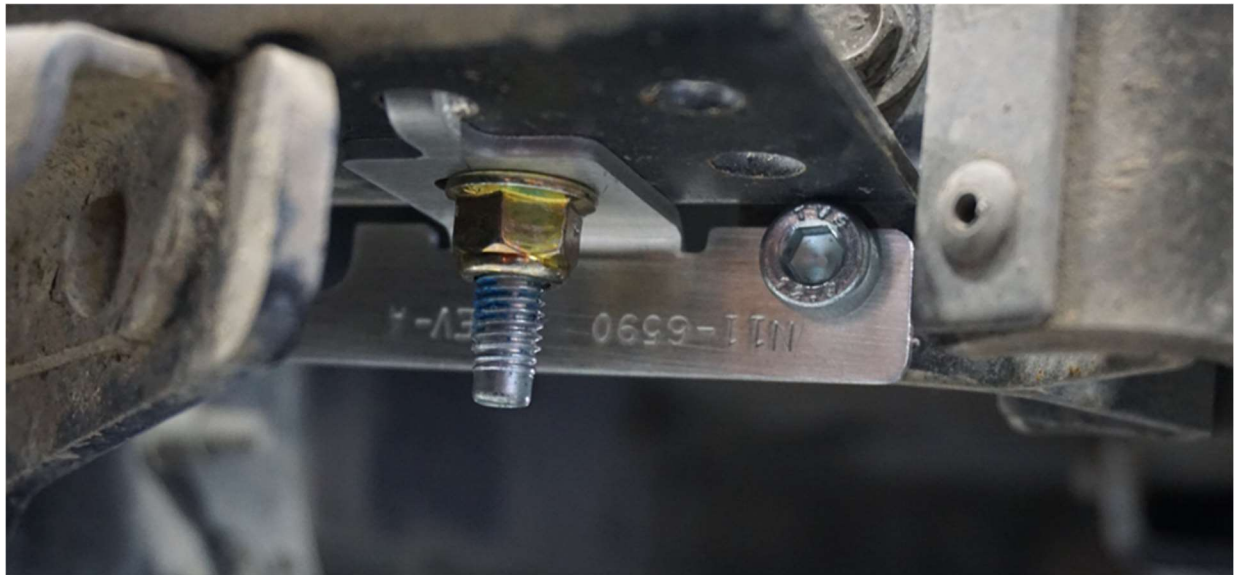
Figure 12

13. Complete the installation of the Chassis Fairing Isolator Bracket (both sides) by installing to the isolator and tightening the bolt loosely installed into the lower step. See Figure 12.
