Vehicles affected: P15 - Senna

Location: Body & BIW - Active Aero

Concern: Airbrake Fault Warning Message on Driver Display

**Diagnostic Trouble Codes:** TCU - C100B21 Airbrake position 1 signal low, C101022 Airbrake position 2 signal high

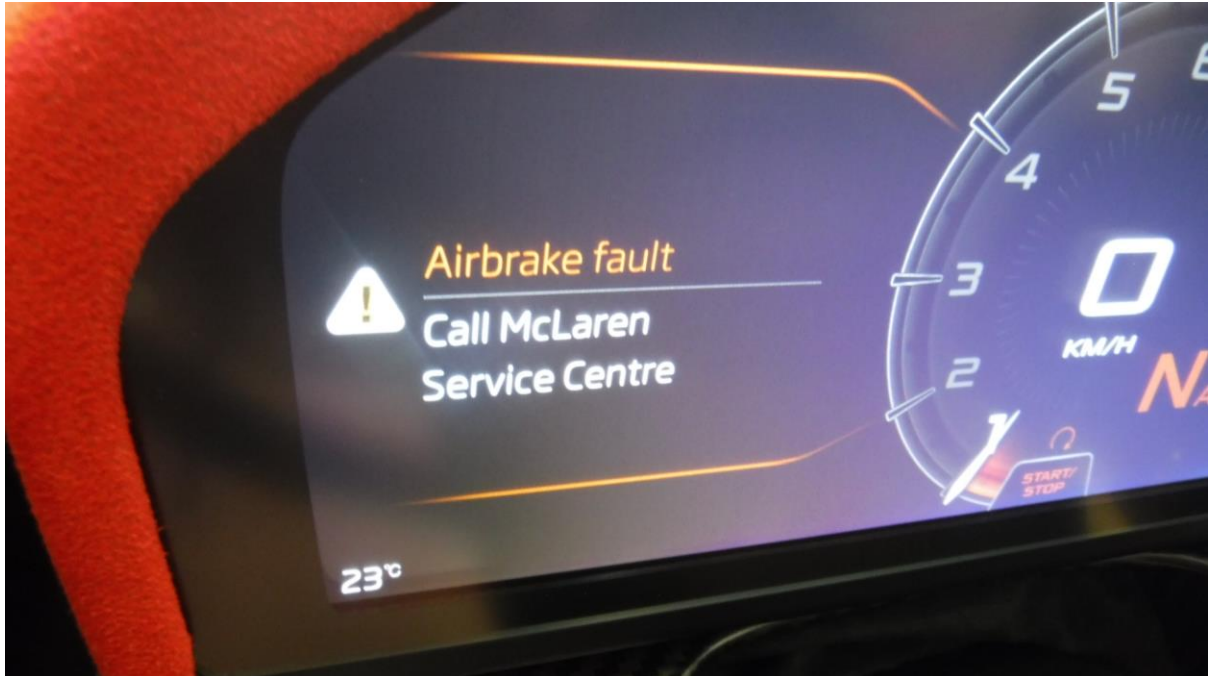
If the following error message is displayed in the driver's display, check in the TCU for DTCs.

If C100B21 Airbrake position 1 signal low and/or C101022 Airbrake position 2 signal high are logged, this can be due to the Drive Pin is not inserted into the sensor correctly. As a result the sensor's output will be at 0.00V.

If this situation is found, remove the Airbrake Rear Wing following the SIS instructions:

Then, remove the pylon upper aesthetic cover and access to access the airbrake sensors as shown in SIS instructions:

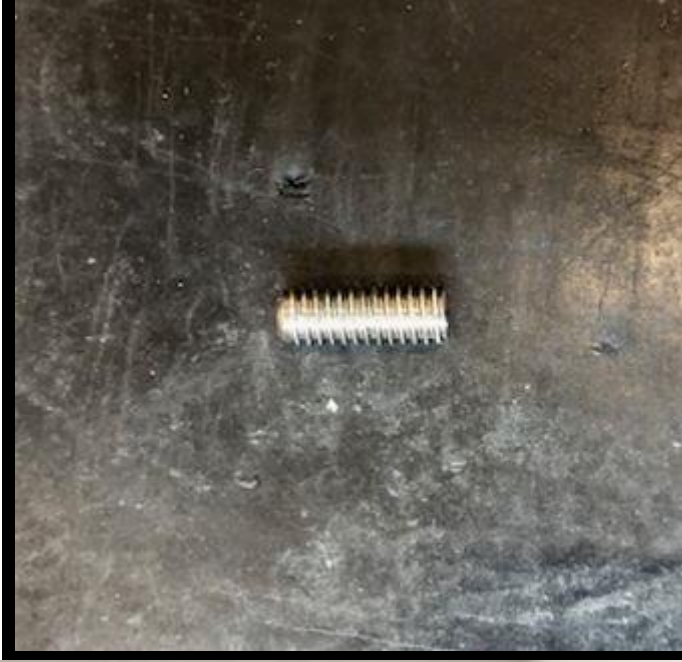
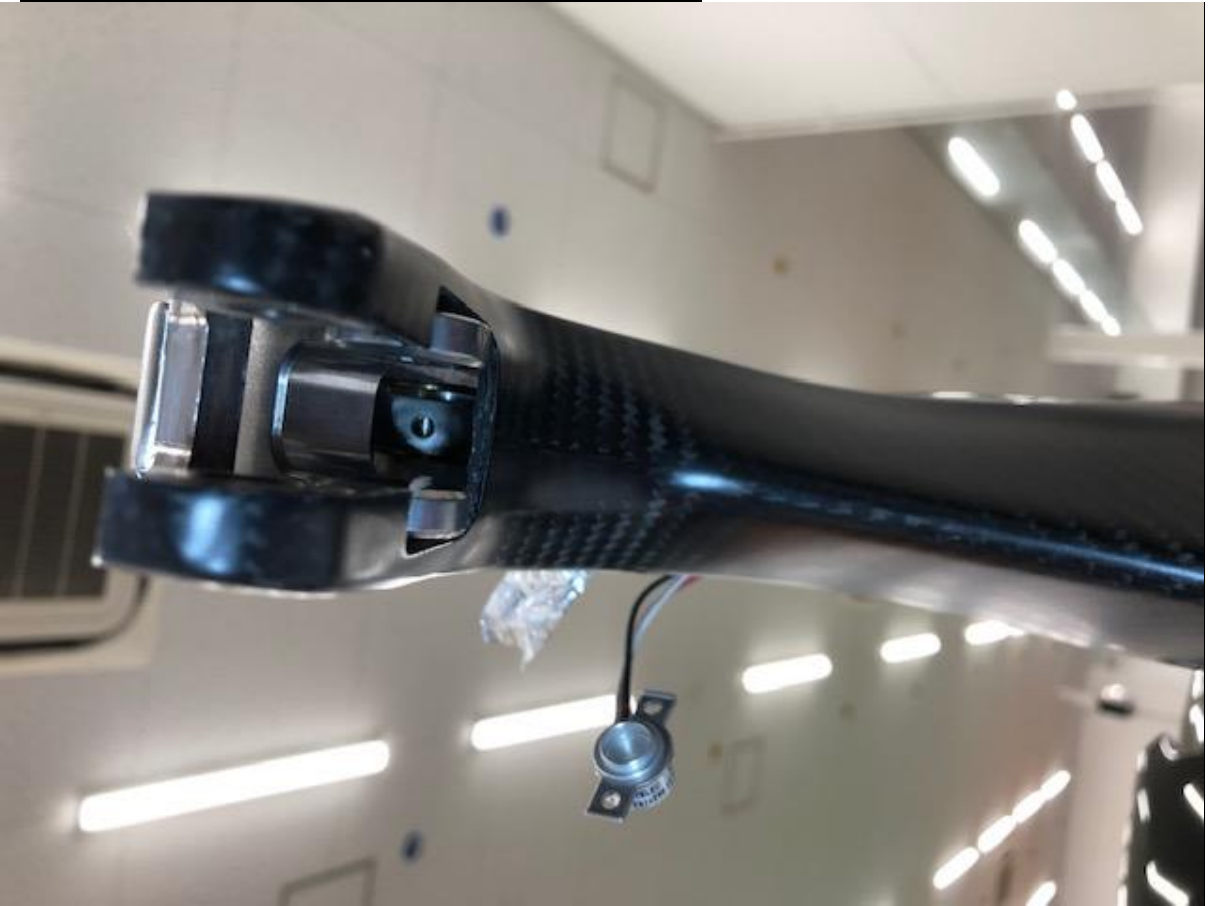
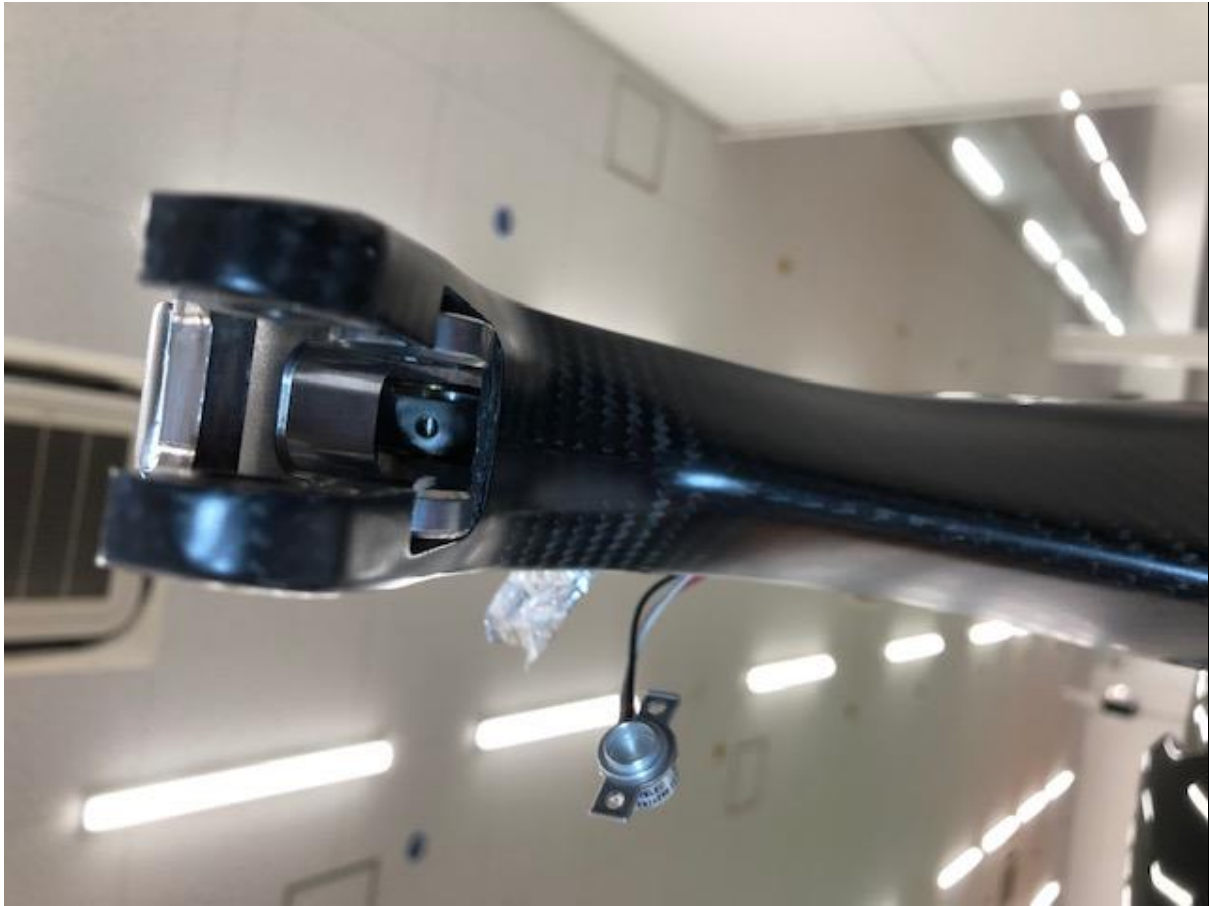
Secure the locking grub screw to the kinematic with a small application of Loctite 238 to the threads, tighten the grub screw to 1.6Nm, this will secure the drive pin to the kinematic.

After the drive pin is secured to the kinematic, allow the kinematic to return to the rest position, refit the Rear Wing following the procedure within SIS:
