CAMPAIGN BULLETIN

Moonroof Inspection Dealer Inventory

Reference: PC800
Date: March 26, 2021

PC800 - 2021 ALTIMA MOONROOF MIS-SET

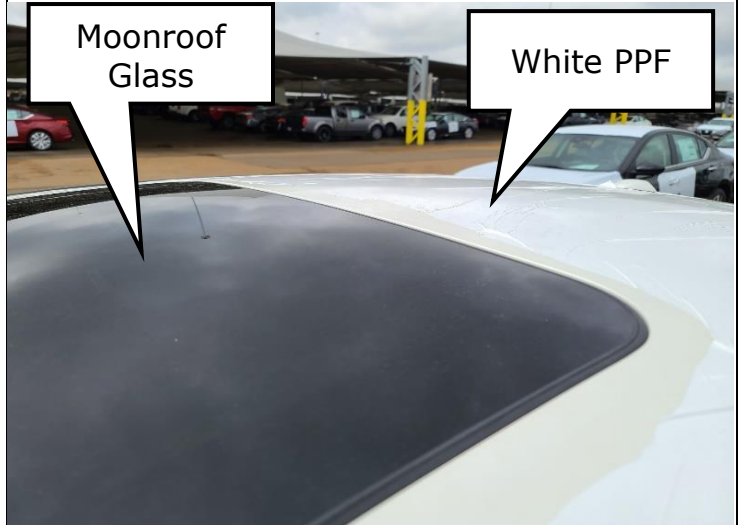
Figure 1

1. If applicable, peel back the white PPF (Paint Protective Film) to uncover the moonroof and roof panels (Figure 1).

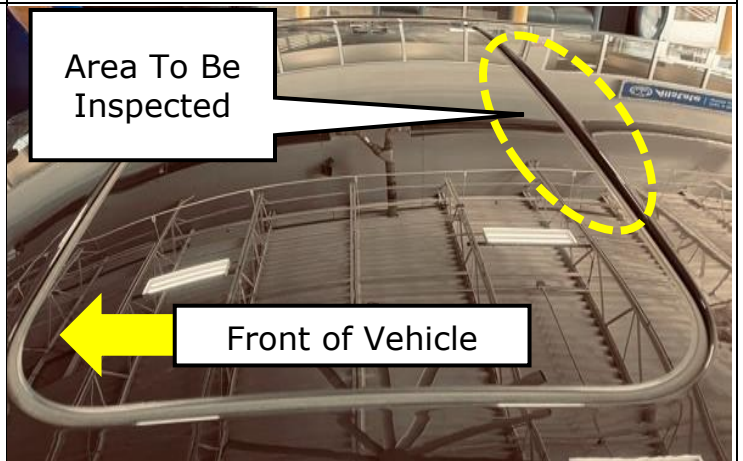
2. Locate the center rear of the moonroof glass (Figure 2).

3. Visually inspect height difference between the roof surface and the rear center of the moonroof glass.

- Use a metric steel rule to measure the height difference
- Set steel rule on moonroof glass and measure the height difference between the roof surface and the moonroof glass (see Figure 2 for area to be measured)
- Use care not to scratch roof paint or moonroof glass
- Review examples in Figures 3 and 4 below:

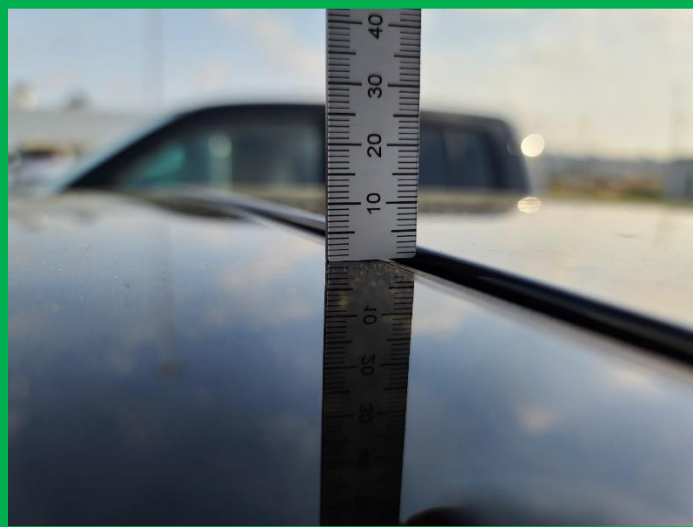
Figure 3

2 mm Height Difference Shown Below

GOOD

- The height difference is less than 7 mm (**GOOD** Condition). Inspection is complete. Submit a warranty claim for PC8000 per the Claims Information.
- The height difference is 7mm or greater (**NO GOOD** Condition). Do NOT submit a warranty claim. Go to Step 4.

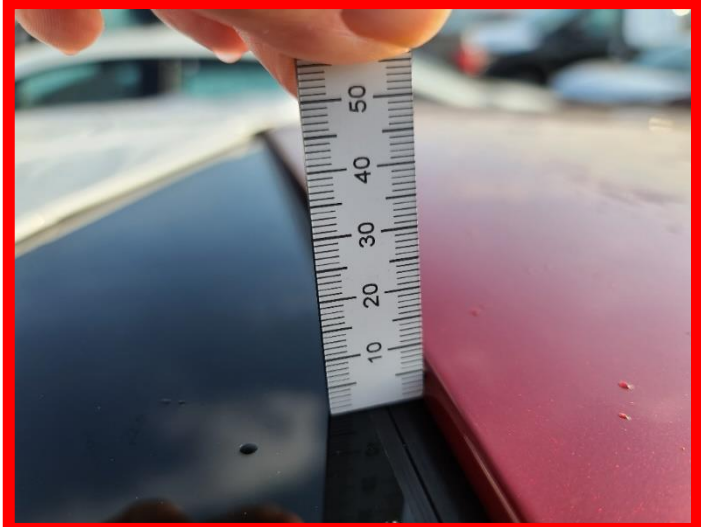
Figure 4

8 mm Height Difference Shown Below

NO GOOD

4. Provide clear photos of the measured height difference between the roof surface and the moonroof glass with a metric steel rule to FQA using the information below.
