# SERVICE BULLETIN

Classification:	Reference:	Date:
DA15-032C	NTB15-099C	March 12, 2021

## SERVICE INFORMATION FOR DTCs C1A12 AND C1A16

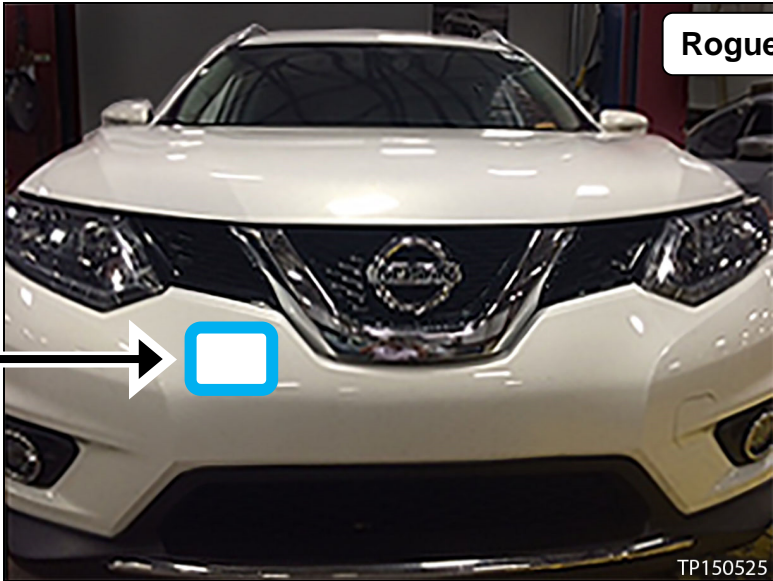
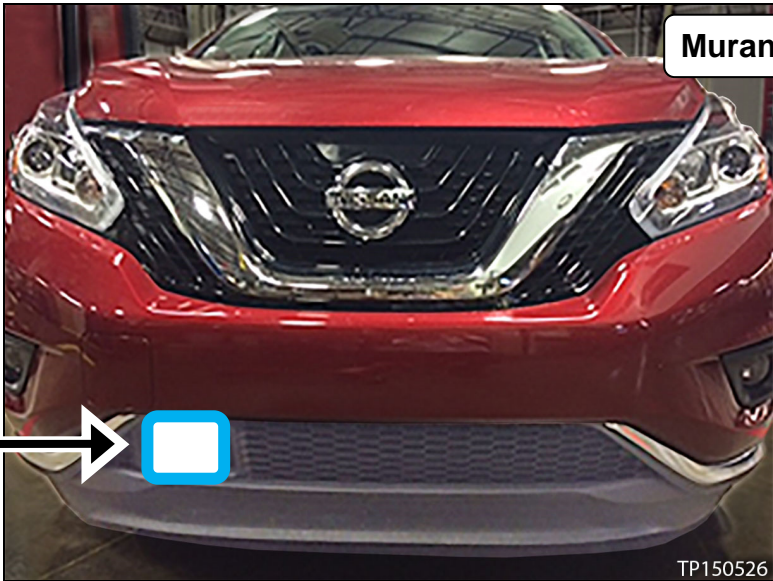
Location of ICC/distance sensor, behind or below bumper fascia

- Check the ICC/distance sensor lens or the bumper fascia in front of the sensor (see pages 2, 3, and 4). Remove any obstructions, including any clear bra or film, and clean off any stains (mud, dirt, road debris, dirty rain water, etc.), and then verify proper system operation.

- Inspect the bumper fascia in the area in front of the ICC/distance sensor (see pages 2, 3, and 4).
  - Check for stains and/or physical damage (for example, mud/dirt, road debris, dirty rain water, scrapes, punctures, misshapen surface).
  - If there is physical damage but not severe, clean the area in front of the ICC/distance sensor, perform an ICC/distance sensor alignment using CONSULT-III plus (C-III plus), and then verify proper system operation.
  - If an ICC/distance sensor alignment is not successful, inspect the ICC/distance sensor bracket for damage (see page 5).
    - If damaged, replace the ICC/distance sensor bracket, and then perform an ICC/distance sensor alignment again.

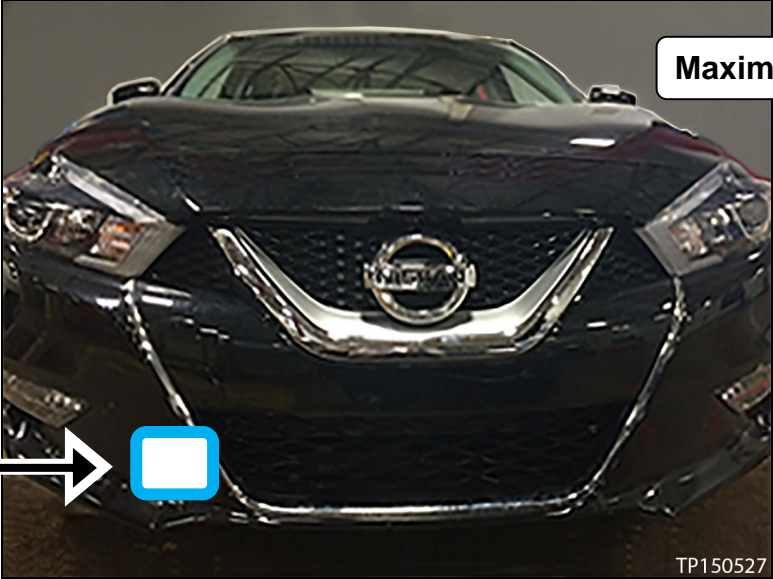
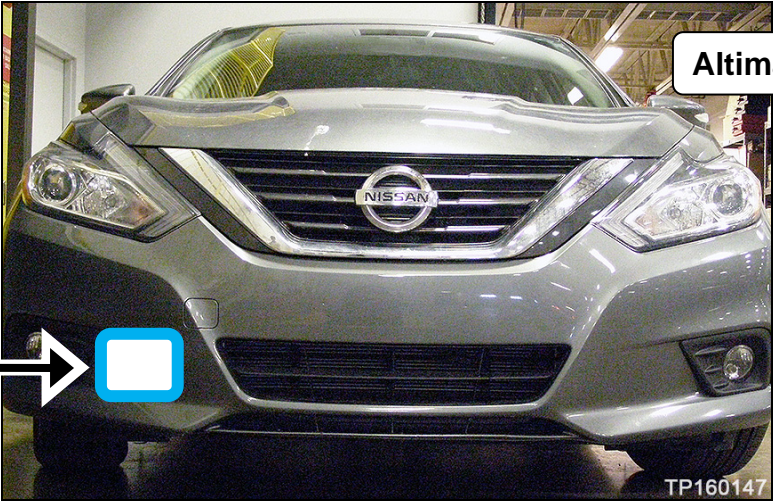
Location of  
ICC/distance  
sensor, behind  
or below  
bumper fascia

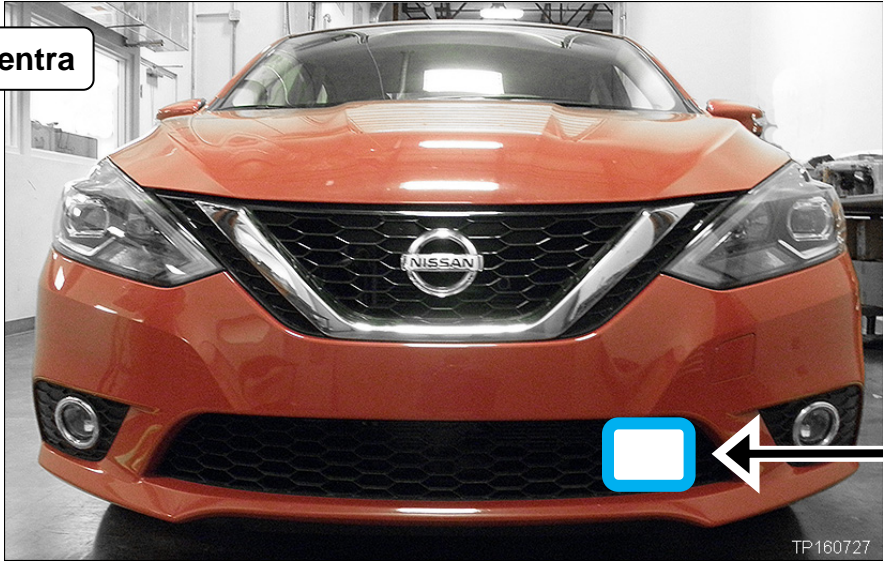
Sentra

Location of  
ICC/distance  
sensor, behind  
or below  
bumper fascia
