Technical Service Bulletin

44 Wheel alignment

44 21 82 2056386/5 May 6, 2021. Supersedes Technical Service Bulletin Group 44 number 21-80 dated February 10, 2021 for reasons listed below.

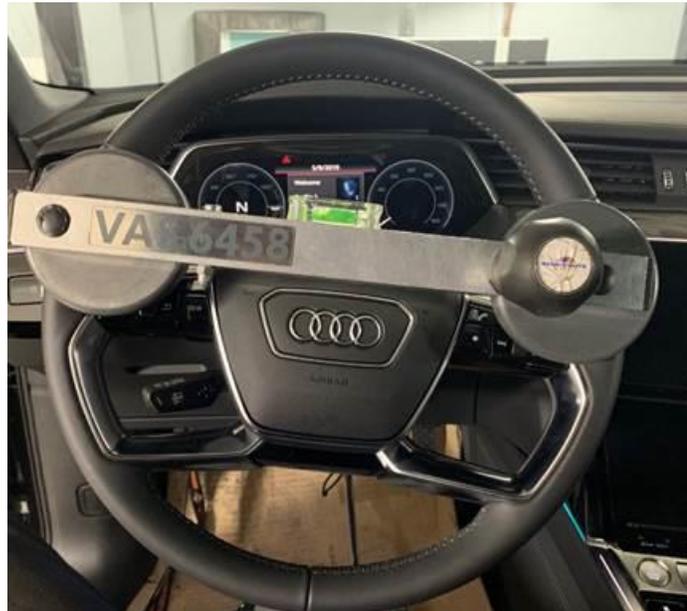
Figure 1. VAS 6458 installed with steering wheel off-center.

5. If the concern was “steering wheel crooked”, upload a picture of the steering wheel with VAS 6458 installed (Figure 1).
 - Deviations at the steering wheel position by +/- 2 degrees are the result of permissible tolerances of the track adjustment and therefore acceptable.
