GROUP CLI	MODEL 2022MY Stinger (CK) w/3.3L T-GDI
	NUMBER 050	DATE May 2021

TECHNICAL SERVICE BULLETIN

**SUBJECT: SERVICE ACTION: HEATER HOSE CLAMP INSPECTION
AND REPLACEMENT (SA479)**

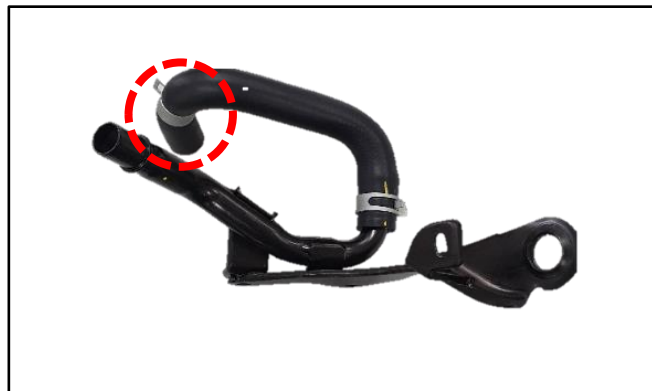
This bulletin provides the procedure to inspect and if necessary, replace the heater hose clamp on some 2022MY Stinger (CK) vehicles equipped with 3.3L T-GDI LAMBDA II engine, which may have had the incorrect diameter hose camp installed in one of the hose ends during assembly. The larger Ø24 diameter hose clamp may cause the heater hose to leak coolant. To correct this concern, replace the Ø24 with the correct Ø21 hose clamp. Before conducting the procedure, verify that the vehicle is included in the list of potentially affected 47 VINs.

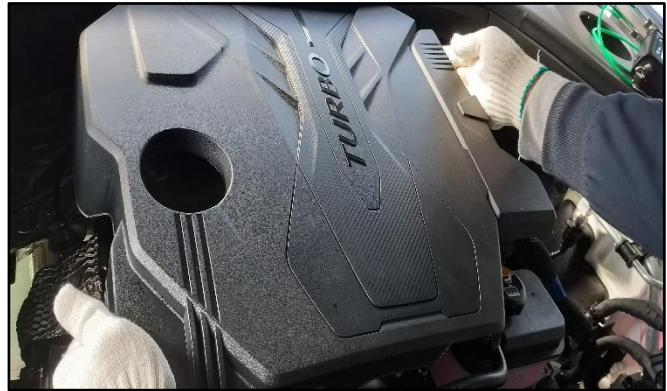
1. Open the hood and remove the engine cover.

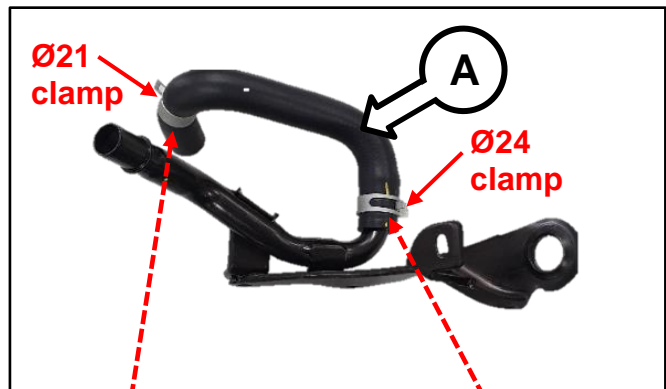
2. Locate the heater hose (A) and confirm the correct hose clamp(s) size stamping is found on opposite ends as shown.

- If the $\text{\O}24$ is found on the end requiring the $\text{\O}21$ size hose clamp, proceed to the '**Replacement Procedure**' outlined below.

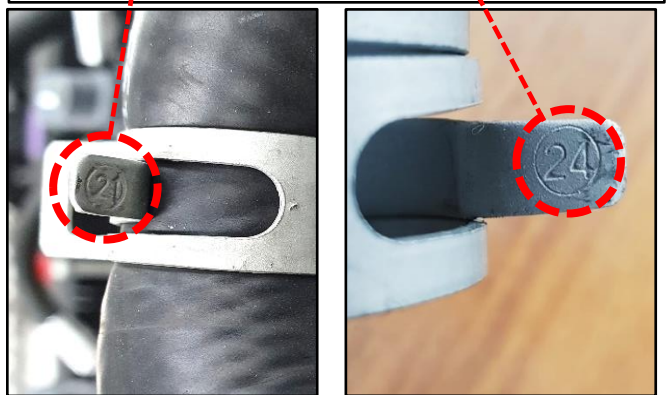
- If the $\text{\O}24$ and $\text{\O}21$ hose clamps are found to be correctly installed in their corresponding ends, no further action is required. Reinstall the engine cover.
