# Technical Service Bulletin

| <b>Technical Service Bulletin:</b> TSB210076 | <b>Released Date:</b> 07-Apr-2021 |
| <b>HDKCx Incorrect Enclosure Screw</b> | |

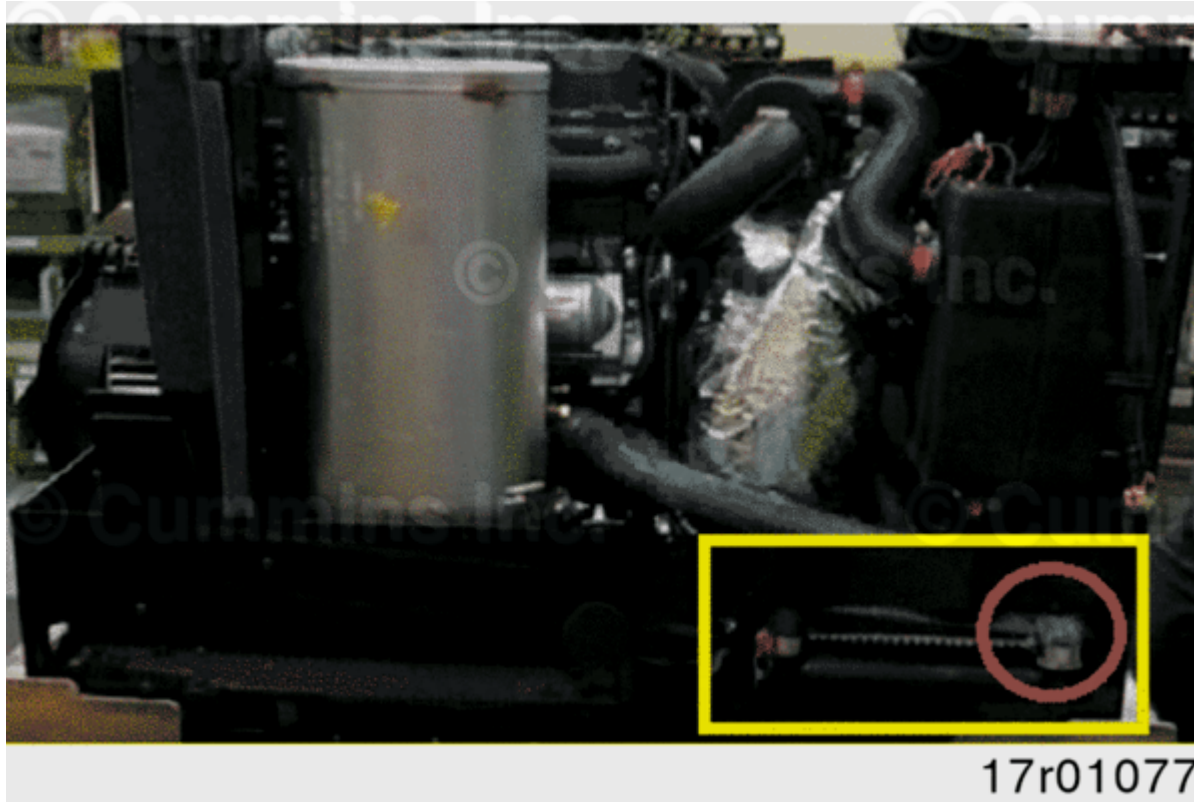
Figure 1, Screw Location

- Top right screw on the radiator mounting panel can interfere with the coolant hose potentially causing a chafing and/or puncture issue.
- If hose is punctured the unit will lose coolant and shut down on FC 1 for high engine temperature or FC36 for mechanical shutdown.

1. Locate and remove the top right screw on the radiator mounting panel.

Replace incorrect screw with correct screw PN 0821-2096-02. Replace coolant hose PN 0503-2501 if significant puncture/chafing mark is found using the steps in the service instruction section below.

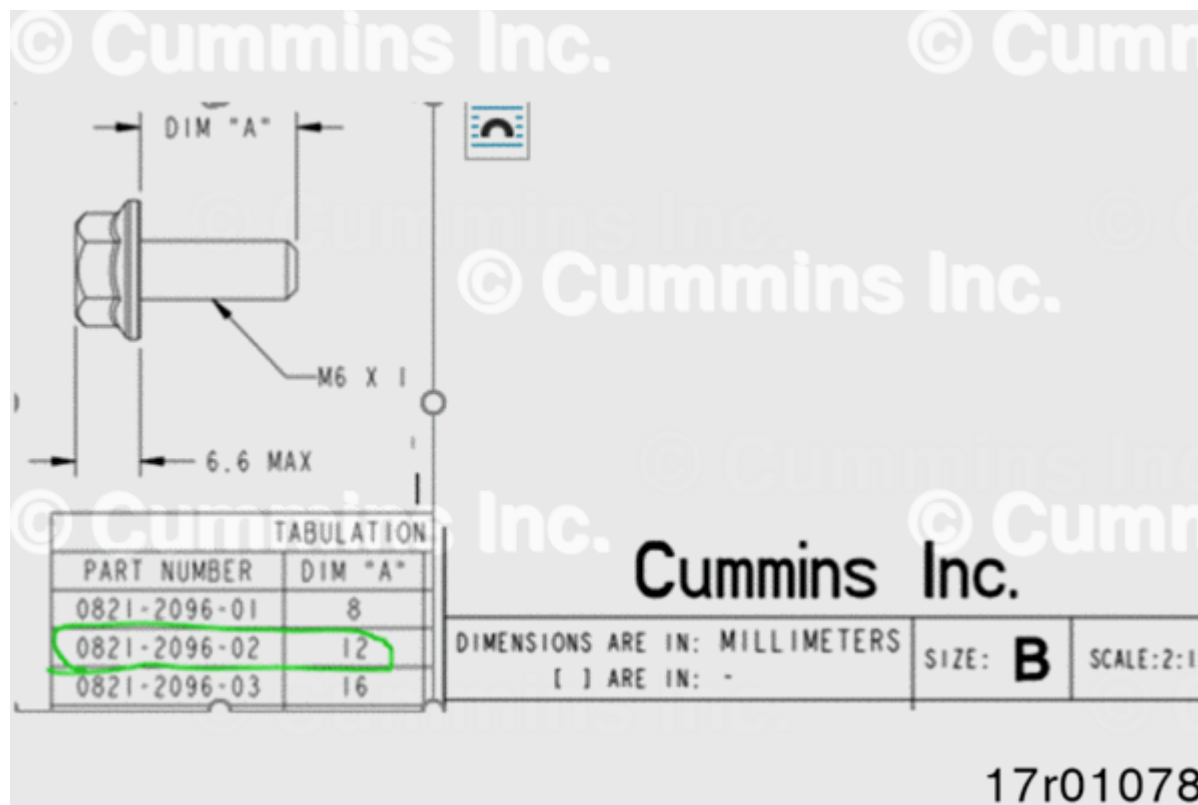
Figure 2, Screw Measurement

- Incorrect screw was used at the factory. Correct screw length is 12 mm of threading. Incorrect screw has 16 mm of threads.

2. Measure the length from the bottom of screw head to the end of the threads. See Figure 2 below.
  - If the threaded portion is 12 mm, the correct screw was used. Reinstall the screw, and no further action is required.
  - If the threaded portion is 16 mm the screw needs to be replaced. See resolution section for the next steps.

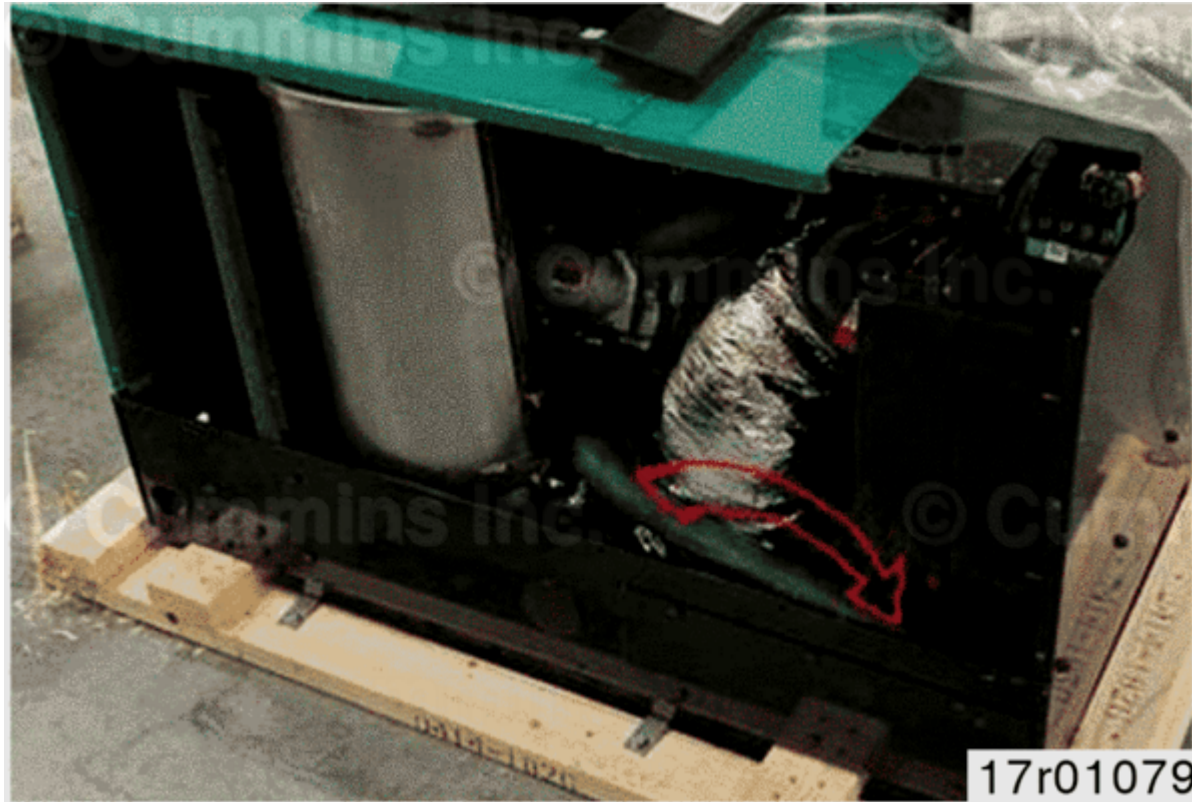
Figure 3, Inspection location

1. Gain access to inspect the coolant hose.
  - 1 a. To thoroughly inspect the hose, inspect it from the top with the side enclosure panel removed.

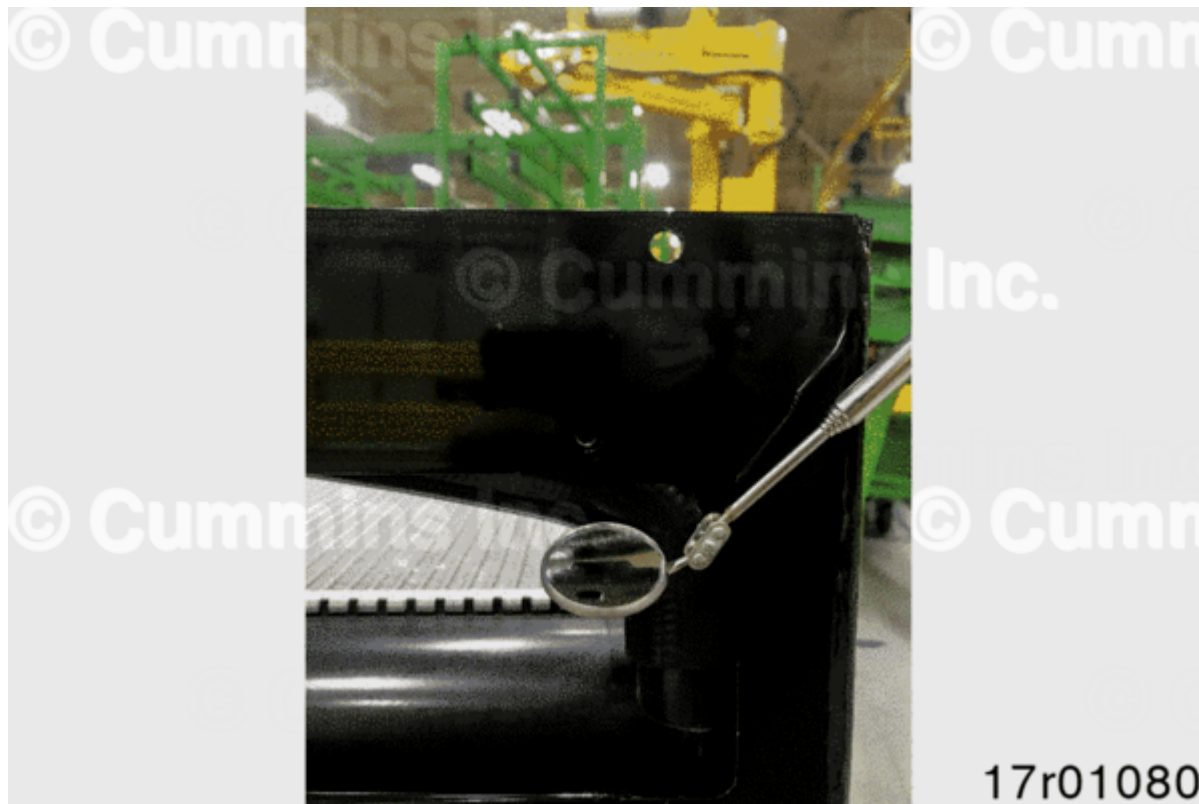
Figure 4, Inspection Using Mirror

1 b. If the installation does not allow the side panel to be removed, inspect through the radiator mount panel using a mirror.

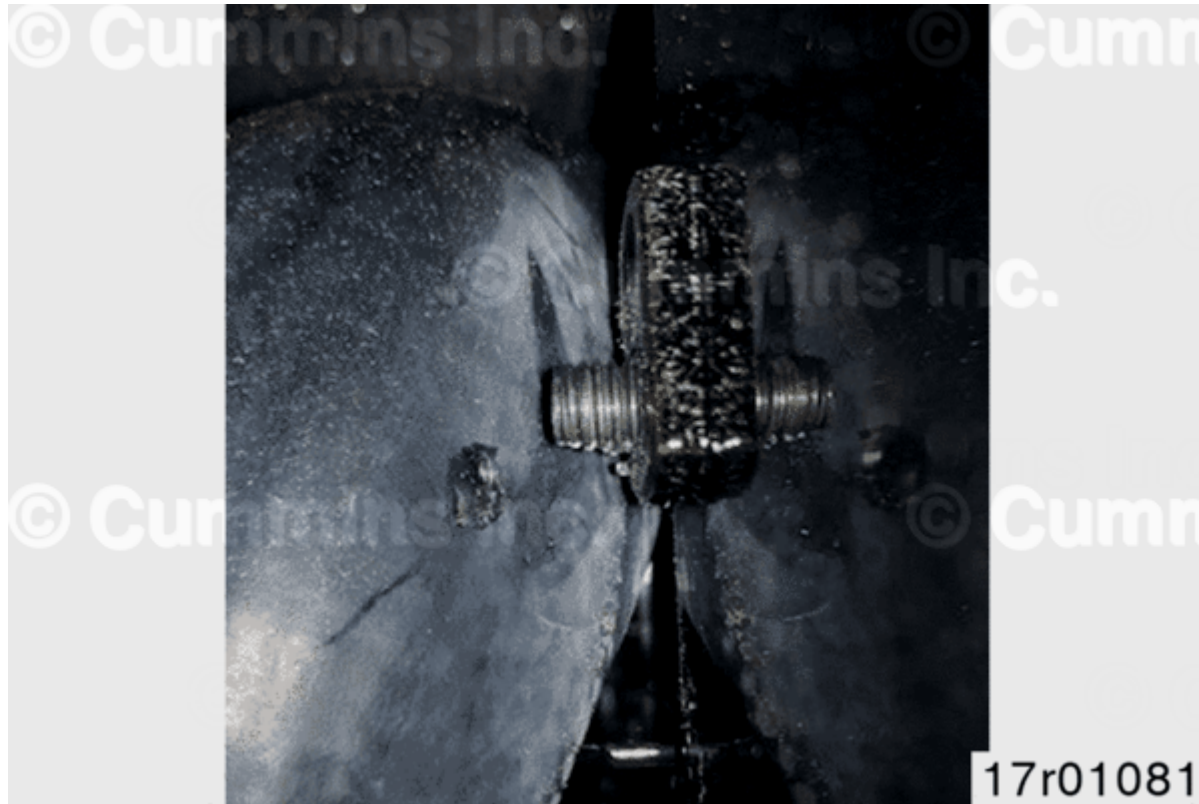
Figure 5, Damaged Coolant Hose

2. Inspect the coolant hose for puncture or chaffing marks.

2 a. Below is an image of a damaged coolant hose. Replace damaged hose with PN 0503-2501 following the steps listed in service manual A043M526.

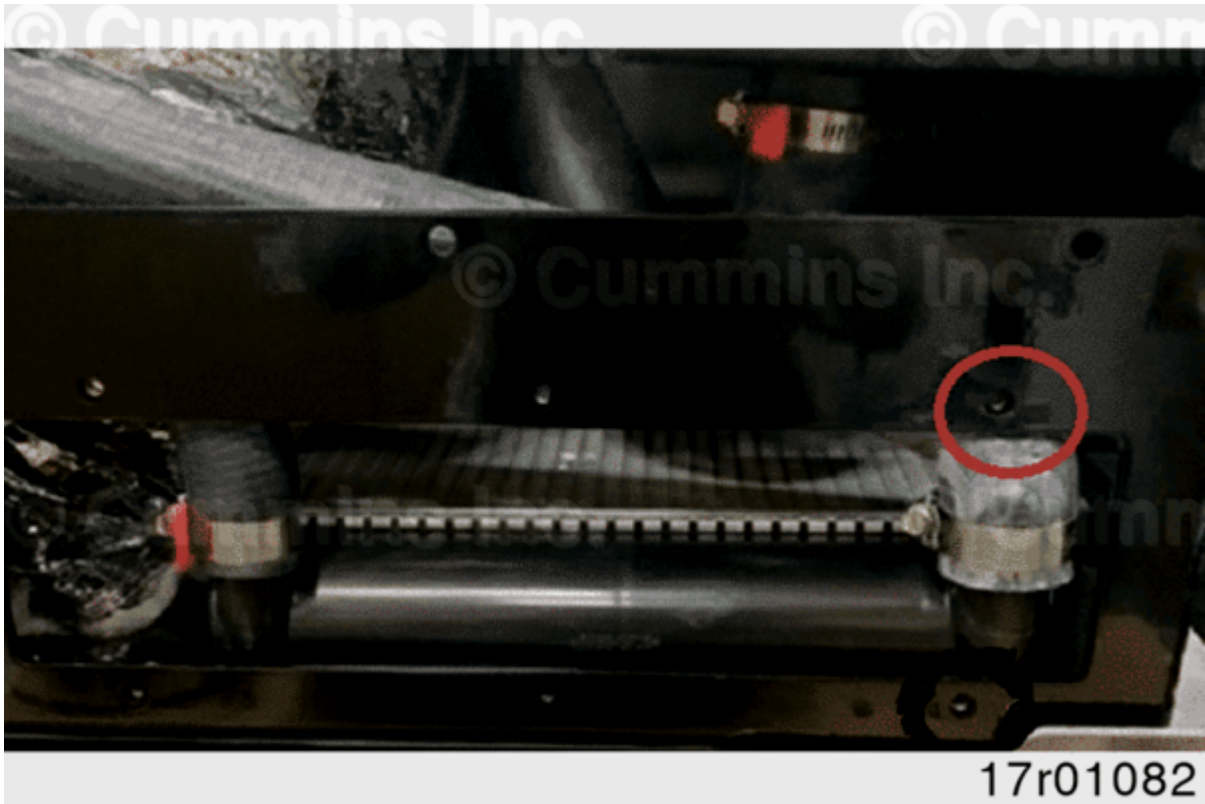
Figure 6, 12 mm Short Screw Location

3. Install shorter screw, PN 01821-2096-02 in the top right corner hole circled in red.

4 a.**Note: The original screws can be used at all locations on the radiator mounting panel except for the location circled above in Figure 6. This location must use the 12 mm screw and not the 16 mm screw.**

4. Reinstall the remaining 5 enclosure screws.
