**NUMBER:** 08-066-21

Installing the Battery Positive Protection Cover (Missing)

2021 (B1) Jeep Renegade

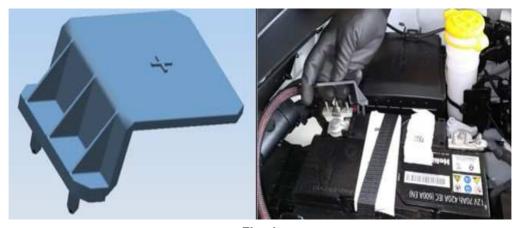
Fig. 1
Positive Battery Protective Cover

The positive battery cable protective cover is missing.

1. Install the protective cover for the positive post on the battery, by pushing the tabs into the locating holes in the battery (Fig. 1).
