GLOBAL SAFETY FIELD INVESTIGATIONS
DCS5763
URGENT - DISTRIBUTE IMMEDIATELY

Subject: N202309630 - Customer Satisfaction Program
Trailer Information Label Incorrectly States Trailering Capabilities

Models: 2020 Chevrolet Silverado 1500 and GMC Sierra 1500

N202309630 Trailing Information Label Incorrectly States Trailing Capabilities

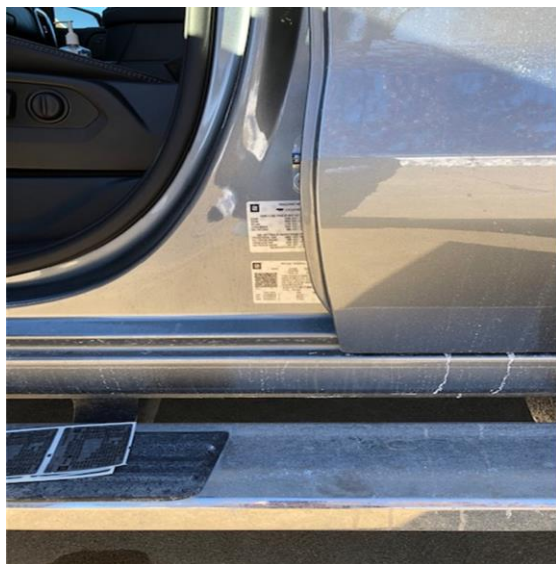
5735373

1. Open the left front and rear doors.

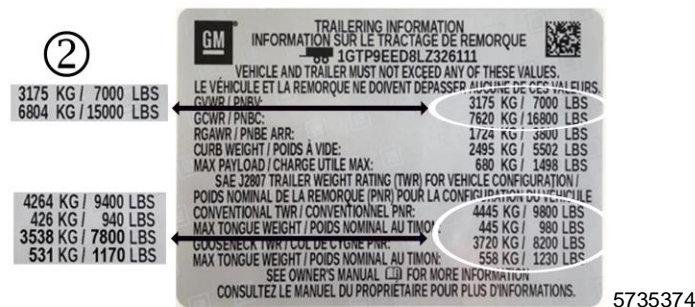
5750826

3. Using water, clean and dry the surface with a clean, lint-free cloth. The surface must be clean, dry and free of any contaminants.
4. Apply the two new label overlays to the locations shown above. US (1) and Canada (2) example labels shown. (3) Top Label (4) Bottom Label.
5. Firmly hold the new label and peel the protective liner from the back side, being careful not to touch or contaminate the adhesive with dirt or foreign matter.
6. Affix the new trailing information overlay labels onto the existing "B" pillar label in the locations shown above. Carefully align the new label to the surface and press firmly to smooth out the entire label ensuring the corners are fully adhered.
7. Close the doors.

Important: If the values are the same as the new label overlay, only install the label overlays that need to be updated.

Important: DO NOT use any cleaners or solvents to clean the label surface.

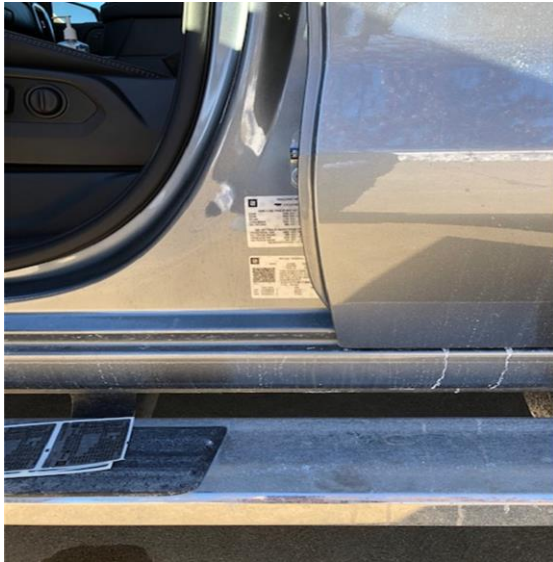
5735373

1. Open the left front and rear doors.

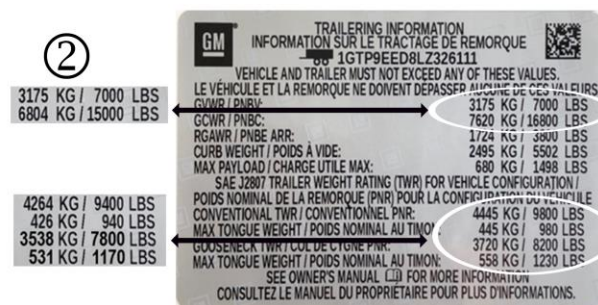
5735374

2. Locate the trailing information label on the left side "B" pillar.
