SIB 52 02 21

## SECOND ROW SEAT LEATHER CLOUDY/DISCOLORED

This Service Information Bulletin (Revision #1) replaces SI B52 02 21 **dated March 2021**.

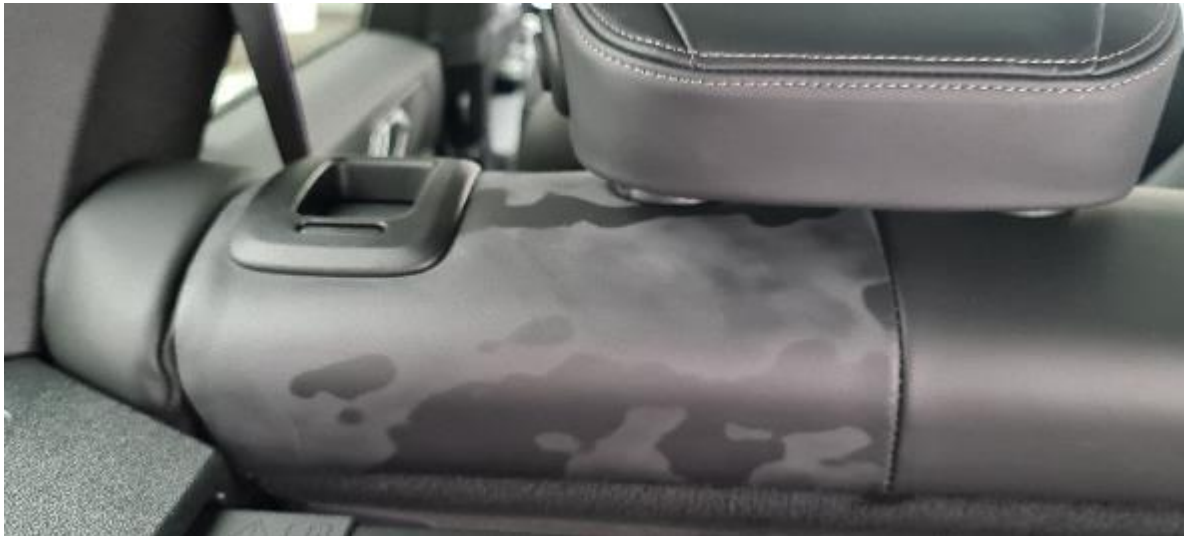
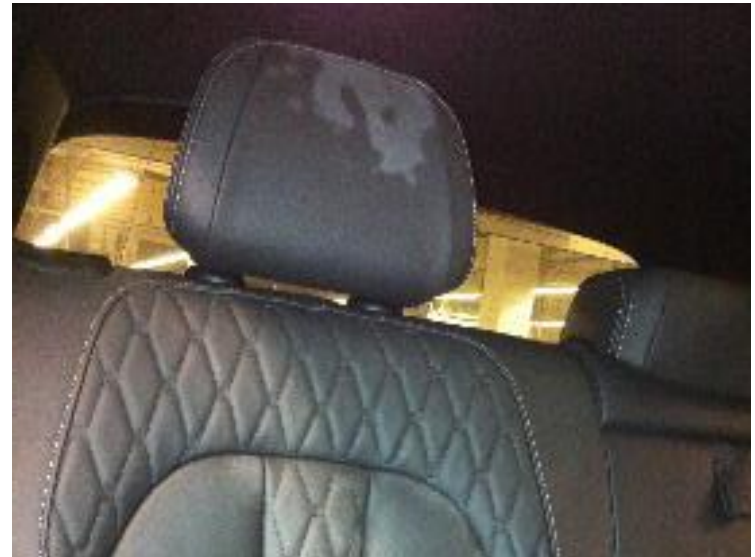
[picture\\_as\\_pdf Attachment B520221.pdf](#)

Milky-white stains (discolorations) in the leather are observed in the second-row seat bottom, backrests and/or headrests. Refer to attachment for details.

An unfavorable leather tanning process can result with isolated cases of grease residue accumulating in the second-row seat leather surfaces.

Only for the specific issue identified in the attachment, remove the tanning process-related residue in the second-row seat leather as outlined in the PROCEDURE section below.

- 1) Using a hot air blower held at 4" to 8" from the affected area, heat the leather surface with circular movements at a temperature above 160 °F/ 70 °C until the greasy residues disintegrate completely.

**Ensure that the temperature of the affected area does not get warmer than 195 °F/ 90 °C as otherwise the leather can be damaged.**

- 2) Wipe the treated surface with a clean, absorbent cleaning cloth.
- 3) Use a microfiber cloth (yellow 6 pack, part number 51 91 2 466 423 or blue 6 pack P/N 51 91 2 466 842) soaked either with leather cleaning foam (P/N 83 12 2 298 210) or with the leather and upholstery cleaner (P/N 83 12 5 A16 459), clean the surface with circular movements.
- 4) Wipe the treated surface with a clean, absorbent cleaning cloth until it is dry.
- 5) Apply a leather lotion (included in kit P/N 83 19 2 339 687) using a leather care cloth included in the kit until the surface has a uniform appearance.
