SIB 52 07 21

SERVICE ACTION: ROUTING OF DRIVER'S SEAT WIRING HARNESS

E-Series	Model Description	Production Date
G29	Z4 Roadster	March 4, 2021 – March 5, 2021

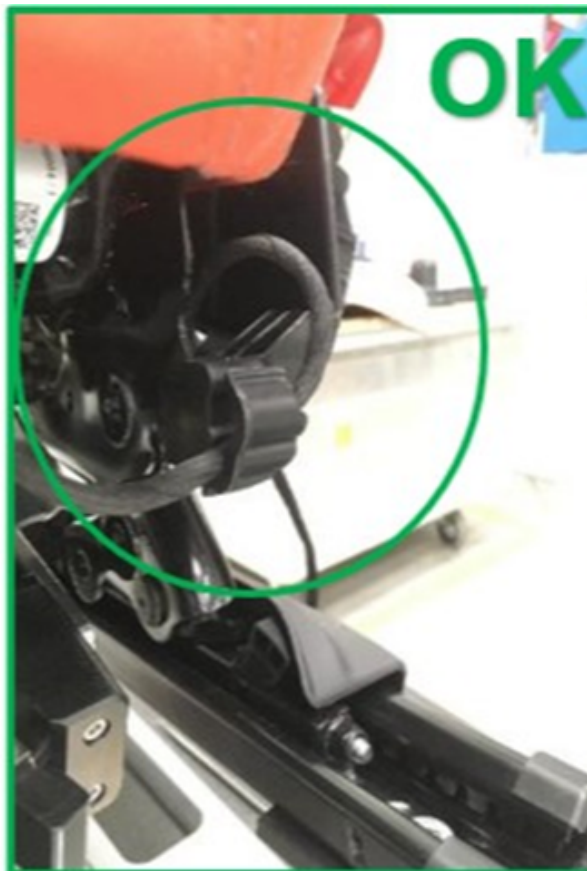
1. Check the wiring harness installation arrangement on the installed left front seat.

If the routing of the seat wiring harness is OK, this Technical Campaign is now complete. Replace no parts.

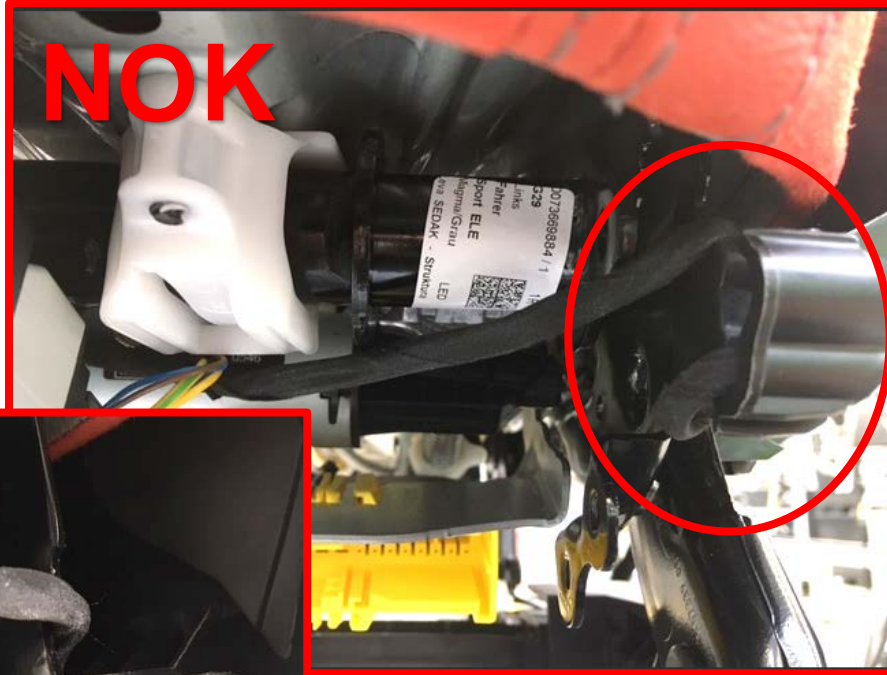
Mistake – wrong cable routing

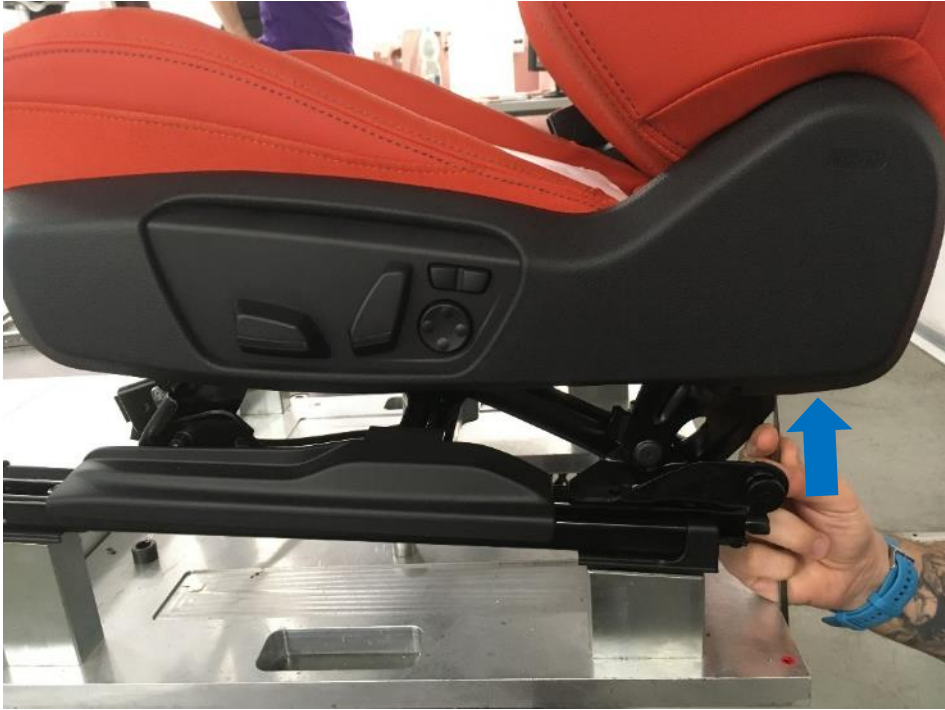
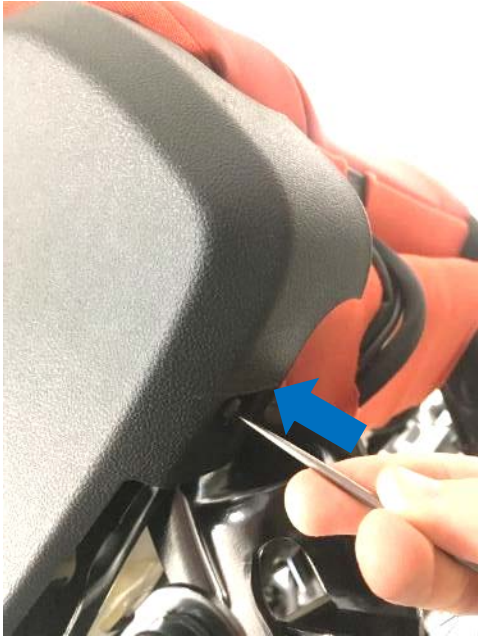
1. Push pin take out

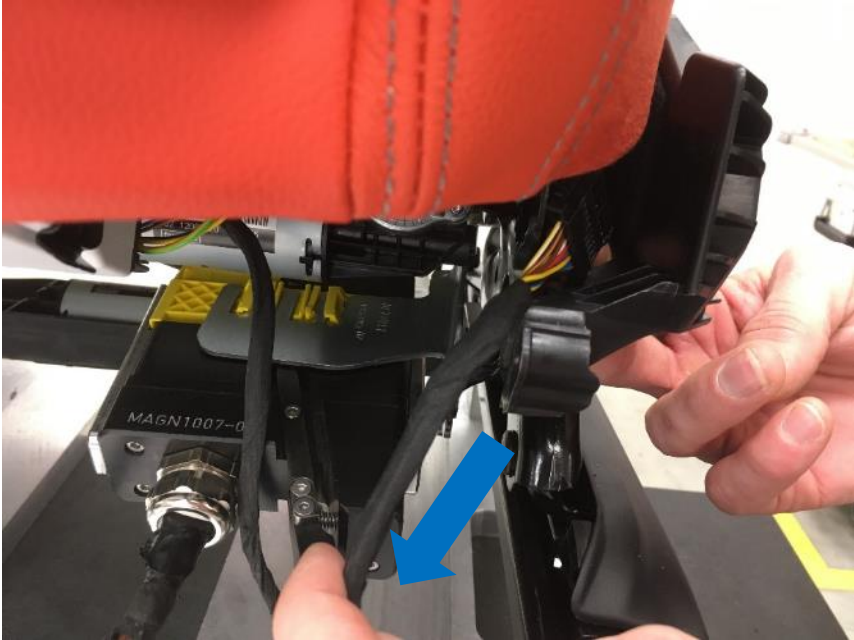
4.2 Take out: cable from holder

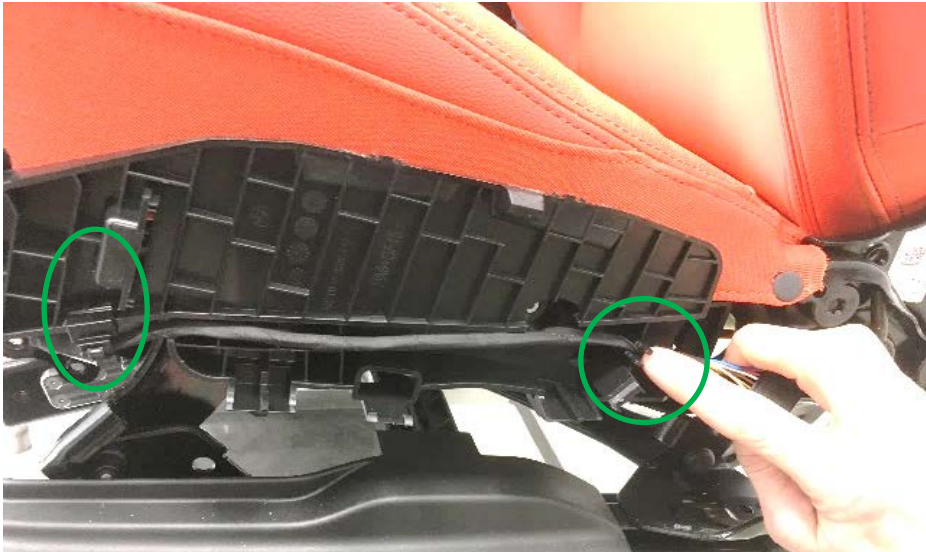
1.2 Assembly with clip and cable guide

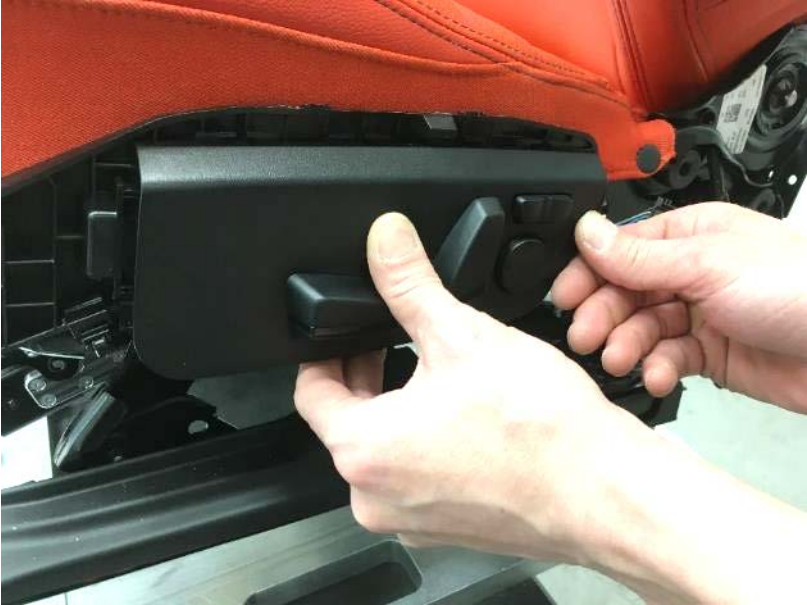
2.1 Take on switch in all clips / click

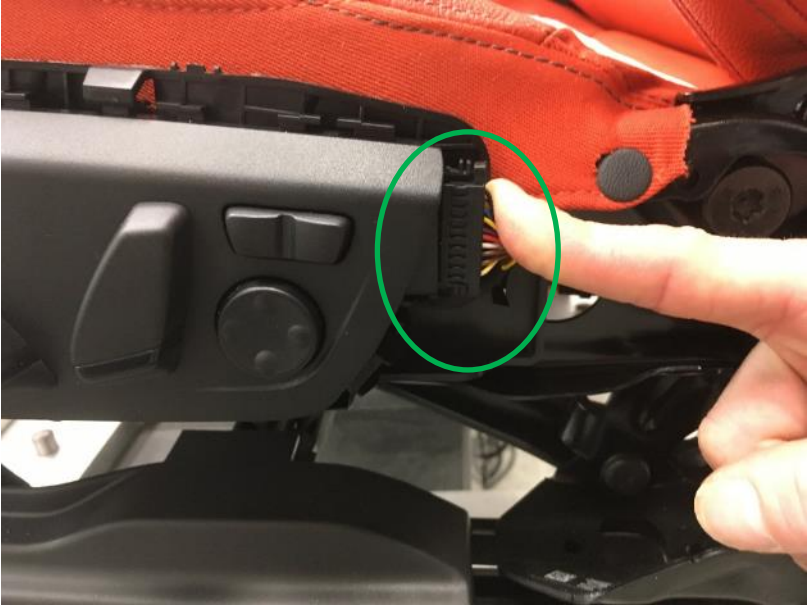
2.2 Plug in the cable connector

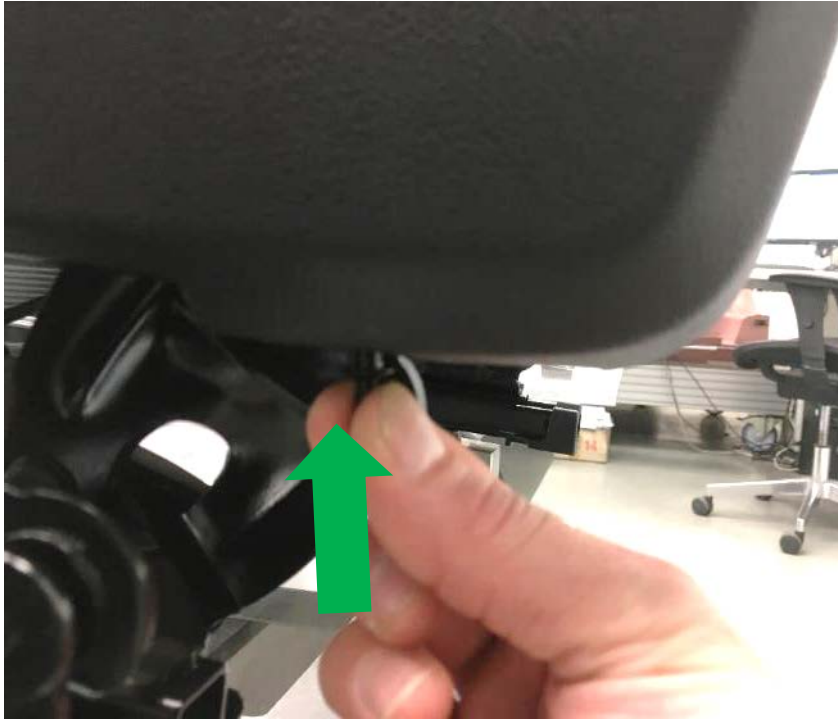
4. Push pin take on

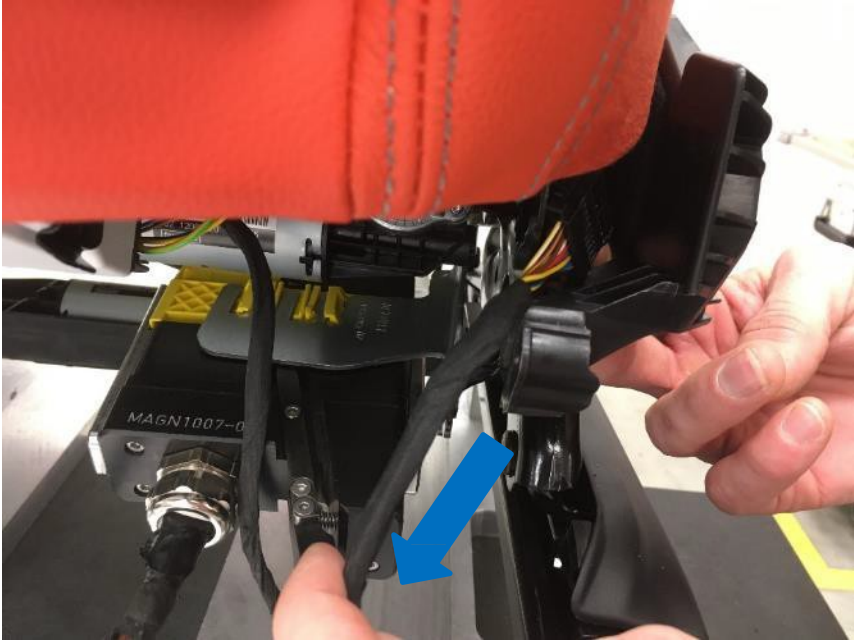
4.2 Disassembly of cable of the plastic holder

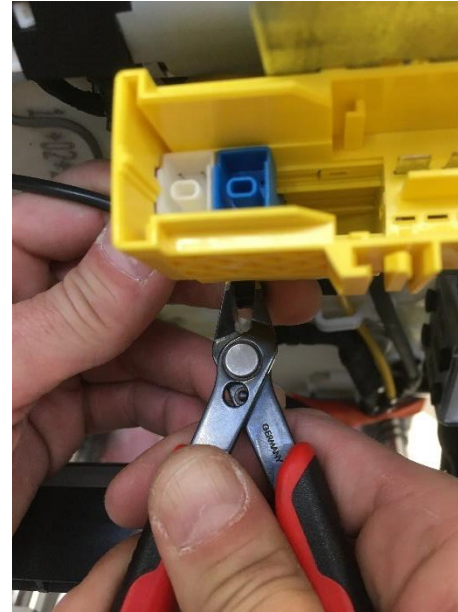
5.3 Remove the cable tie

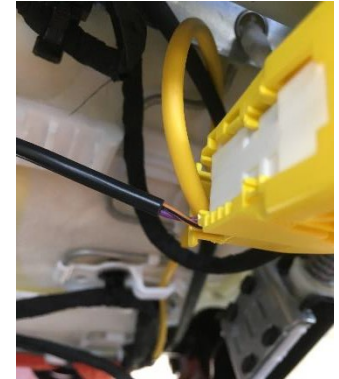
5.4 Condition without cable tie

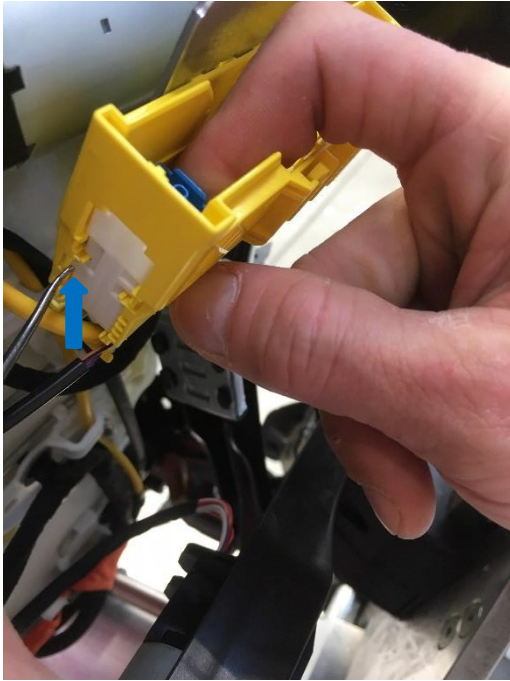
6.1 Remove plugs – by pushing (1)

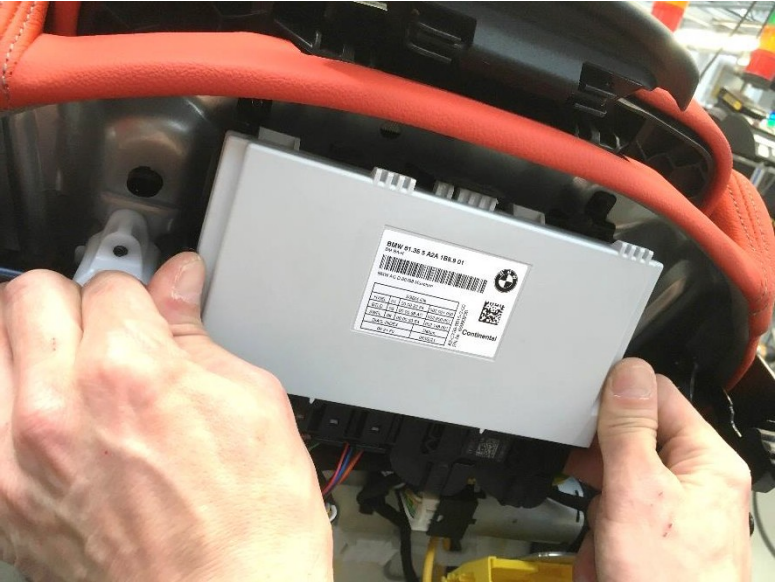
7.1 Disassembly of memory unit

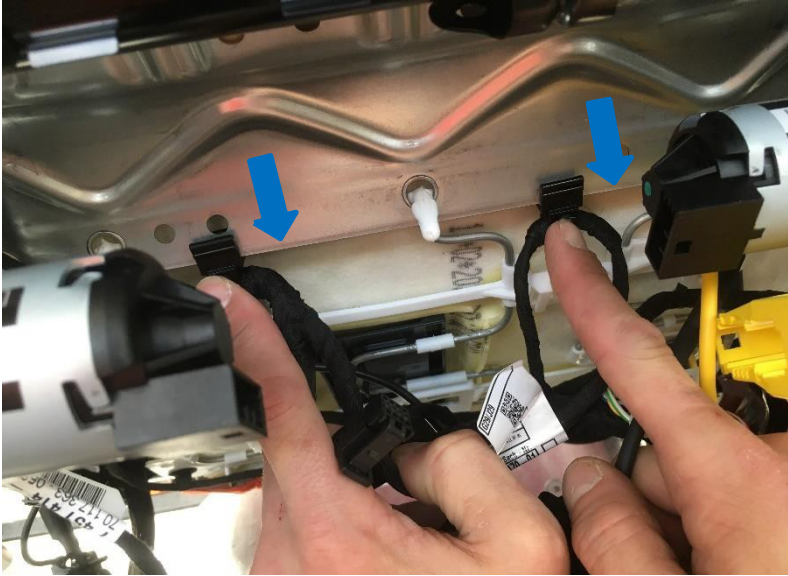
9.2 Disassembly of two clips(2x)

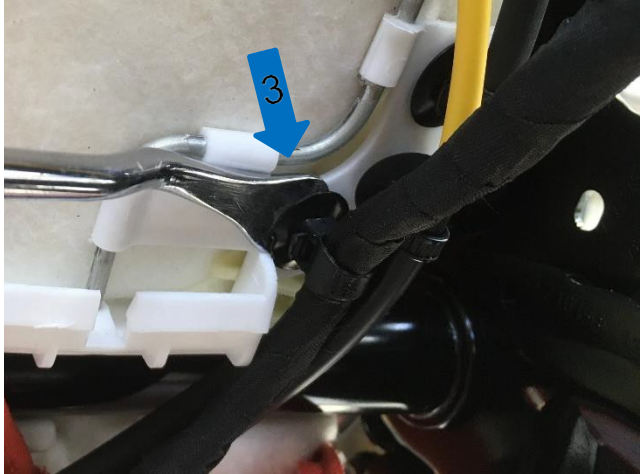
11.2 Disassembly of push pin(3)

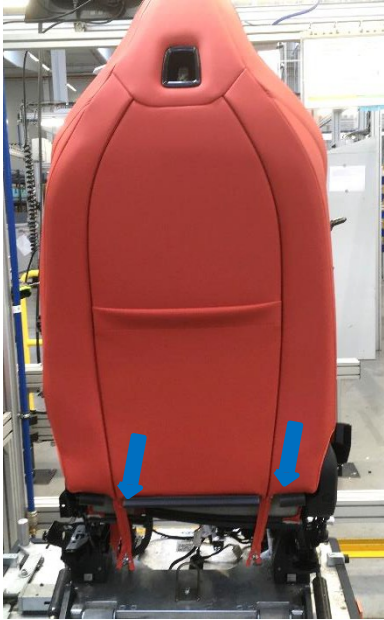
13.1 Take out the end of zipper

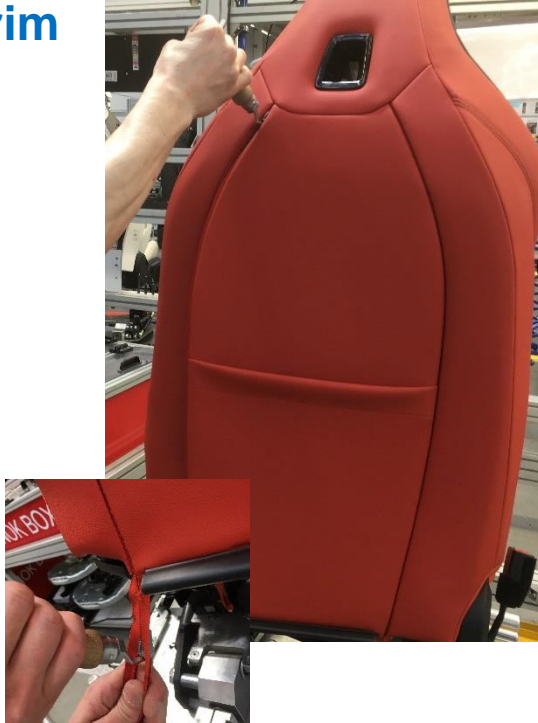
13.2 Open the zipper (2x)

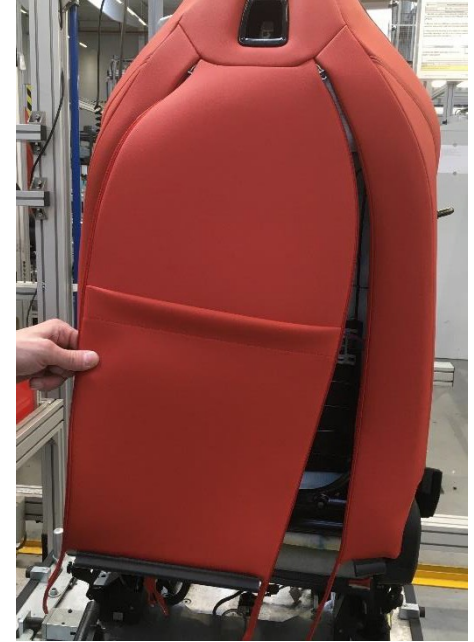
13.3 Open the back side

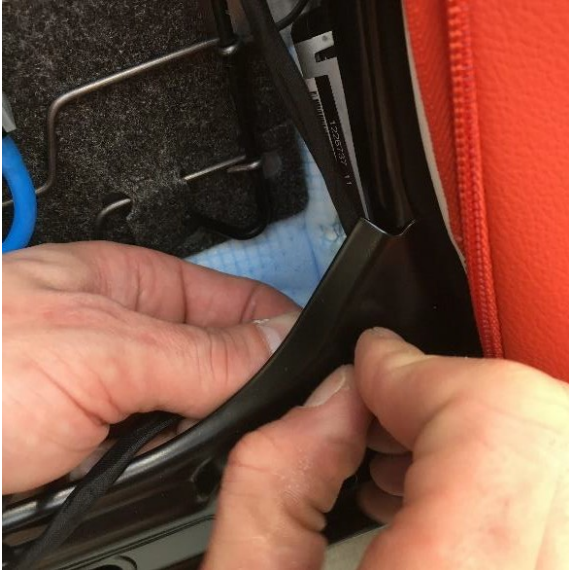
15.1 Disassembly of push pin

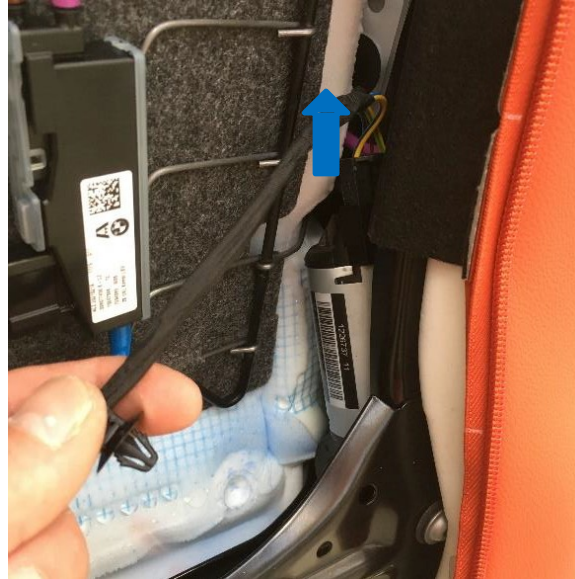
15.2 Disassembly of plug from motor (Backrest)

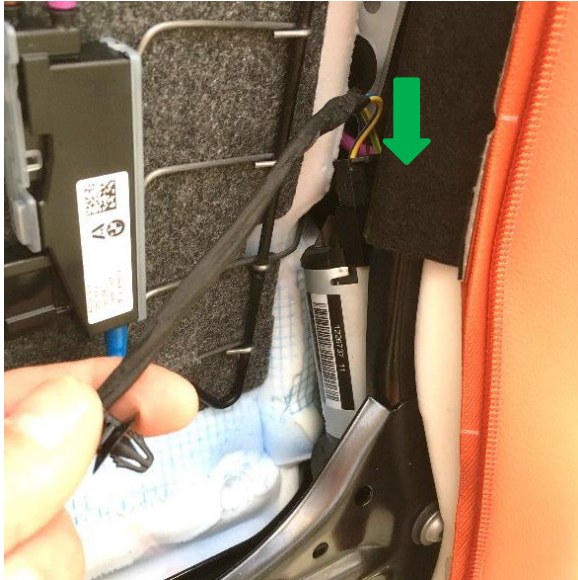
1.1 Connect the plug to motor (Backrest)

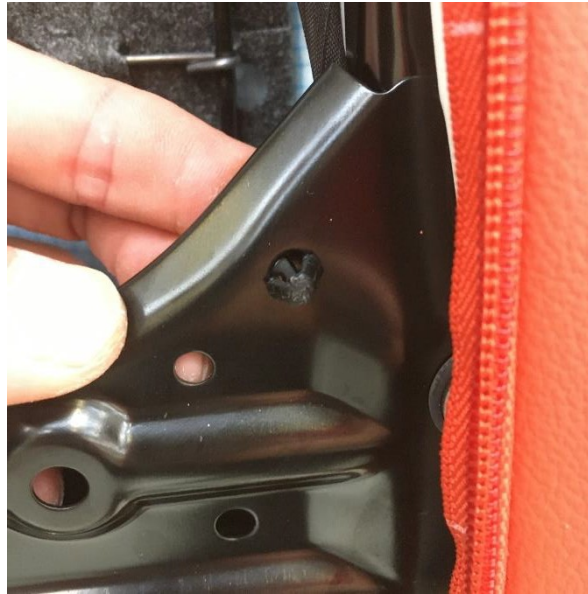
1.2 Assembly the push pin to the structure

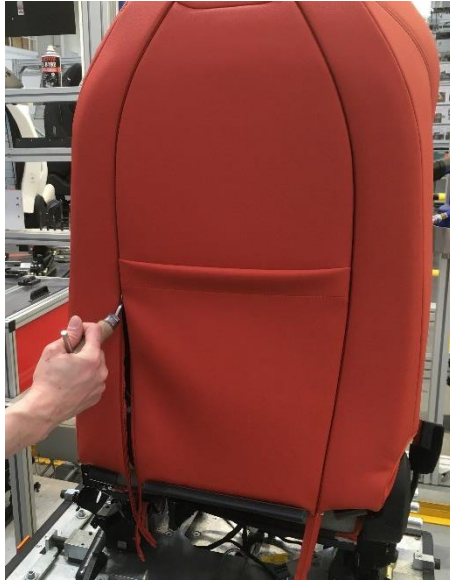
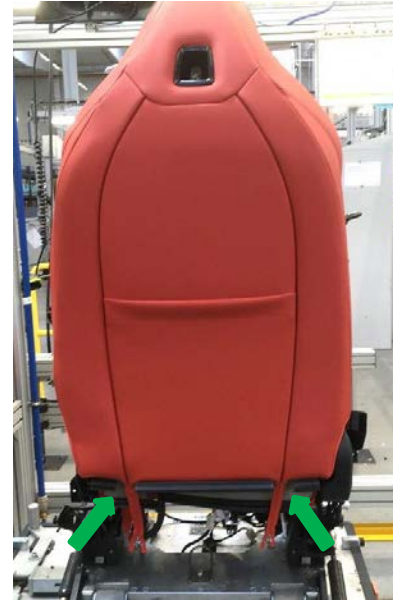
3.2 Hide the end of the zippers under the foam

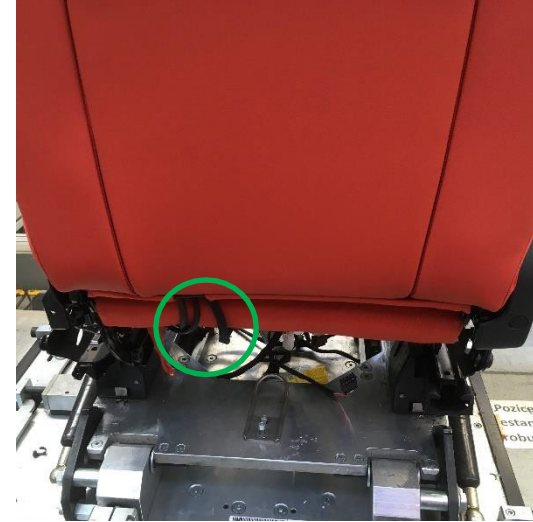
4.3 The cables must be routed through the hole in the cover

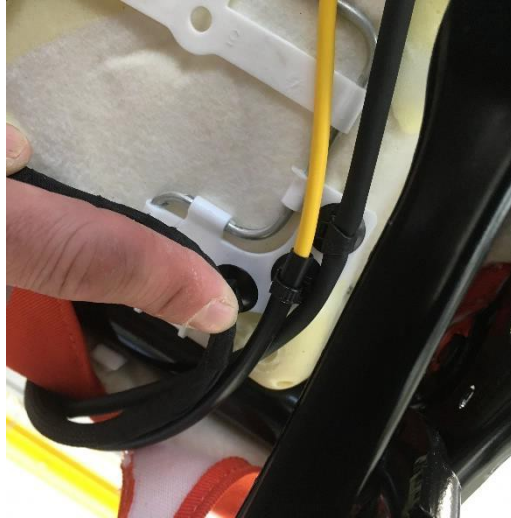
5.2 Assembly the push pin to the structure

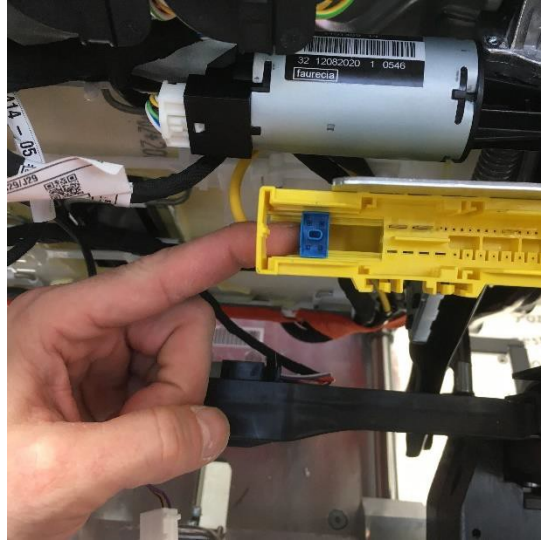
10.2 Mount the airbag plug to the central plug

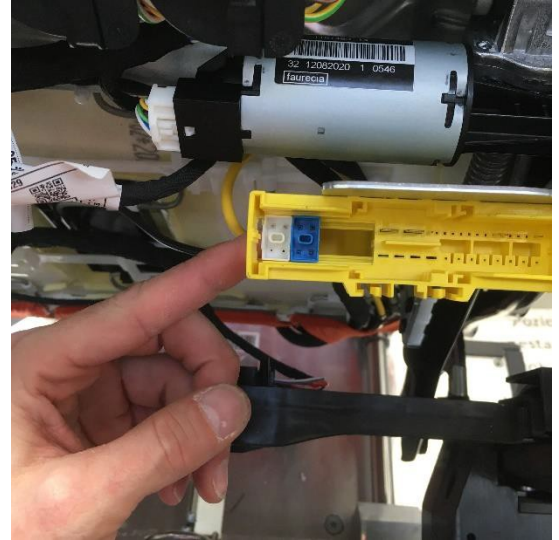
10.3 Mount buckle plug to the central plug

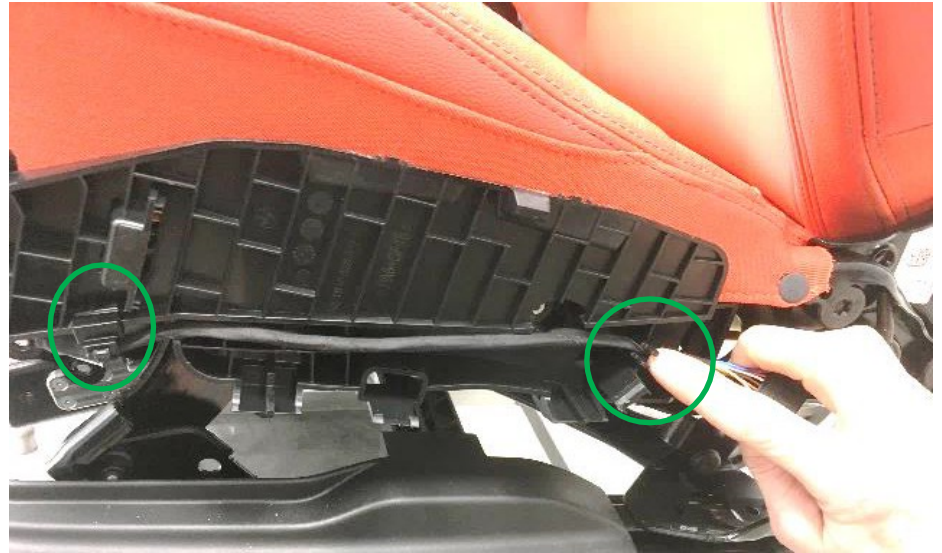
12.2 Assembly with clip and cable guide

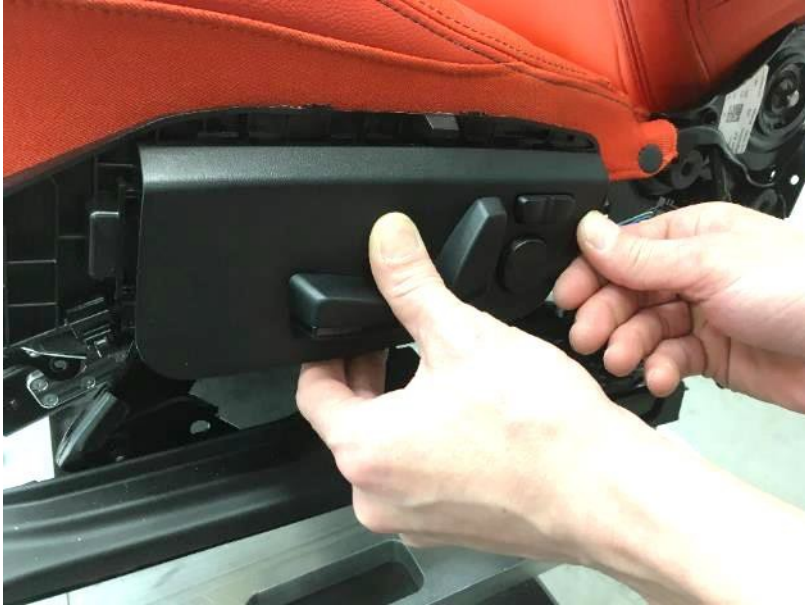
13.1 Assembly the adjuster on all clips – correct assembly -> click noise

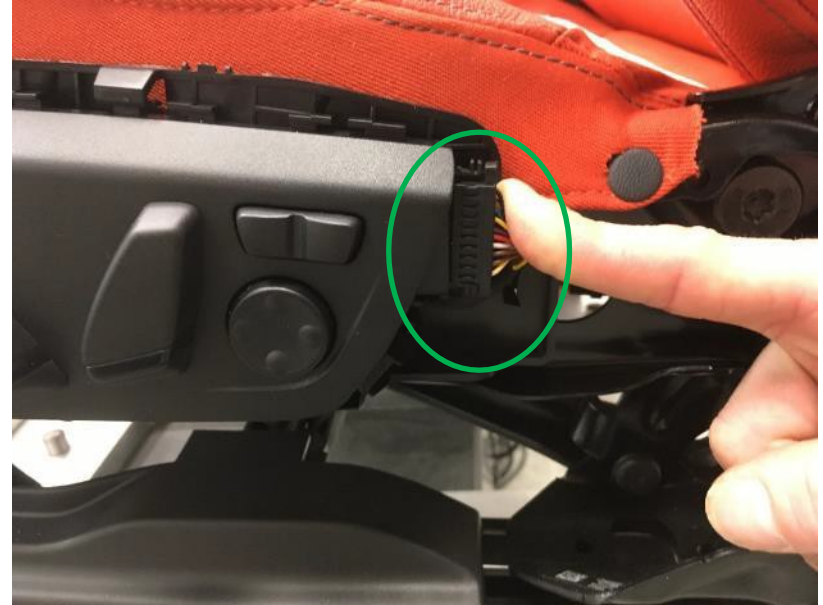
13.2 Connect the plug to the adjuster
