GROUP Body	MODEL Forte/Forte Koup
NUMBER 049	DATE October, 2009

TECHNICAL SERVICE BULLETIN

SUBJECT: SERVICE ACTION: ENGINE COMPARTMENT
JUNCTION BOX RELAY REPLACEMENT (SA012)

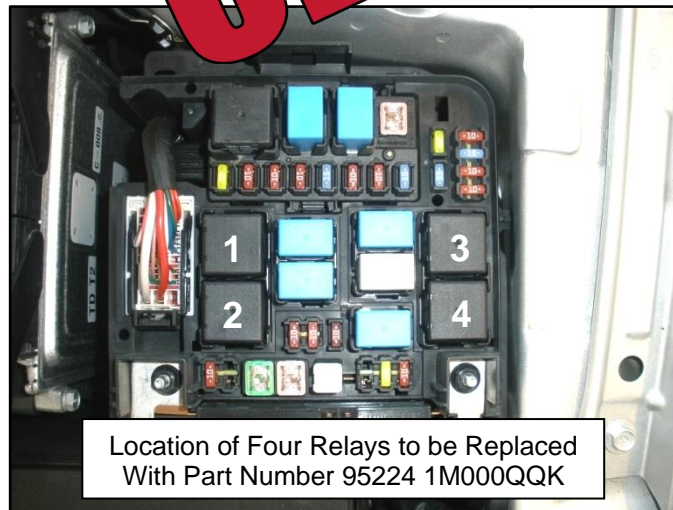
Some Forte/Forte Koup vehicles manufactured from July 16th to August 20th, 2009 may experience concerns of inoperative A/C blower, high/low cooling fans or engine start motor. The concern may be caused by poor contacts inside the four (4) relays located in the engine compartment junction box as shown below. It is recommended that all vehicles within this production range be repaired prior to retail sale to a customer. Additionally, vehicles being in for service should be checked and if necessary repaired before returned to the customer.

Location of Four Relays to be Replaced
With Part Number 95224 1M000QQK

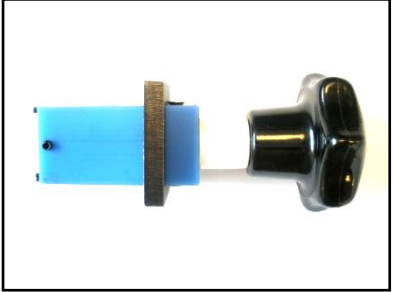
SST Name	SST Number	Figure
Relay Remover	09912 - 38000
