KIA MOTORS

MODEL
2009-2010 Optima (MG)

NUMBER
056 [Revised]

SUBJECT: COMBINED TSB/SERVICE ACTION: OPTIMA (MG)
DOOR TRIM FABRIC COVER REATTACHMENT (SA033)

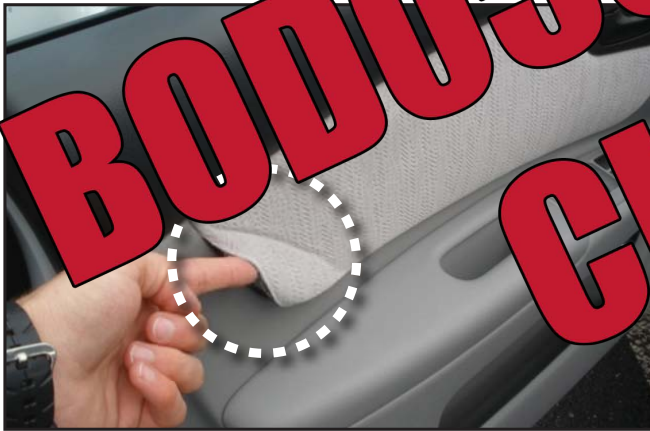
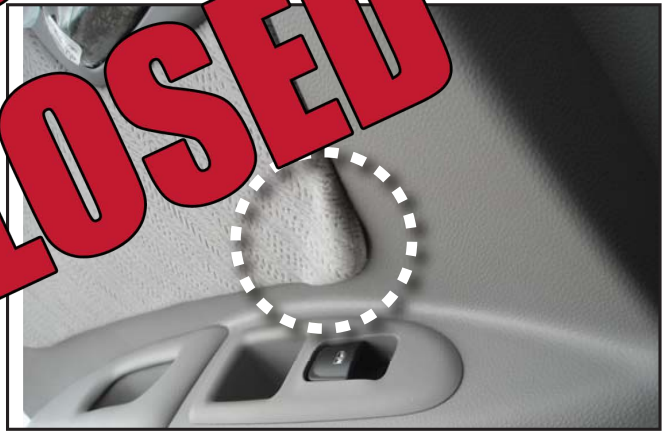
This bulletin provides information relating to some OPTIMA [MG] vehicles built between August 18, 2008 ~ October 26, 2009. In affected vehicles, the door trim fabric cover may come partially unattached from the door trim as shown in the photos below, due to insufficient adhesion/retention. The repair consists of applying 3M Scotch-Weld Superbond Spray Adhesive 90 or equivalent to the detached section of the door trim fabric cover.

Examples of unattached door trim fabric cover
