Title: Sleeper Bunk Cabinet Door Latch Installation and Alignment Concerns

Applies To: LT, RH, Sleepers

This document will guide the user through the installation of a magnetic cabinet door latch and correcting alignment issue on International sleepers with upper bunk cabinets. The magnetic latch will provide additional rigidity between the cabinet door and door frame and the alignment procedure will help assure the cabinet is mounted squarely in to the cab. It will also provide a better visual appearance of the cabinet door fitment once the these procedures are completed.

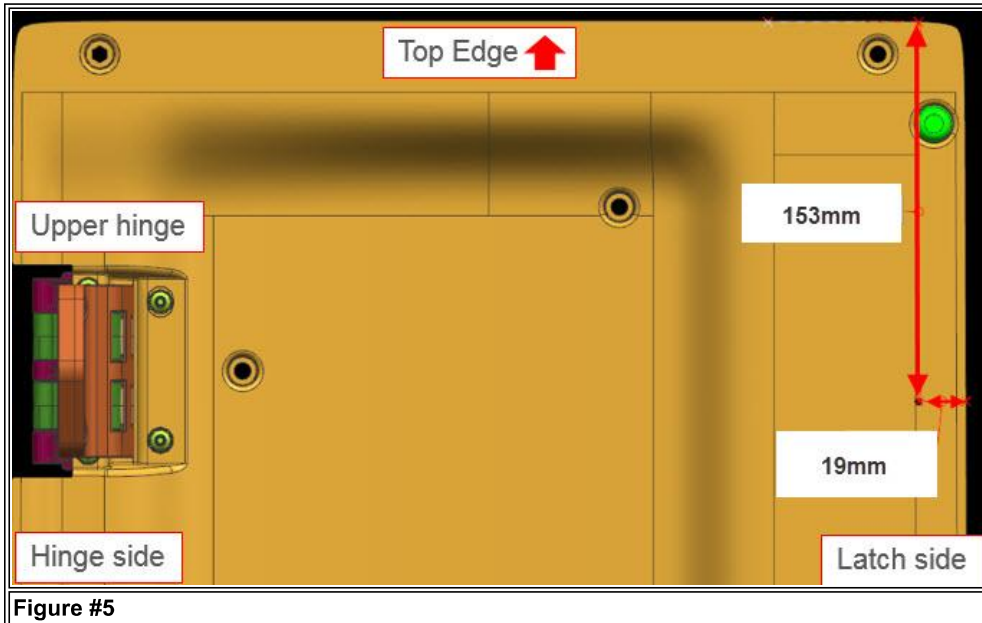
Figure #5

Step 3 - Measure and drill the strike plate mounting hole on the inner cabinet door (Figure #5)

- a. Measure 153mm from the top edge
- b. Measure 19mm from the latch side edge
- c. Drill M3 hole through inner door

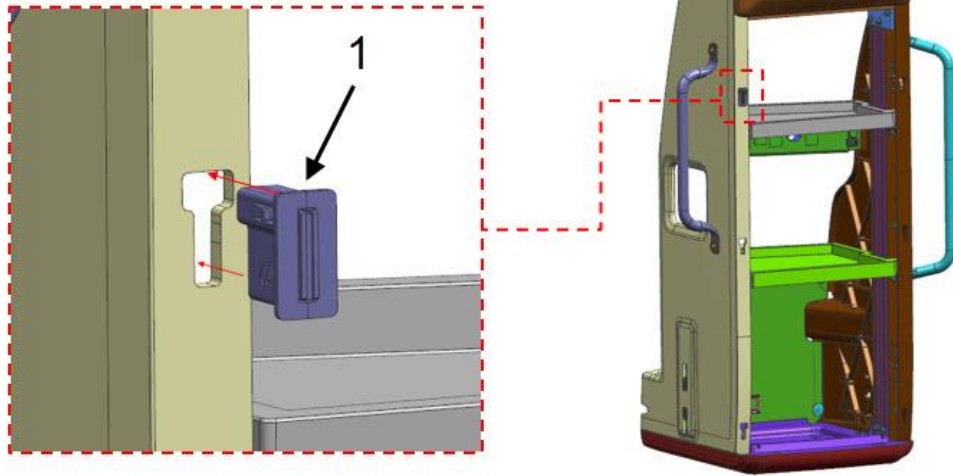
Figure#8

Step 6 - Snap the magnetic latch into the cabinet frame (Figure #8)

Item #1 - Magnetic Latch (4092766C1)
