May 28, 2021

Version 1

## Driver's Seat Frame Noise

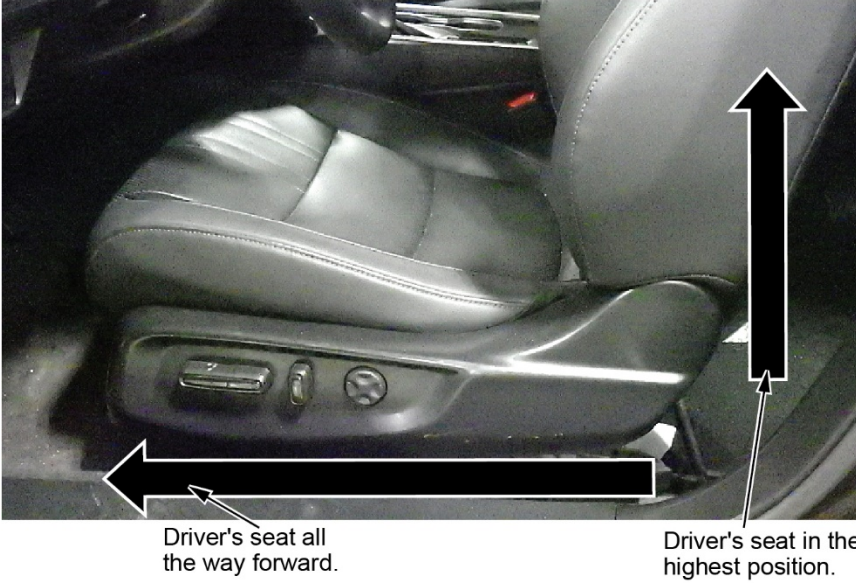
1. Move the driver's seat to its most forward and highest position.

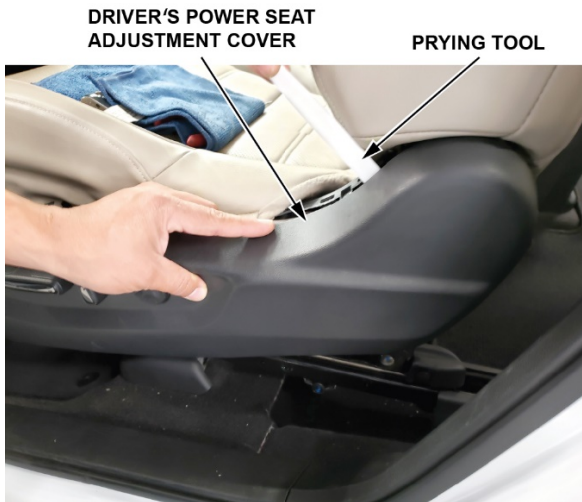
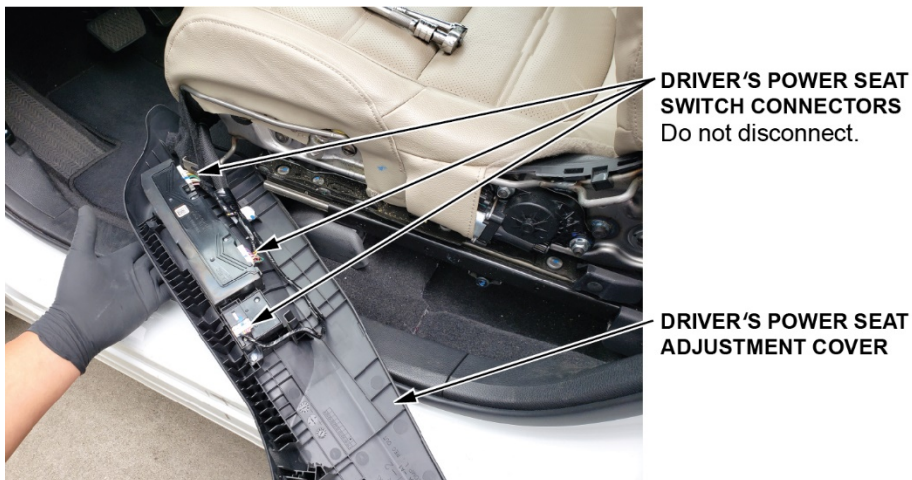
2. Remove the driver's power seat adjustment cover using the prying tool.

NOTE: Do not disconnect the power seat switch connectors.

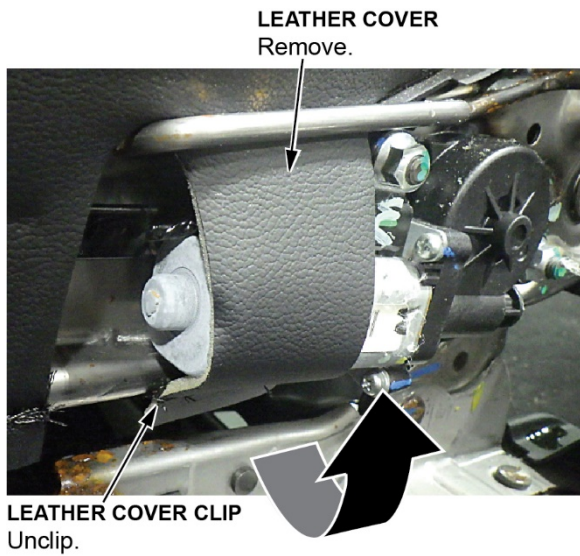
3. Remove the leather cover by detaching it from the bottom.

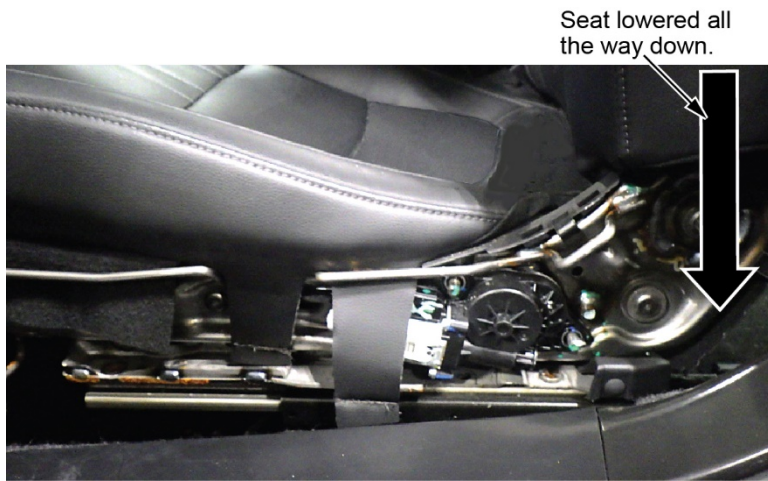
4. Using the power seat adjustment switch, move the seat down to the lowest point.

NOTE: This is important to gain access to the nylon gear.

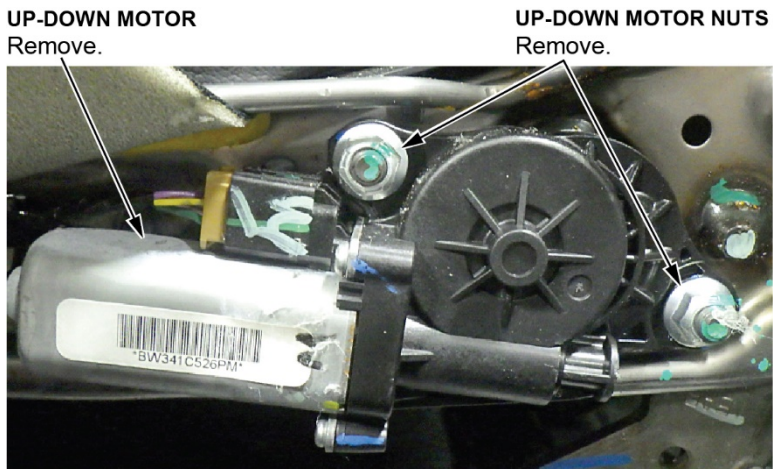
5. Remove the Up-Down Motor nuts.

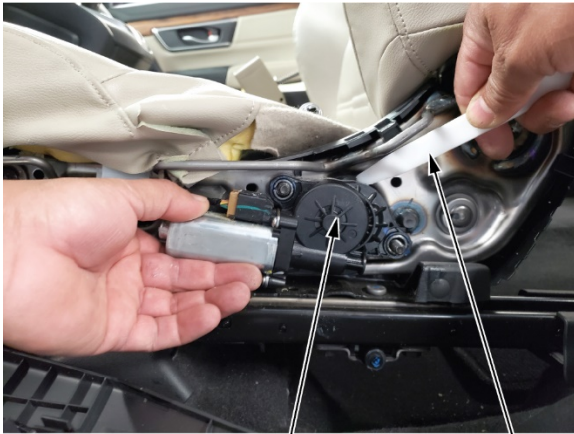
6. Remove the Up-Down Motor using the prying tool.

NOTE: Before removing the Up-Down Motor, move the seat down to the lowest point.

UP-DOWN MOTOR

PRYING TOOL

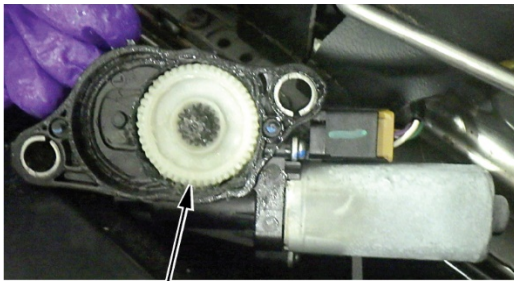
NOTE: When removing the Up-Down Motor, the nylon gear may come out with the motor or stay on the seat frame.

NYLON GEAR ON  
UP-DOWN MOTOR

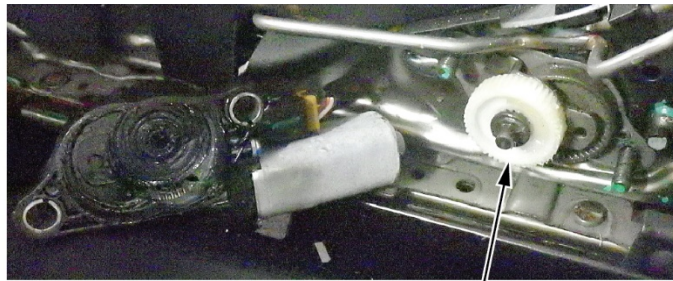
NYLON GEAR ON  
SEAT FRAME

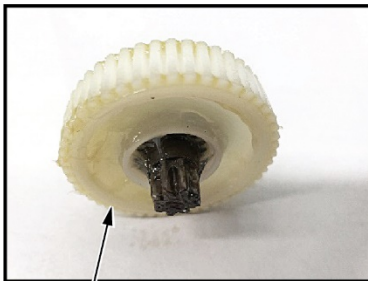
NYLON GEAR BEFORE  
GREASE IS APPLIED

7. Remove the nylon gear and apply a layer of grease.

NOTE: Grease must be applied evenly to both metal and nylon teeth.

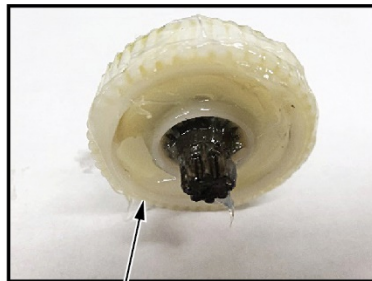
NYLON GEAR AFTER  
GREASE IS APPLIED TO  
METAL AND NYLON TEETH

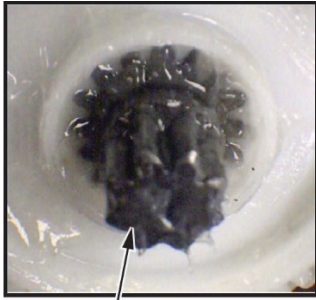
8. Install the nylon gear to the seat frame.

NOTE: The metal teeth of the nylon gear must be aligned with the seat frame teeth when reinstalling. The nylon gear should be flush with the frame.

NYLON GEAR METAL TEETH

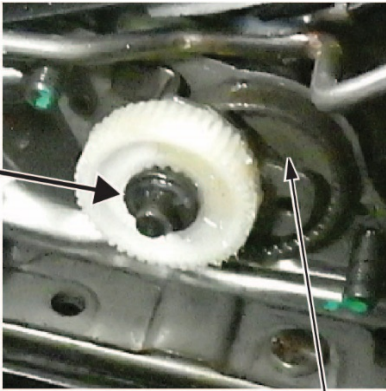
SEAT FRAME

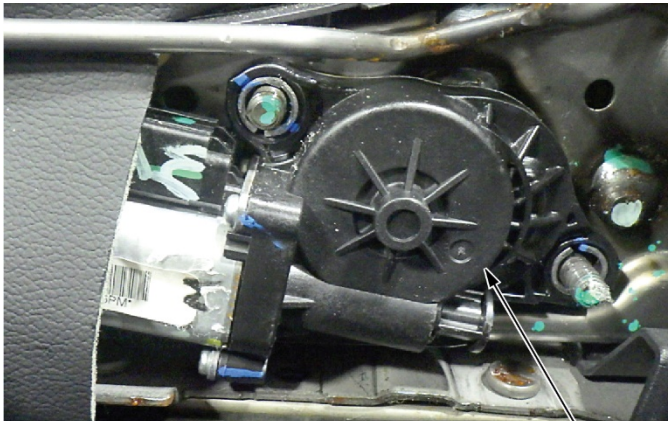
9. Install the Up-Down Motor to the seat frame.

NOTE: Install slowly to make sure the gears fit together.

UP-DOWN MOTOR

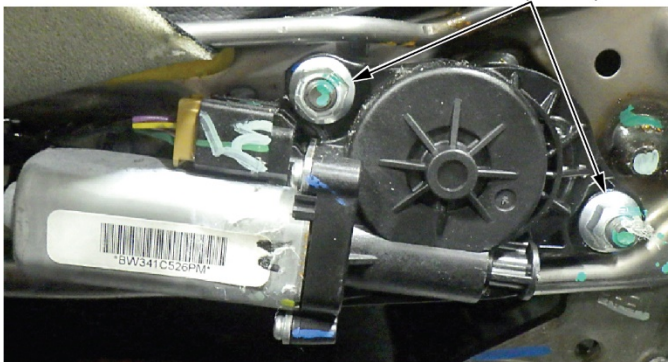
10. Torque both nuts to **19 N·m (14 lb-ft)**.

NOTE: Do not overtighten nuts.

UP-DOWN MOTOR NUTS  
19 N·m (14 lb-ft)
