GROUP	MODEL
ELE	2021MY K5 (DL3a) 2020-2021MY Telluride (ON)
NUMBER	DATE
242	June 2021

TECHNICAL SERVICE BULLETIN

SUBJECT: HEADLAMP SOFT CONNECTION INSPECTION

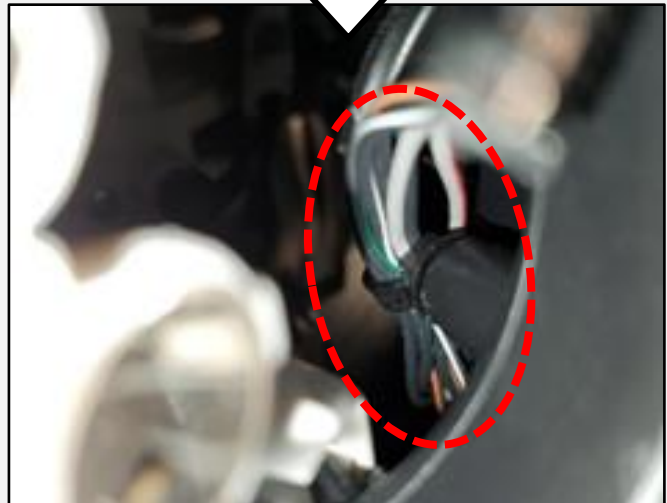
If the clip was pulled out, it does not need to be put back in the same location, however, make sure the wiring is NOT pinched between the LED source and the light tube when reconnecting.

7. Reinstall the heat sink and dust cover.
- 8a. Reinstall the headlamp and verify normal operation.
- 8b. If headlamp does NOT operate normally (low beam or LED strip), replace the headlamp with a new part.
