SIB 61 06 21 WIRING HARNESS CHAFING AGAINST ENGINE

E-Series	Model Description
K63	S 1000 R
K67	S 1000 RR
K69	S 1000 XR

REPAIR INSTRUCTION WIRING HARNESS (TO DDC CONTROL UNIT)

ALL K6X MODELS WITH DDC

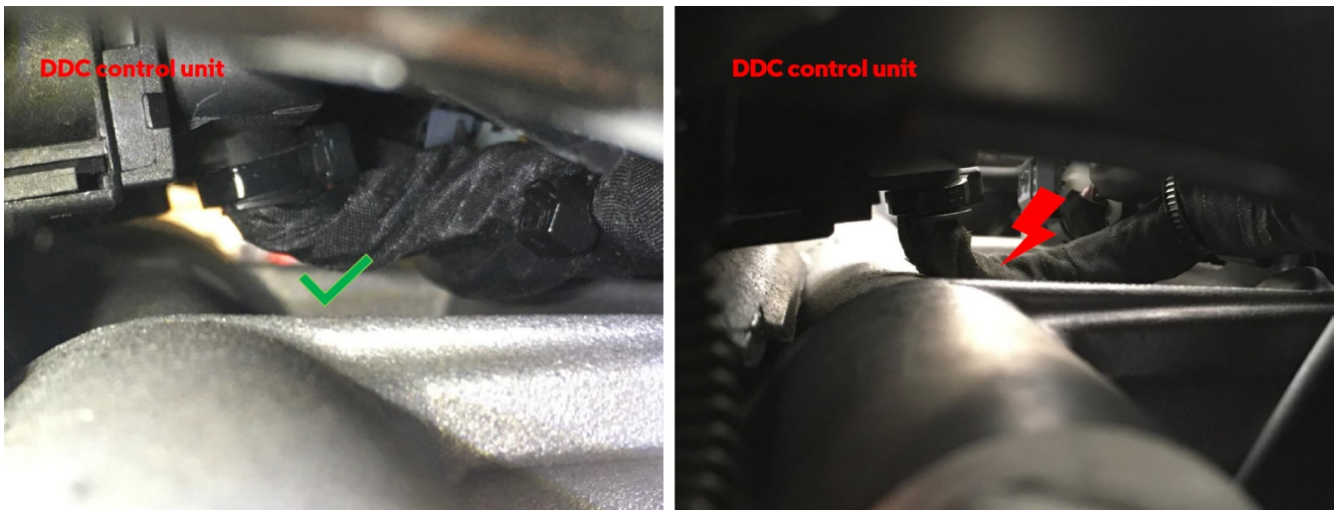
Warning light in the instrument cluster for DCC failure in motorcycles equipped with DCC. This issue may be caused by chafing of the wiring harness.

Figure 1: DETECTION OF A CHAFING MARK VIA THE LEFT SIDE

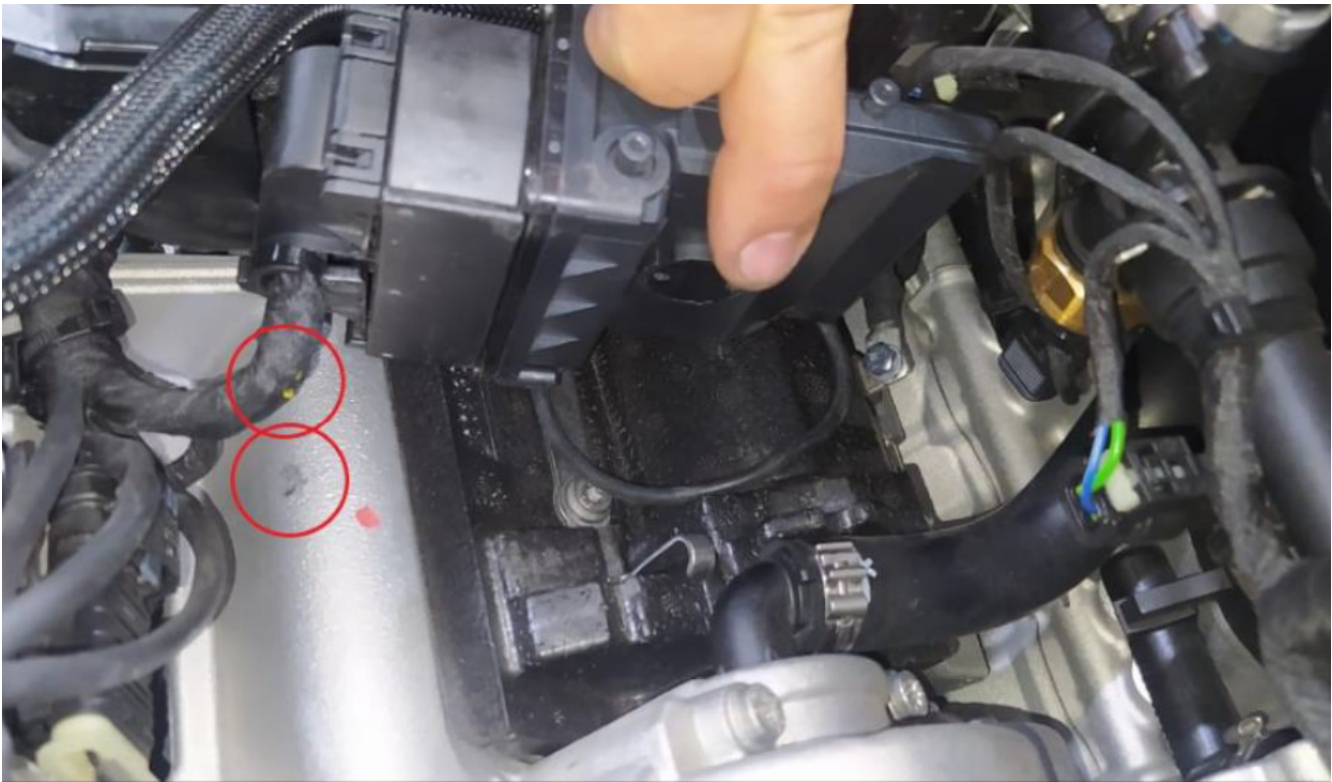
Figure 2: CHAFING MARK ON THE WIRING HARNESS AGAINST THE CRANKCASE

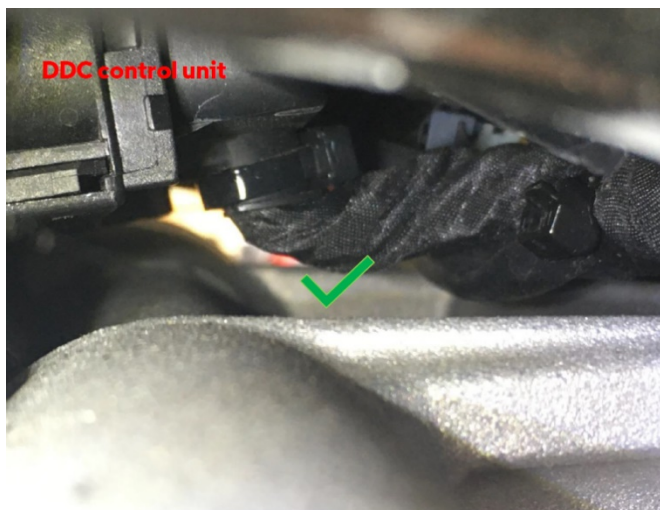
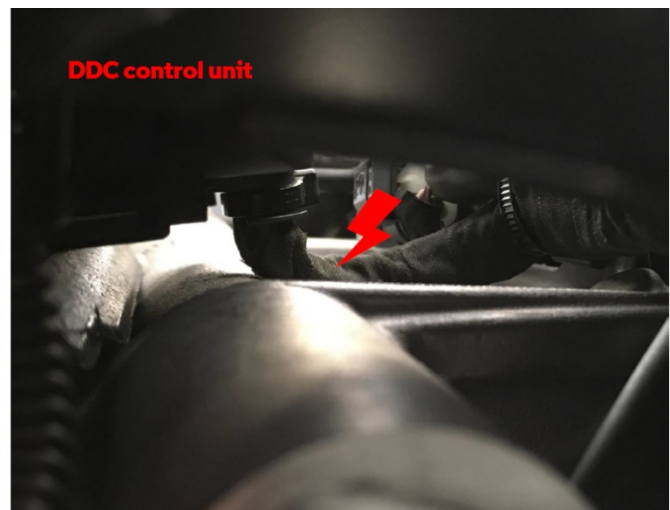
Figure 1: DETECTION OF A CHAFING MARK VIA THE LEFT SIDE

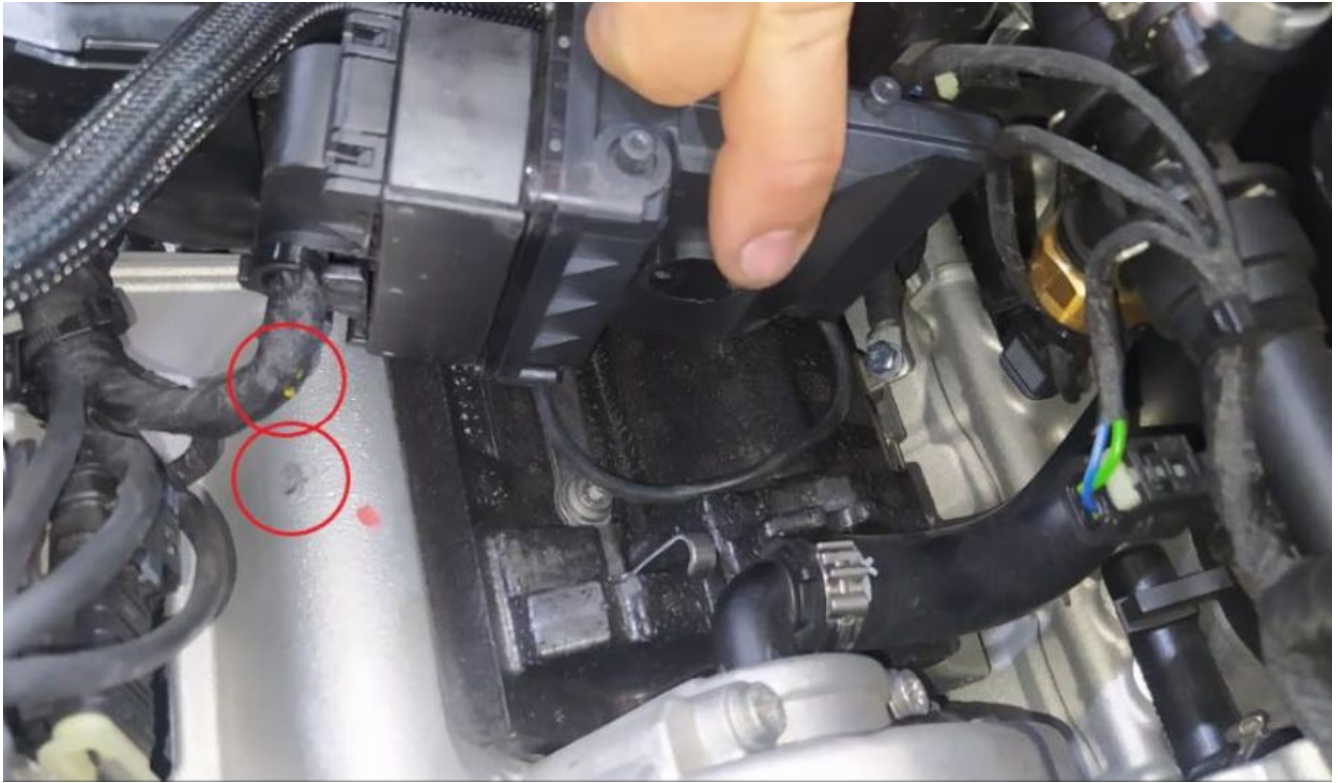
Figure 2: CHAFING MARK ON THE WIRING HARNESS AGAINST THE CRANKCASE

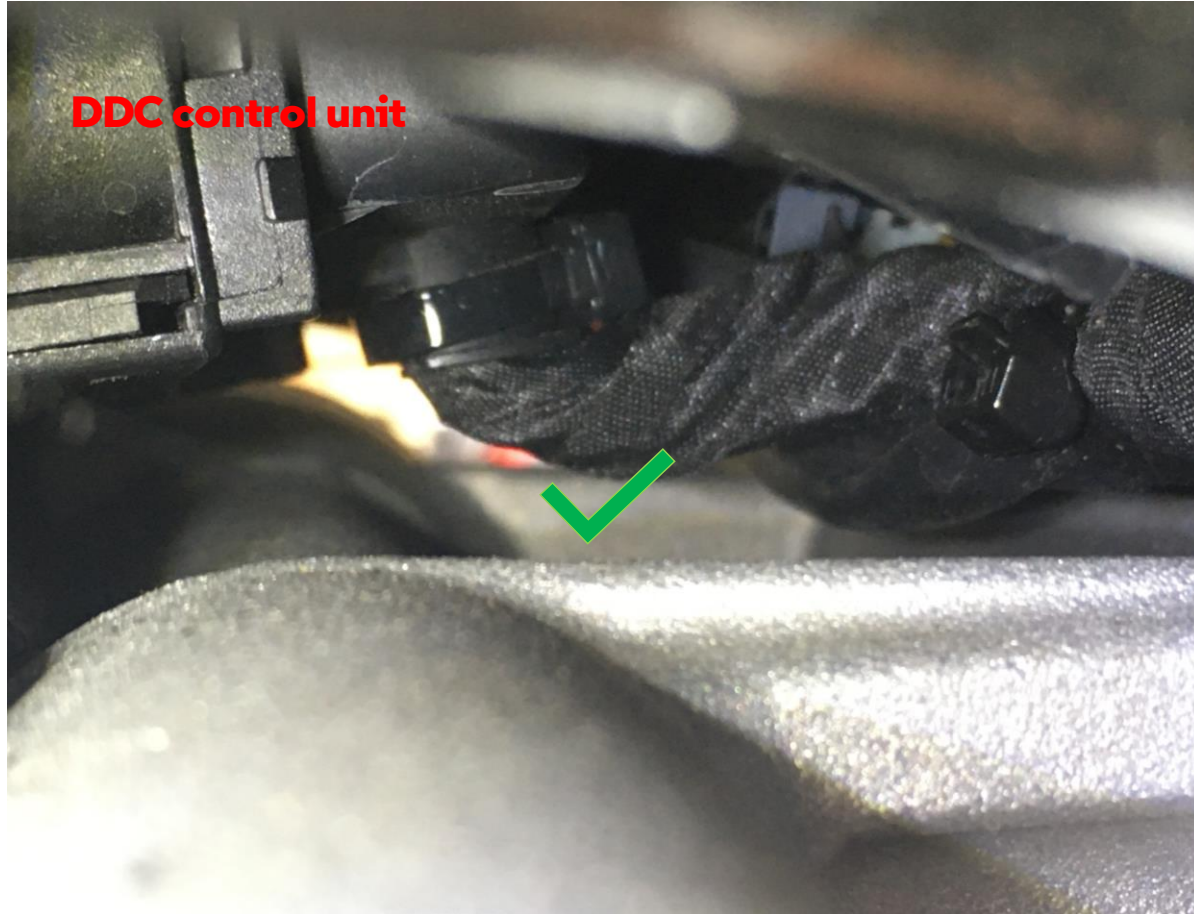
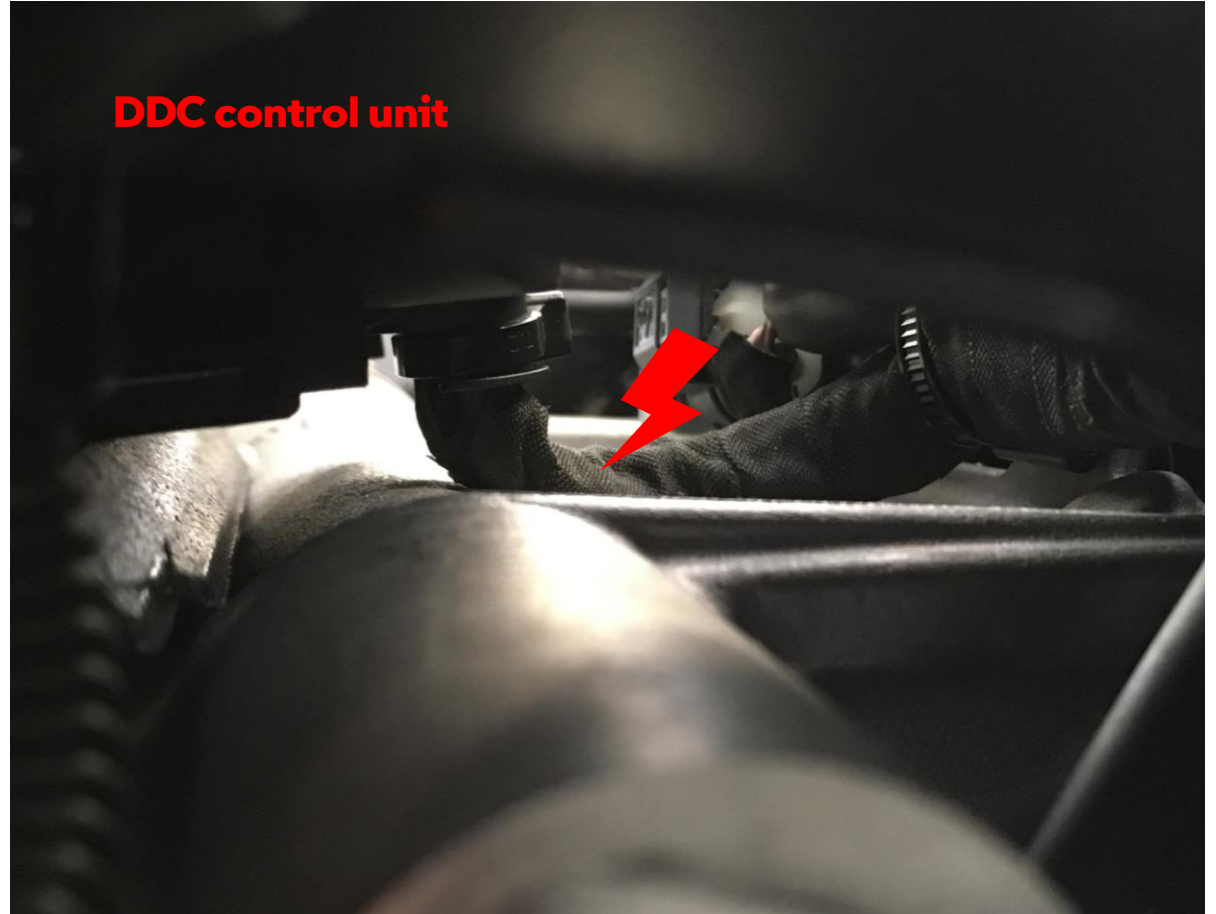
COMPLAINT: DDC FAILURE DETECTION OF A CHAFING MARK VIA THE LEFT SIDE

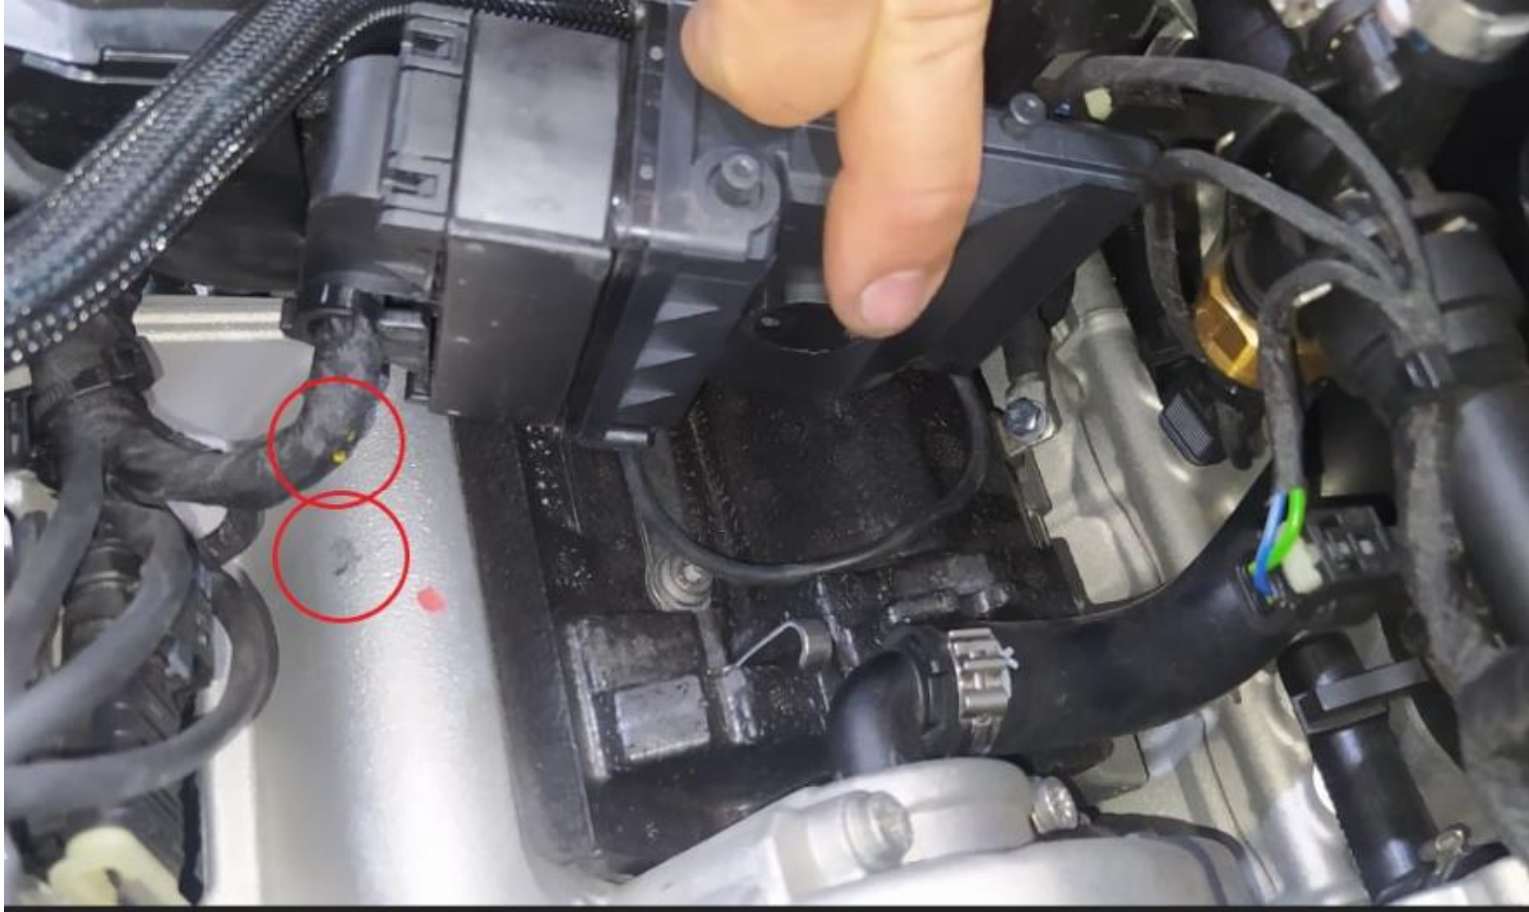
CHAFING MARK ON THE WIRING HARNESS TO THE CRANKCASE
