<h2 style="margin: 0;"><u>Technical Service Bulletin</u></h2>
---	---

Subject: Solitude ST346FLS - 2021 Gray Tank Repair Process	Number	21-002					
	Date	5/26/2021					
	Model	Solitude ST346 FLS/FLS-R					
		Vin Range - Non-Sequential					
Circulate To:	X	Service Manager	X	Parts Manager	X	Technician	573FS3828MAA2229 -
	X	Warranty Processor		Sales Manager			573FS3929MAA6319

**Solitude ST346FLS - 2021
Gray Tank Repair Process**

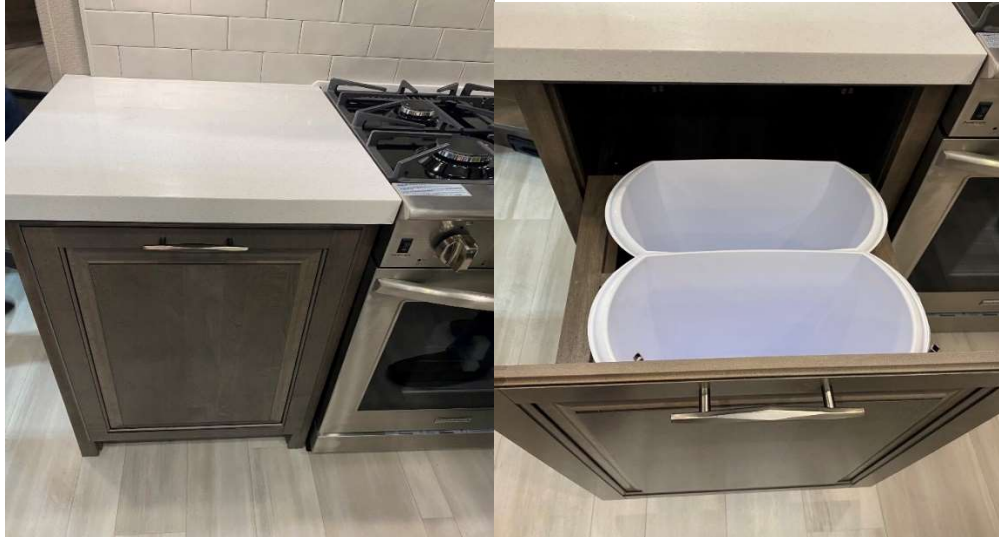
1. Locate and remove the drawer with the trash containers to the left of the stove.

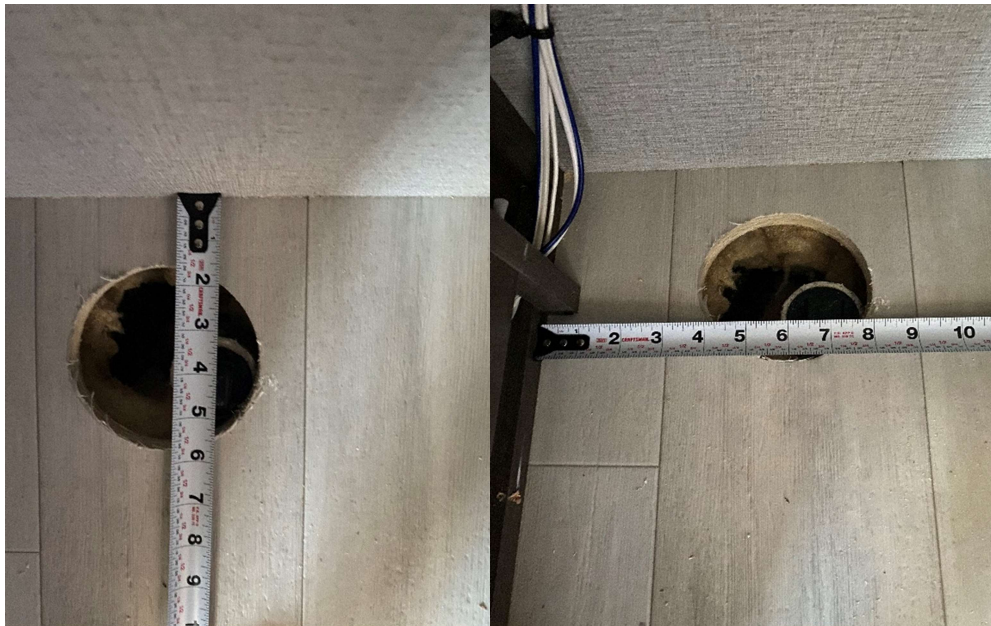
2. From the back wall inside the cabinet, measure forward 4" and from the left side cleat of the cabinet over 7"

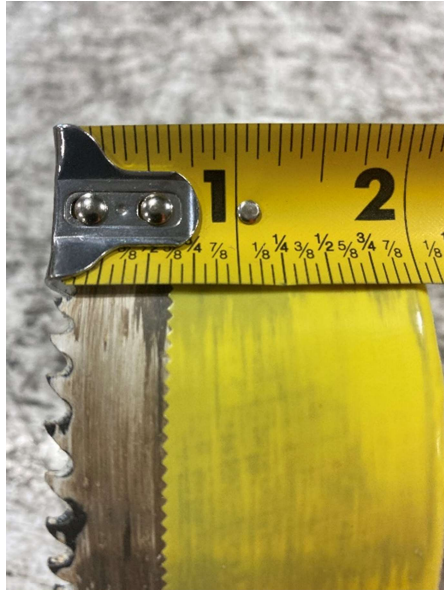
- Using a 4" hole saw mark with tape a depth of 5/8", drill hole through the floor exposing the top of the tank. **CAUTION: Cutting more than 5/8" depth could cause damage to the components below floor.**

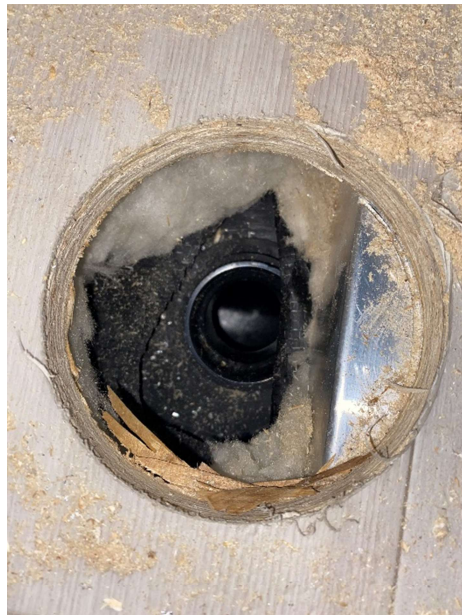
- Once the hole is cut, you will need to move the insulation aside and cut the "Darco" to expose the pipe.

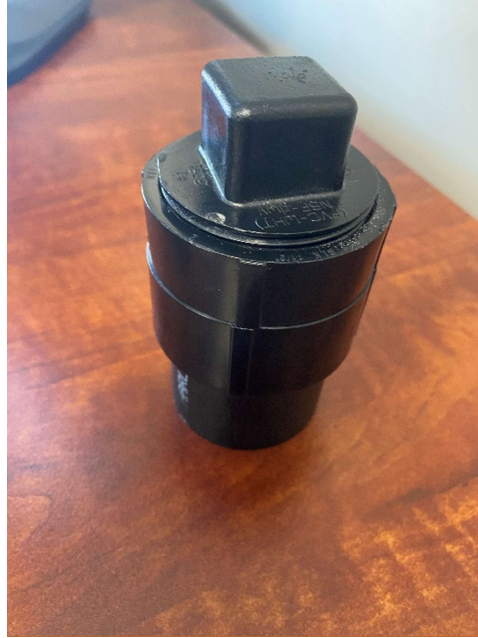
- Using the pipe assembly supplied in the kit, install into the tank using proper primer and glue.

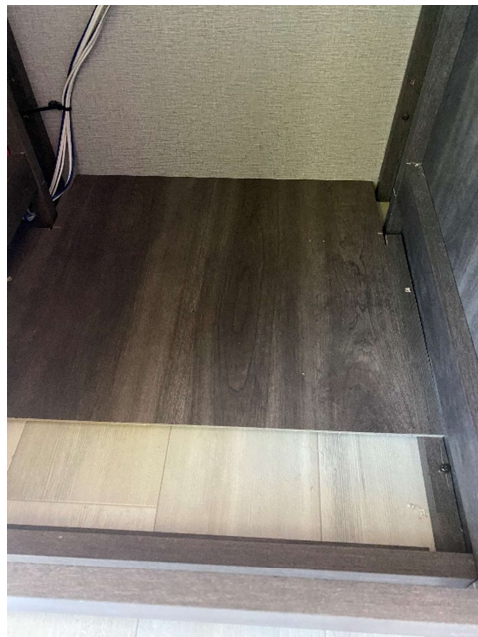
6. Install the supplied panel to cover the hole in the floor as shown below. Reinstall the drawer. Repair is complete.
