# HYUNDAI

## Technical Service Bulletin

GROUP <b>Body</b>	NUMBER <b>21-BD-005H</b>
DATE  <b>May, 2021</b>	MODEL(S) <b>Accent (RB), Accent (HC) Elantra (MD/UD), Azera (HG), Sonata (LF/LFa), Sonata Hybrid (LF HEV)</b>

**SUBJECT:** TRUNK LATCH BASE REPLACEMENT

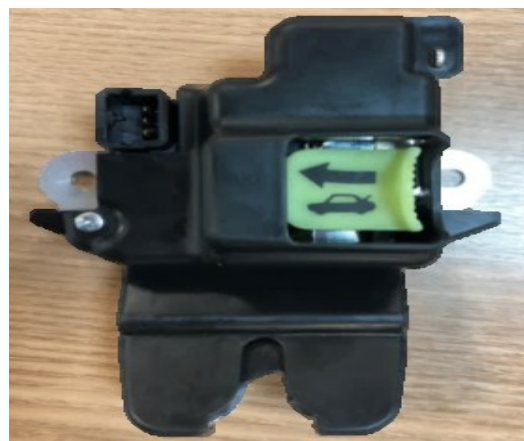
1. Remove the trunk latch assembly according to the applicable vehicle shop manual.

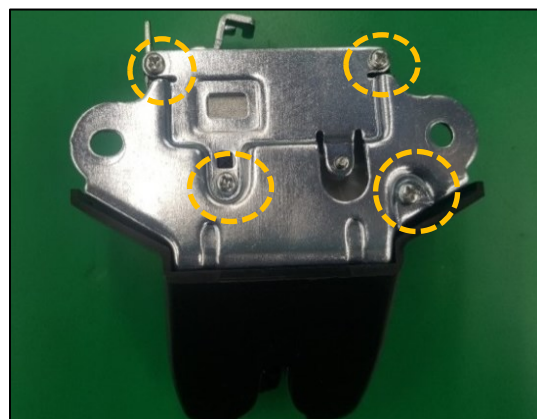
2. Remove the four trunk latch assembly screws.

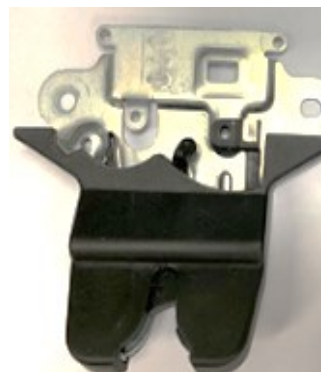
Latch Base

3. Replace the trunk lid latch base and reuse the actuator.

When reusing the actuator, do not contaminate the motor area.
