01-18-13 - MIL ON, DTC P0401 Exhaust Gas Recirculation Flow Insufficient

Release date: 6/2/2021

## Technical Background

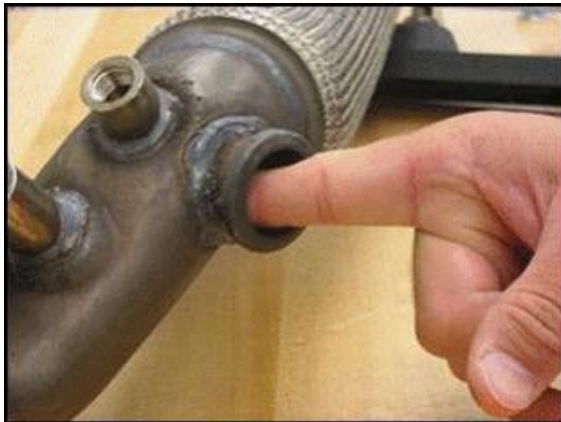
Figure 1

- Remove the EGR filter from the Diesel Particulate Filter (DPF) and swipe the inside of the exhaust pipe at the EGR filter connection point using a clean cloth or your finger. See figures 1 and 2 below.

If your finger or the cloth comes out with black soot:

- Replace the DPF & EGR filter together.
- Smoke test the charge air system for leaks (see procedure below).

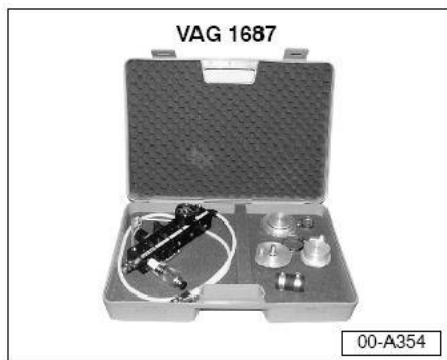
The charge air pressure system can be checked using the VAG 1687. Charge air system tester along with the VAG1687/10 adapter as follows:

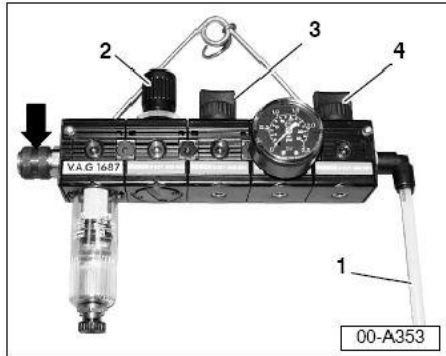
**Special tool VAG 1687 Charge air system tester, preliminary set-up**

- Back off pressure regulator knob -2- of VAG 1687 fully to protect gauge when shop air supply is applied to the assembly.
- Close valve -3- before gauge.
- Close valve -4- after gauge.
- Shop air supply line will later be attached to inlet of VAG 1687.
- Remove “female” fitting from tester (arrow) and install an appropriate “male” air fitting that will connect to your shop air supply line (See Note below).

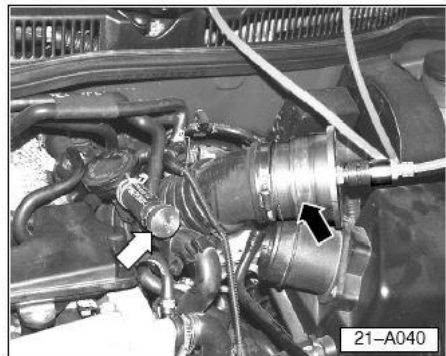
**Special tool VAG 1687/10 pressure adapter, installing**

- Separate intake hose from the Mass Airflow Sensor assembly (MAF).
- Insert VAG 1687/10 pressure adapter in intake hose -black arrow- using existing clamp (as shown).
- Remove crankcase ventilation valve or tube from intake hose at -white arrow-.
- Plug hose with appropriate metal plug and hose clamps supplied with VAG 1687 special tool kit at -white arrow-.

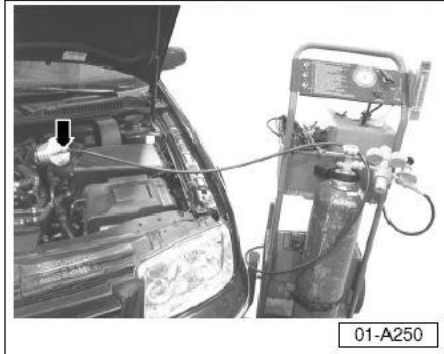
**Special tool KLI9210 (EVAP system leak detector)**

- Install optional fitting KLI 9210/50 on hose of special tool KLI9210.
- Connect KLI9210 to VAG 1687/1 adapter (KLI 9210 is shown attached to VAG1687/1 at arrow on 1.8L Turbo).

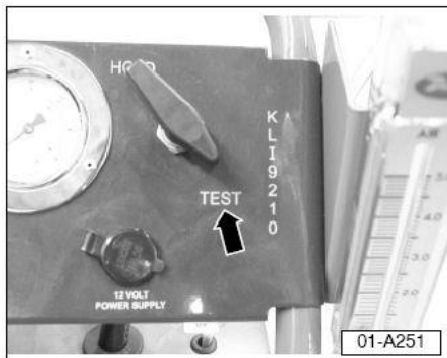
**Special tool KLI9210 (EVAP system leak detector), preliminary set-up**

- Setup KLI 9210 as described in user manual regarding self-test and output pressure.
- Connect smoke generator leads to vehicle battery.
- Turn valve to test (black arrow).
- Press smoke generator button to fill system with smoke (see instructions printed on tester).
- Check for escaping smoke for two minutes.

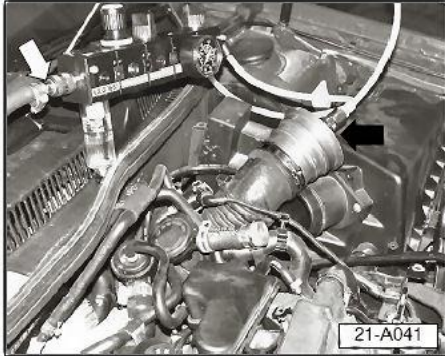
**Special tool VAG 1687 connecting to pressure adapter 1687/10**

- Connect VAG 1687 quickly to prevent smoke from leaking out.

VAG 1687 is shown connected to VAG 1687/10 (black arrow)  
Shop air supply connected to VAG 1687 at (white arrow).

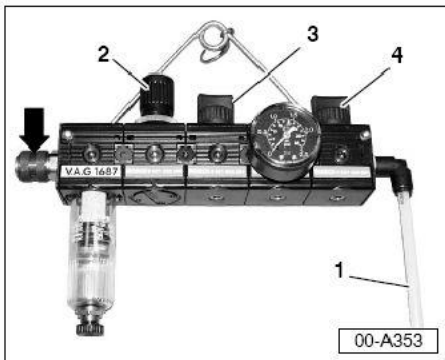
**Performing pressure Test:**

- With outlet hose -1- of VAG 1687 connected to air pressure adapter.
- Attach shop air supply line to previously installed male fitting.

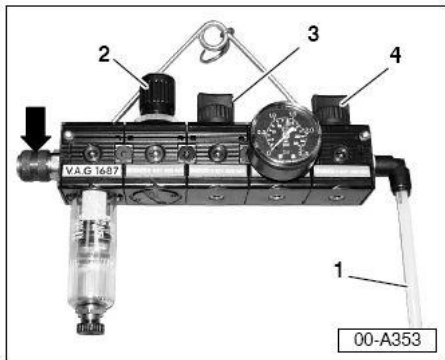
- Open valve -3- between regulator valve and gauge.
- Adjust test pressure up to 0.5 bar (see Note below) by turning the regulator valve -2-.

- Slowly open outlet valve -4- (after gauge) to test hose connections.
- Observe pressure gauge for a drop in pressure.
