June 18, 2021

Warranty Extension: 2016-21 Civic A/C CondenserSupersedes 19-091, dated May 28, 2021, to revise the information in **yellow**.**AFFECTED VEHICLES**

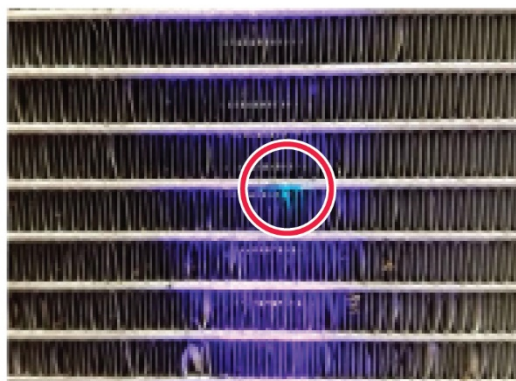
Some condensers may have multiple leaks.

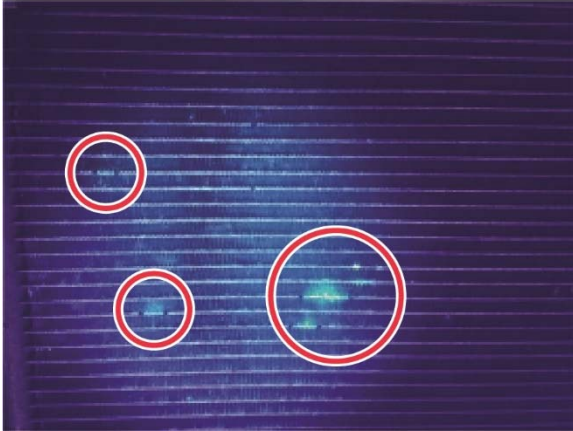
- *If the condenser is leaking, go to the next step.*
- *If the condenser is not leaking, this bulletin does not apply. Continue with normal troubleshooting.*
